# *Landslides at Karwar, October 2009: Causes and Remedial Measures*

**ENVIS TECHNICAL REPORT: 33**  
**November 2009**

# **Landslides at Karwar, October 2009: Causes and Remedial Measures**

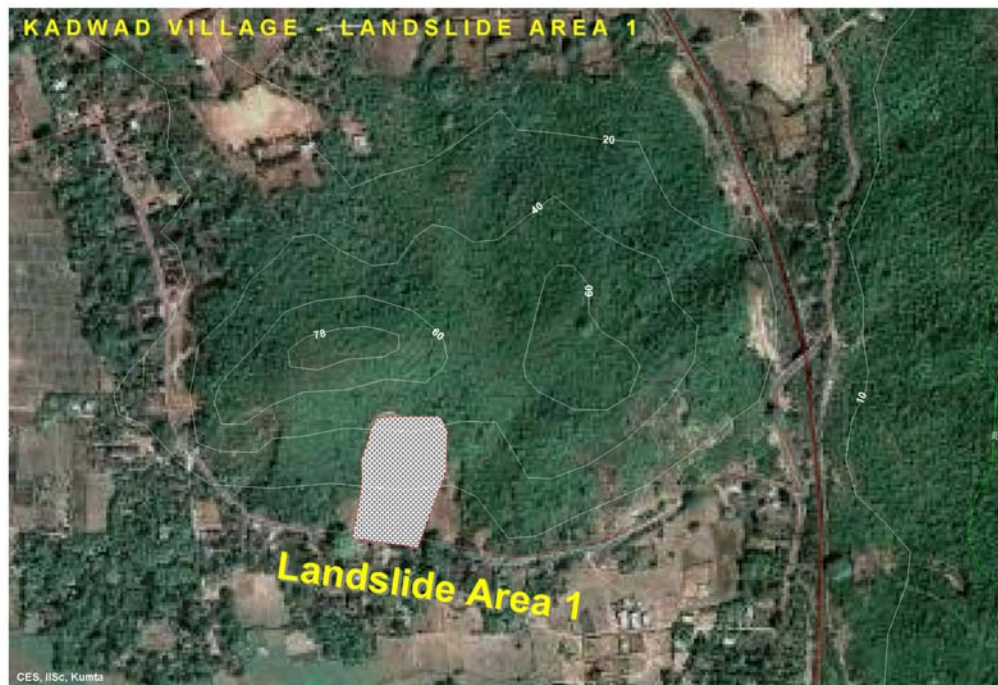
Fig.2.4: Kadwad Landslide Area 1 (no casualties happened here. Note the lineament starting from right of Landslide Area 1 in the NE direction)

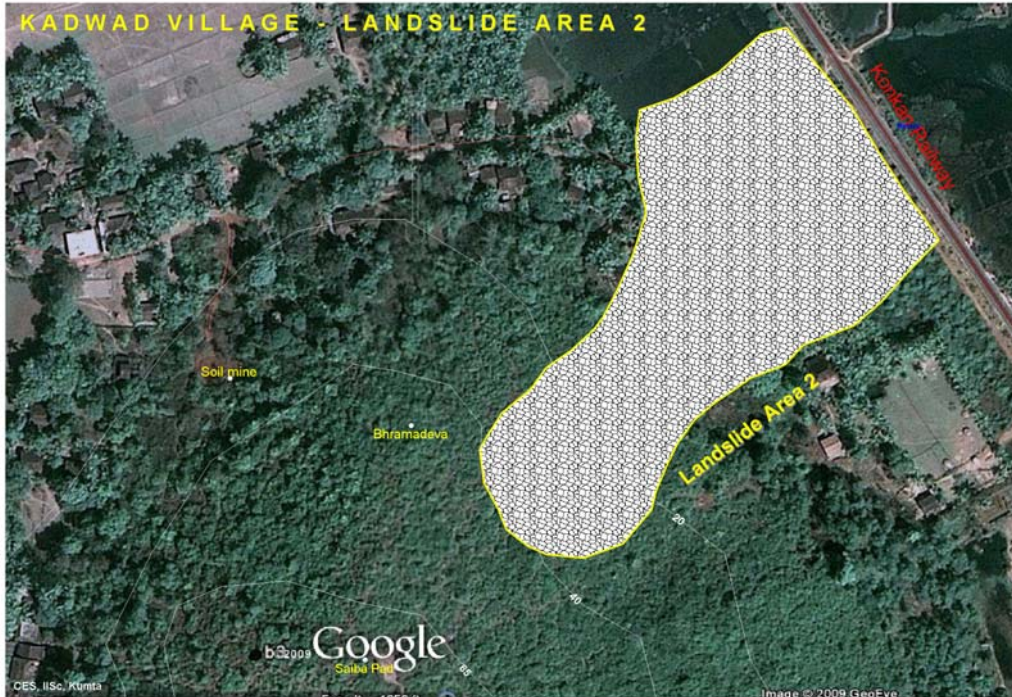
Fig. 2.5: Kadwad-2 (Zariwada) landslide area (where 19 deaths happened)

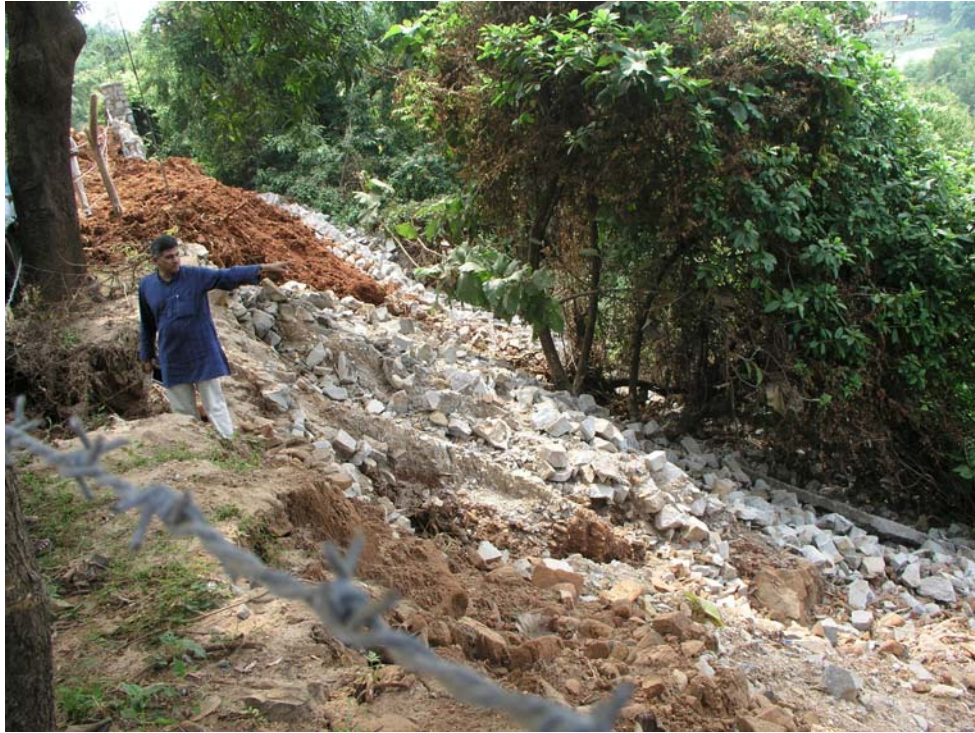
Fig.2.6: Rock and soil that slid into the Project Seabird Naval Base

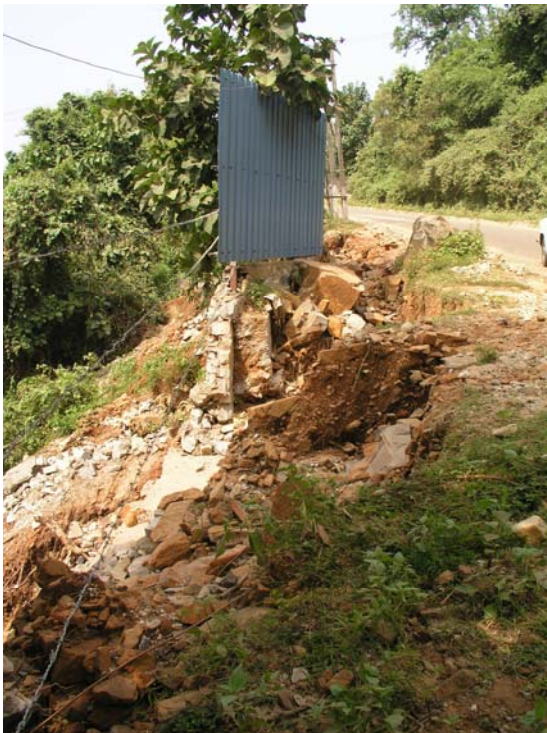
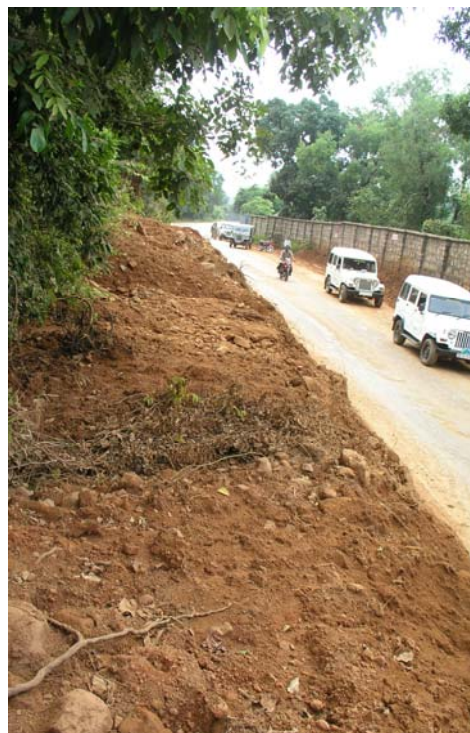
Fig. 2.7: Breach in the wall of the Naval base. Fig. 8: NH-17 cleared of debris; on the right compound wall of Naval Base

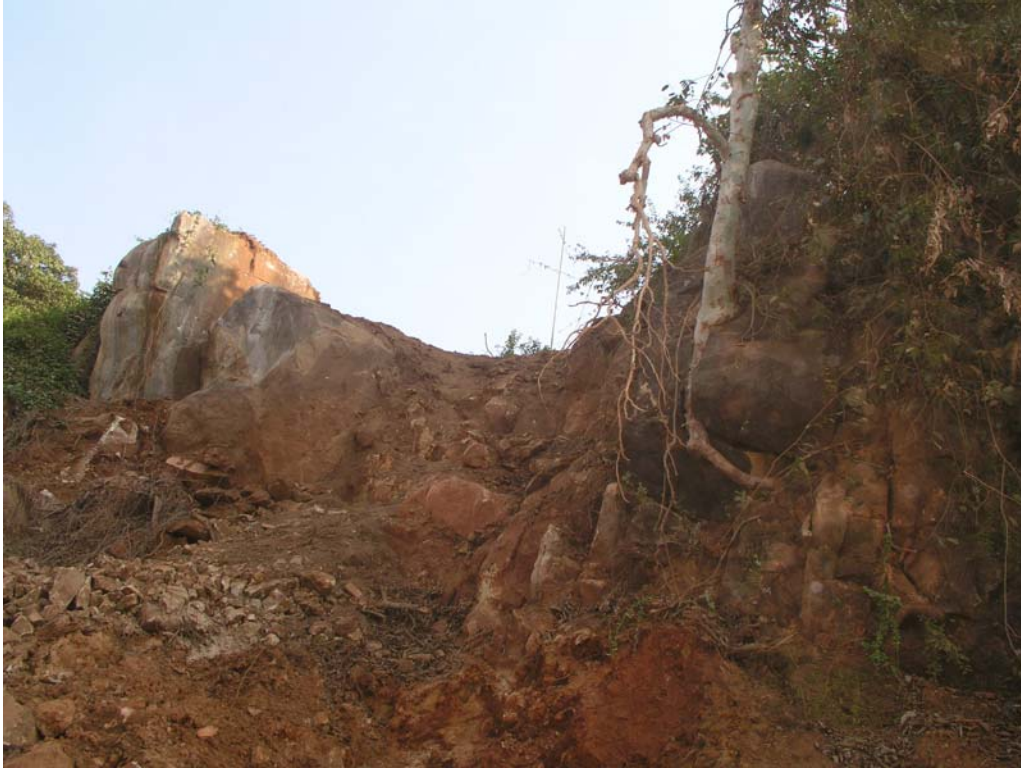
Fig.2.8: Landslide close to NH-17 on steep hill atop which DC's residence is located

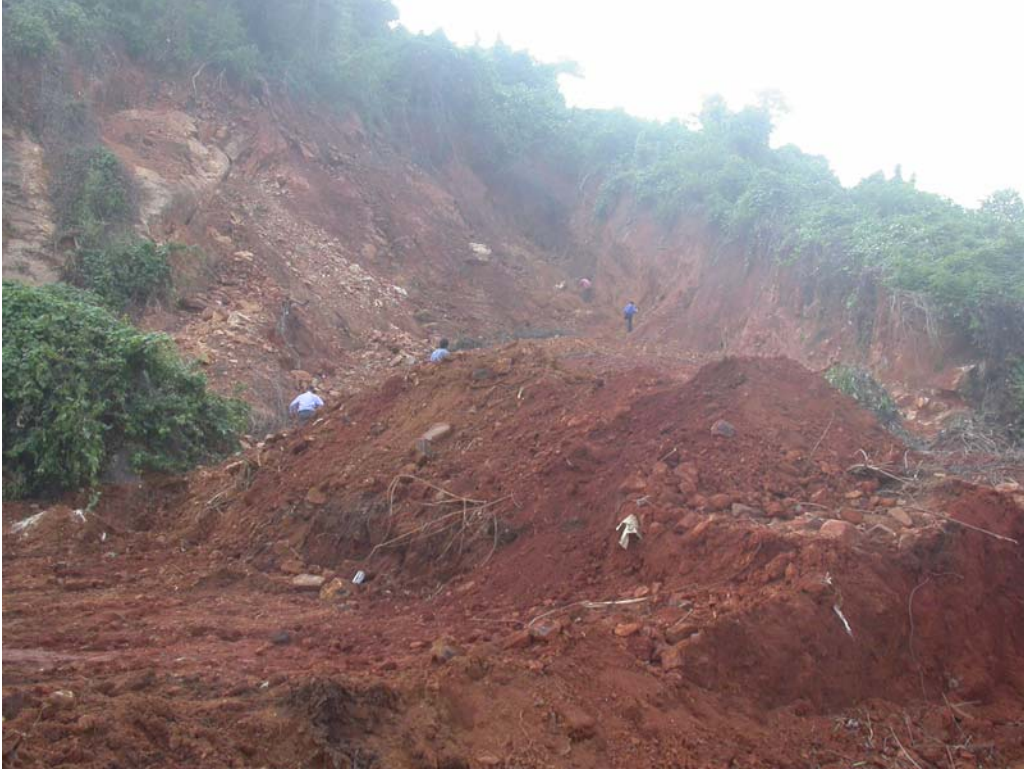
Fig.2.9: Baithkol landslide

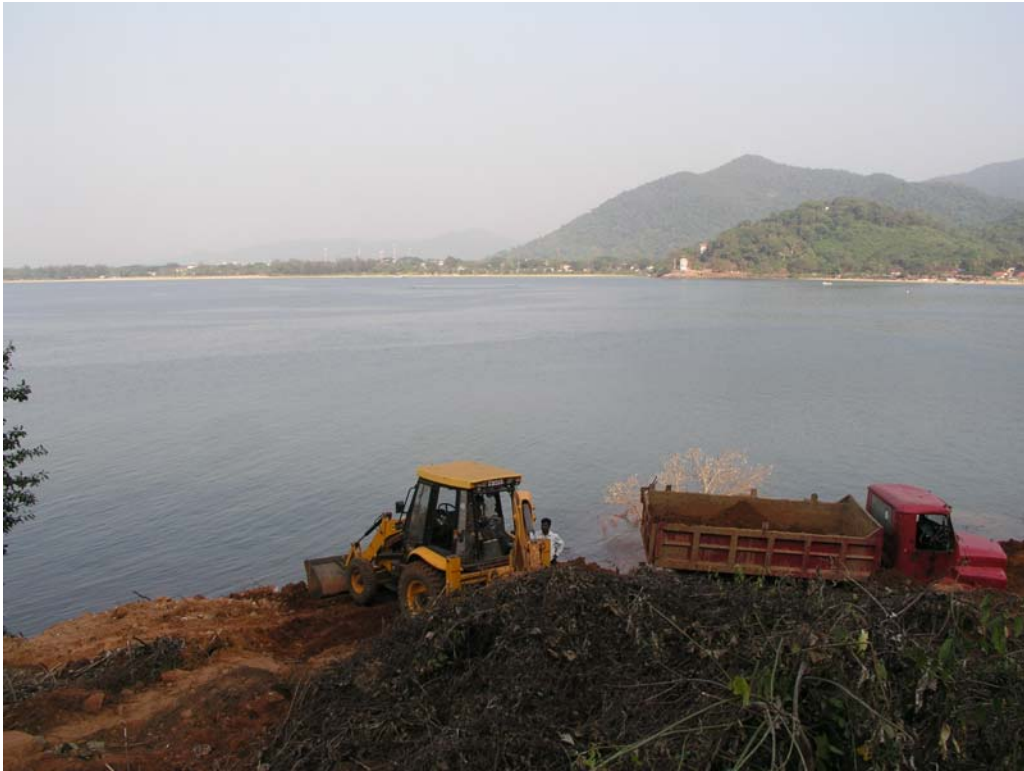
Fig. 2.10: Clearing debris at Baithkol landslide (Karwar Bay in the backdrop)

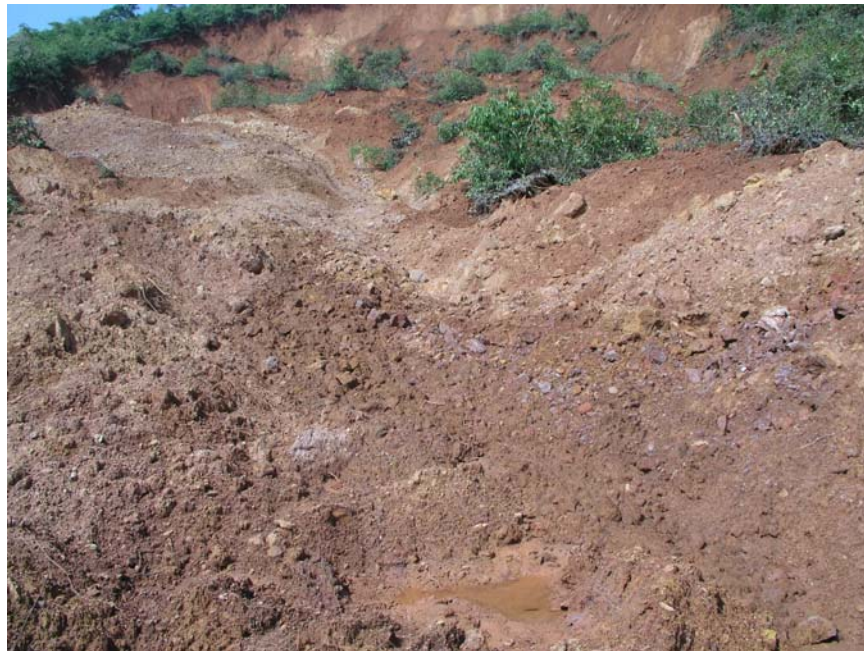
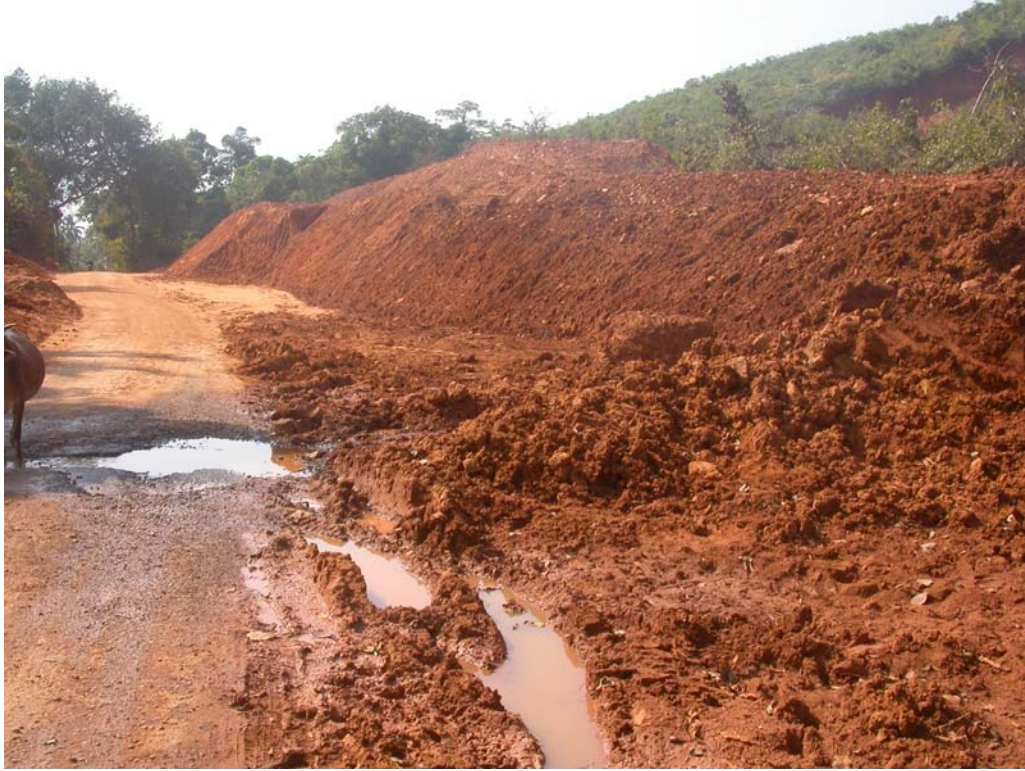
The landslide-1 happened taking away roughly about 100 m wide swathe of a scrub-covered hill. The slide started at about 45 m height in the 78 m hill, towards its southern slope, and the rubble, mostly of soil and mud, moved towards the habitation below, almost crossing the road skirting the hill. The direction of slide was from north-east to south-west. The landslide covered nearly an area of about one hectare (Figures 2.11-2.12). No human casualty happened here, nor any significant loss of property. Preventive measures should be taken forthwith to shelter people and their houses from recurrence of such hazards in the future.

Figs. 2.11-2.12: Images of Landslide-1 in Kadwad, soil and mud predominating

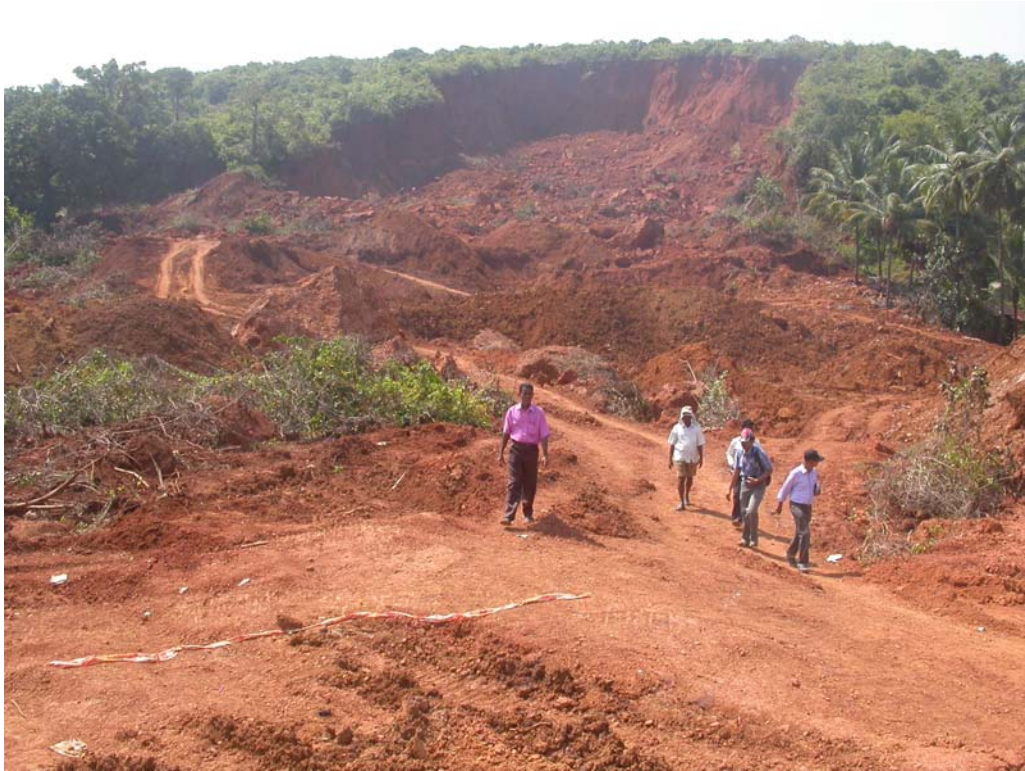
Fig. 2.13: Landslide-2 in a scrub Kadwad village

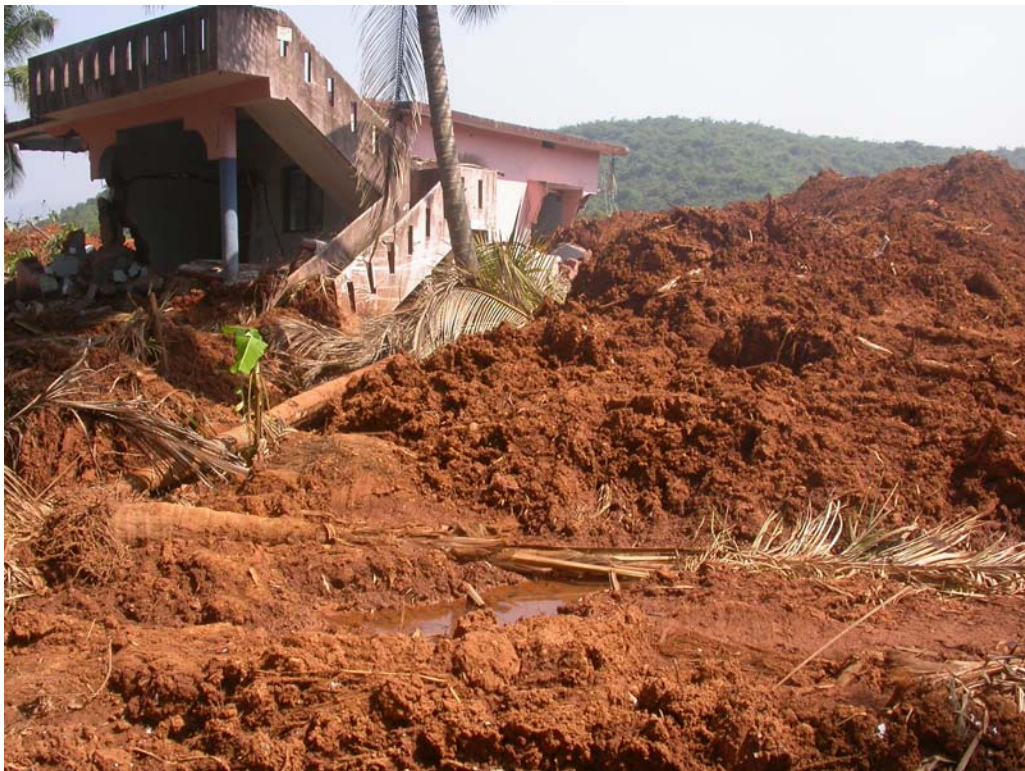
Fig. 2.14: A building that has been carried away by about 15 m in the landslide

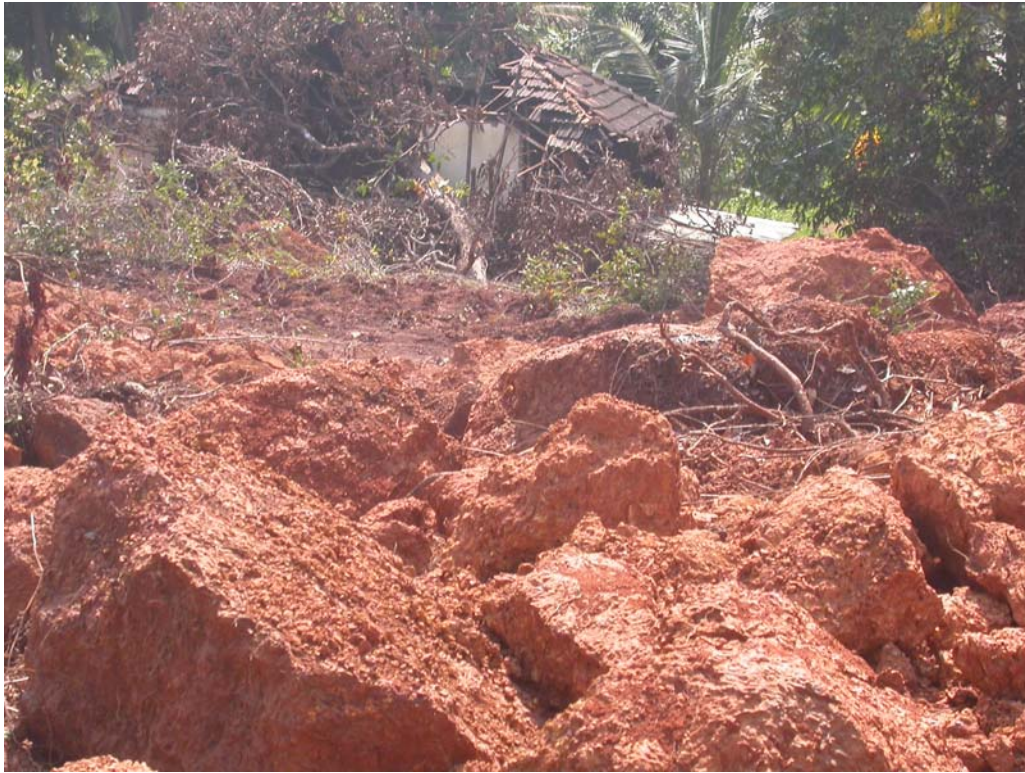
Fig.2.15: Soft laterite in the slide materials at Kadwad Landslide-2

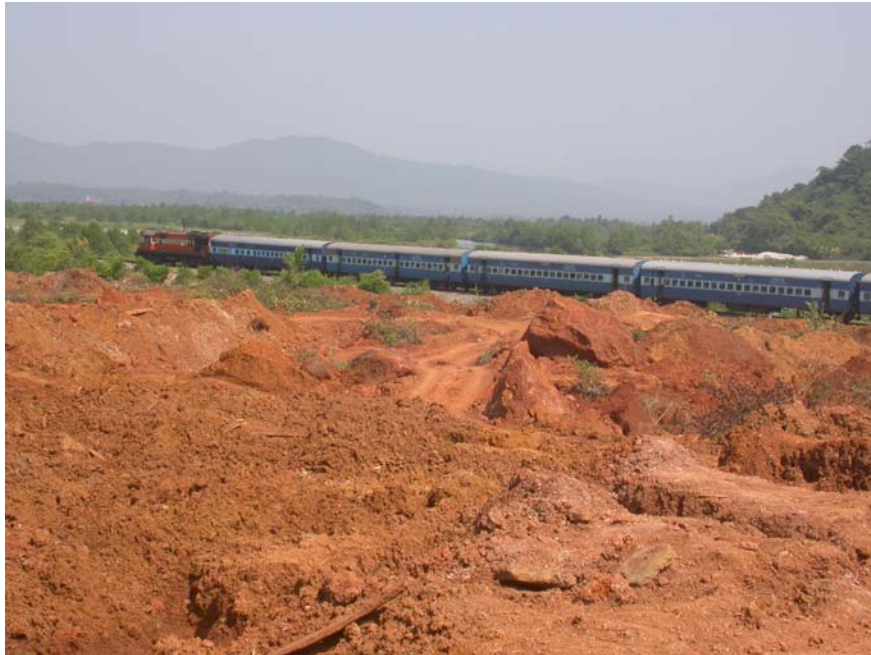
Fig. 2.16: The slide materials at Kadwad Landslide-2 stopped at the railway Embankment

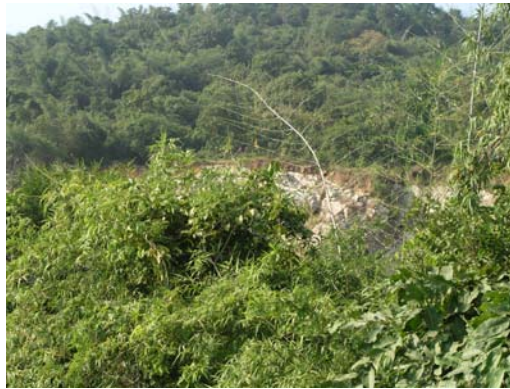
Fig: 3.3. Vegetation of Arga hills (note stone quarry inside forest)

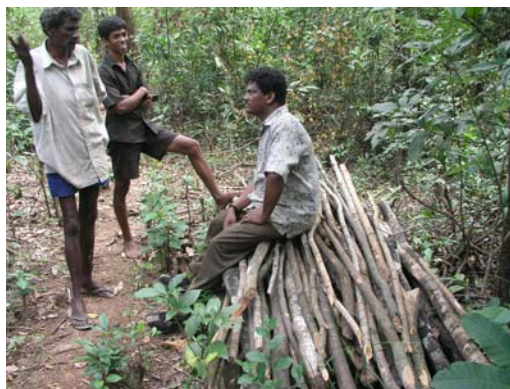
Figs: 3.4. Forest degradation in Amdalli hill

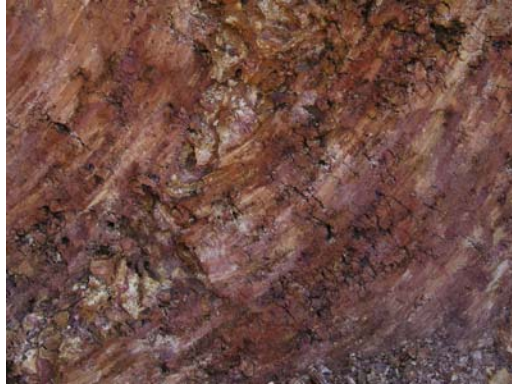
Fig: 4.2. Partially formed soft laterite in Zariwada landslide at Kadwad (lack of erosion due to water logging may be the cause of this formation)

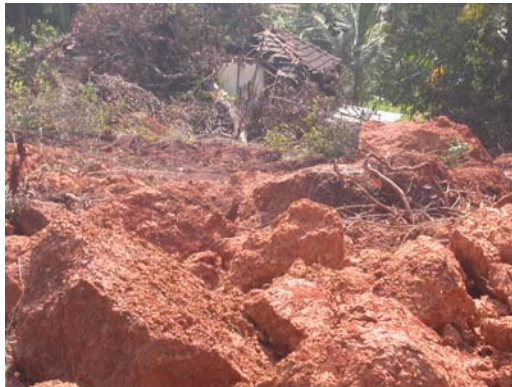
Fig: 4.3. Imperfectly evolved soft laterite in the Zariwada landslide at Kadwad

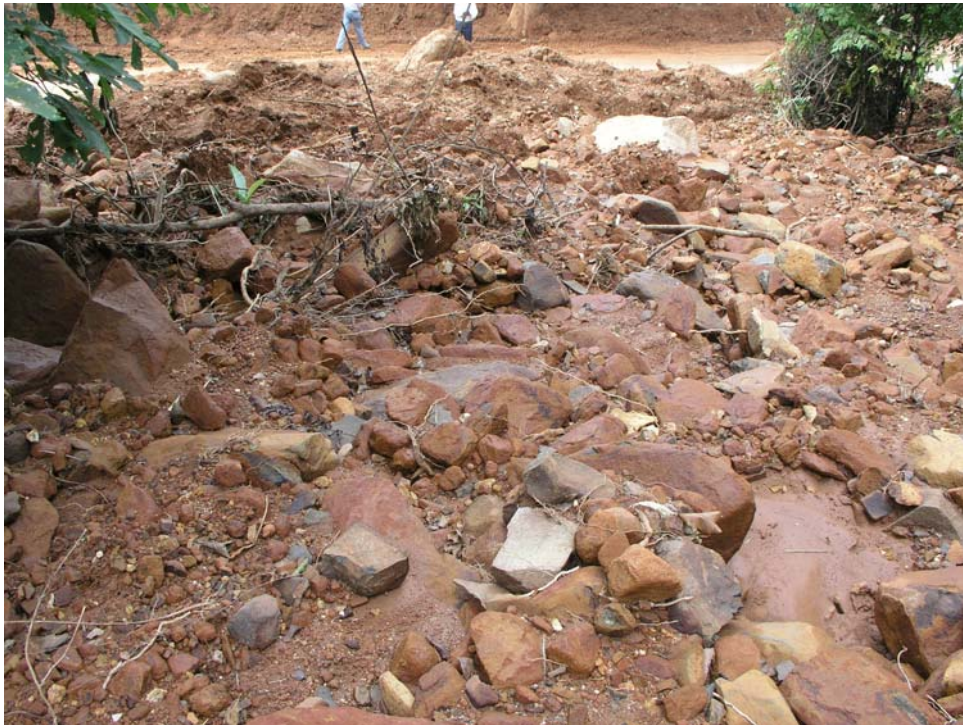
Fig 4.6: NH-17 landslide at Arga hill- unconsolidated mass of soil and granite rocks

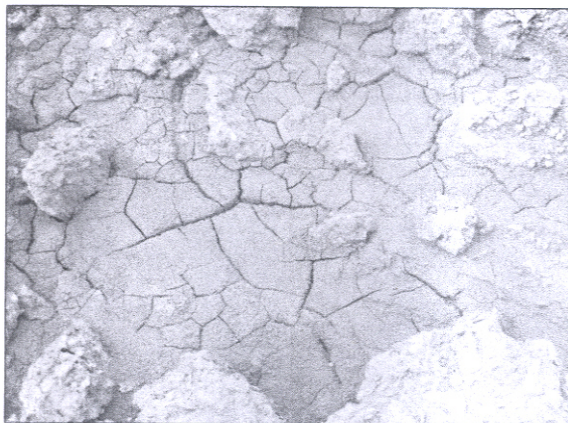
*Photo4: The clayey soil with mud cracks in the debris.*

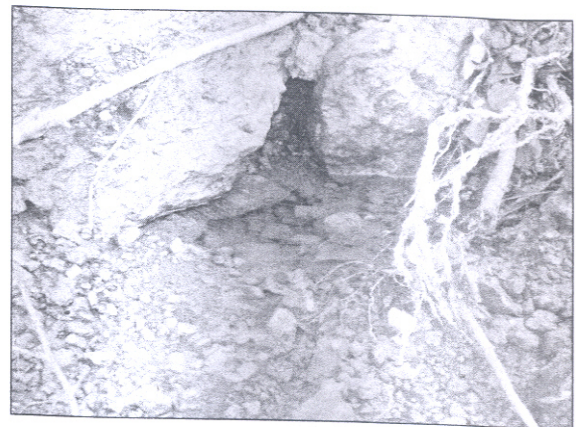
*Photo5: The natural stream formed in the zone of depletion.*

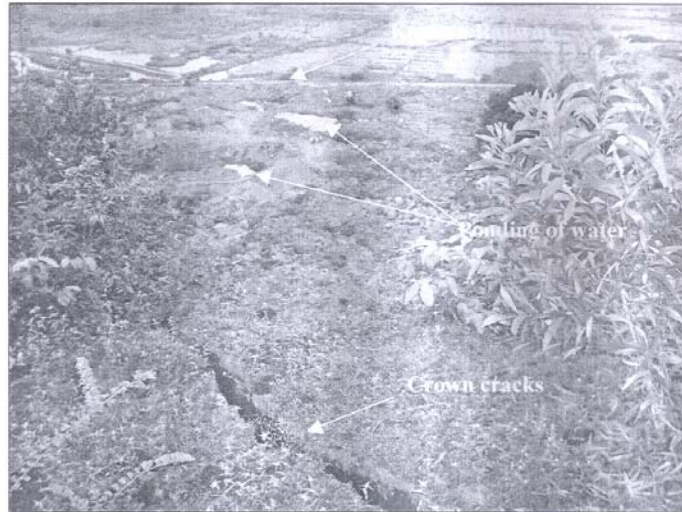
- f. Even though percolation through vesicular laterite is high the drainage facility in the area was poor to drain out the excess infiltrating water from the slope.

*Photo6: View of the crown cracks and the ponding of water in the slide zone*

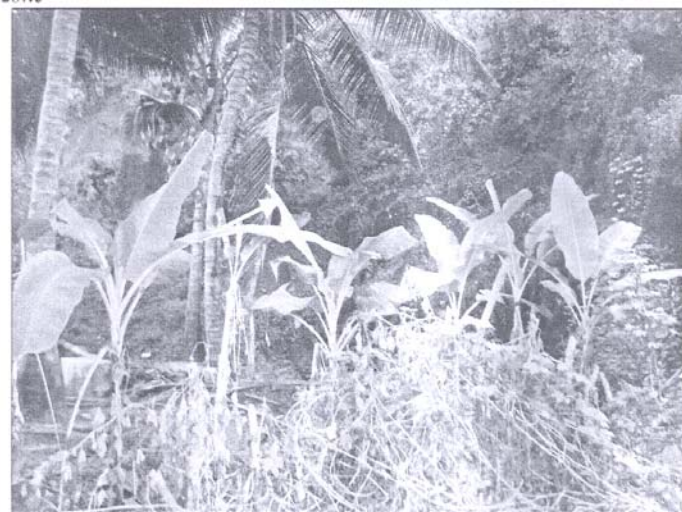
*Photo7: The remnant cut slope exposed in the left flank of the slide*

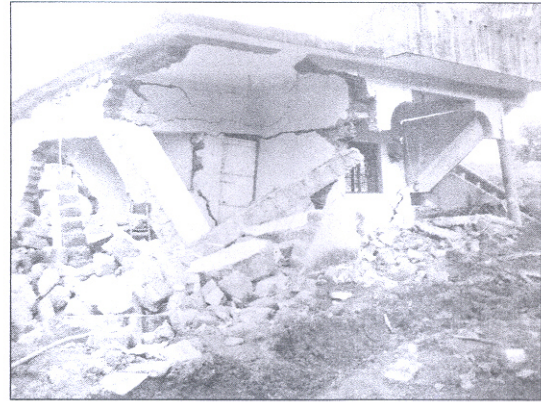
*Photo11: The damaged house near the left flank of the slide*

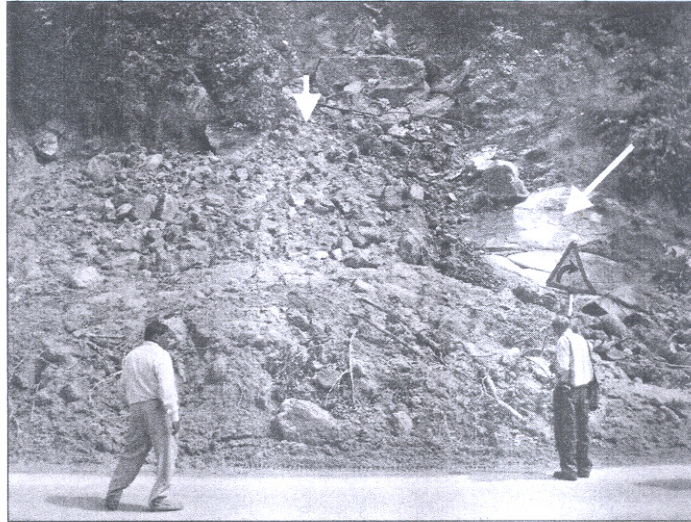
*Photo15: View of the slide with exposed shallow dipping plane (right arrow) and mafic dyke boulders (left arrow)*

- a. A retaining wall at the toe of the slide as the slide toe lies very near to the road cutting
- b. Benching of the slope with grading of the crown, as the slope relief is low and slope angle is gentle
- c. Increasing the land cover with deep rooted plants.

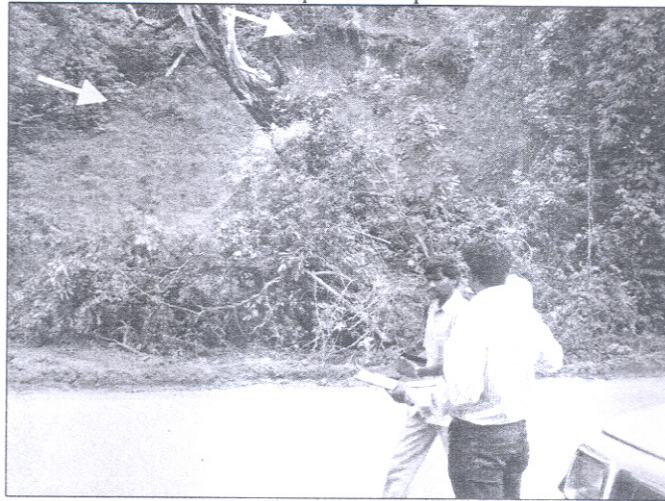
*Photo16: The old slide scar (left arrow) and the new slide (right arrow)*

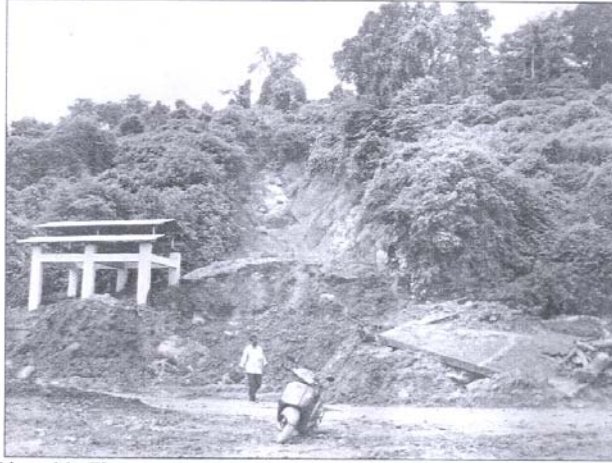
Photo20: The movement of the debris along a joint plane

- a. Retaining wall at the base of the slide after removing the debris.
- b. Removal of the crown scarp from the left flank of slide.

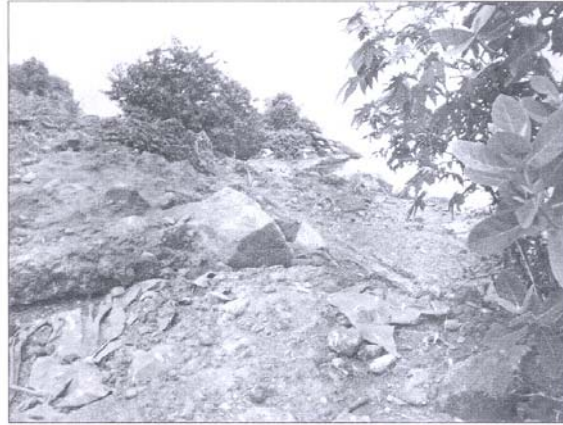
Photo21: The slide debris slammed into the sea.

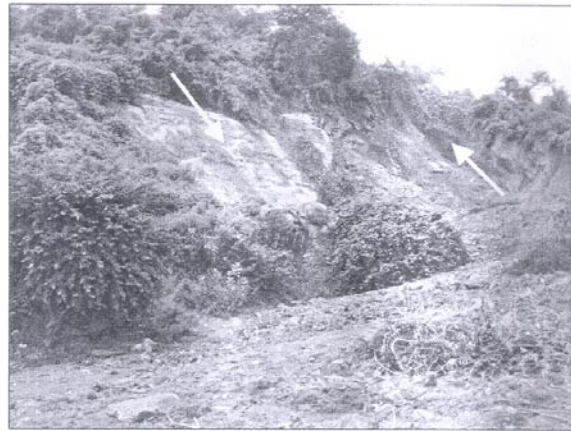
Photo22: The view of the slide zone with both joint controlled (left arrow) planer failure and rotational failure (right arrow).

**Recommendations:** The original slope angle is gentle with a very low relief. As the main cause is road cutting the debris is to be removed and retaining wall with weep holes at the toe should be provided.

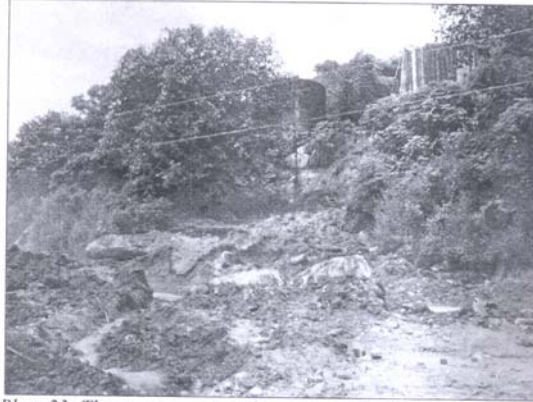
*Photo23: The structures near the crown of the slide are in danger.*
