# Two years, two floods, Karnataka got no solutions yet

*Large number of unscientific development works in Talacauvery led to landslides; neighbours have to sort out water-sharing issue to prevent future calamities*

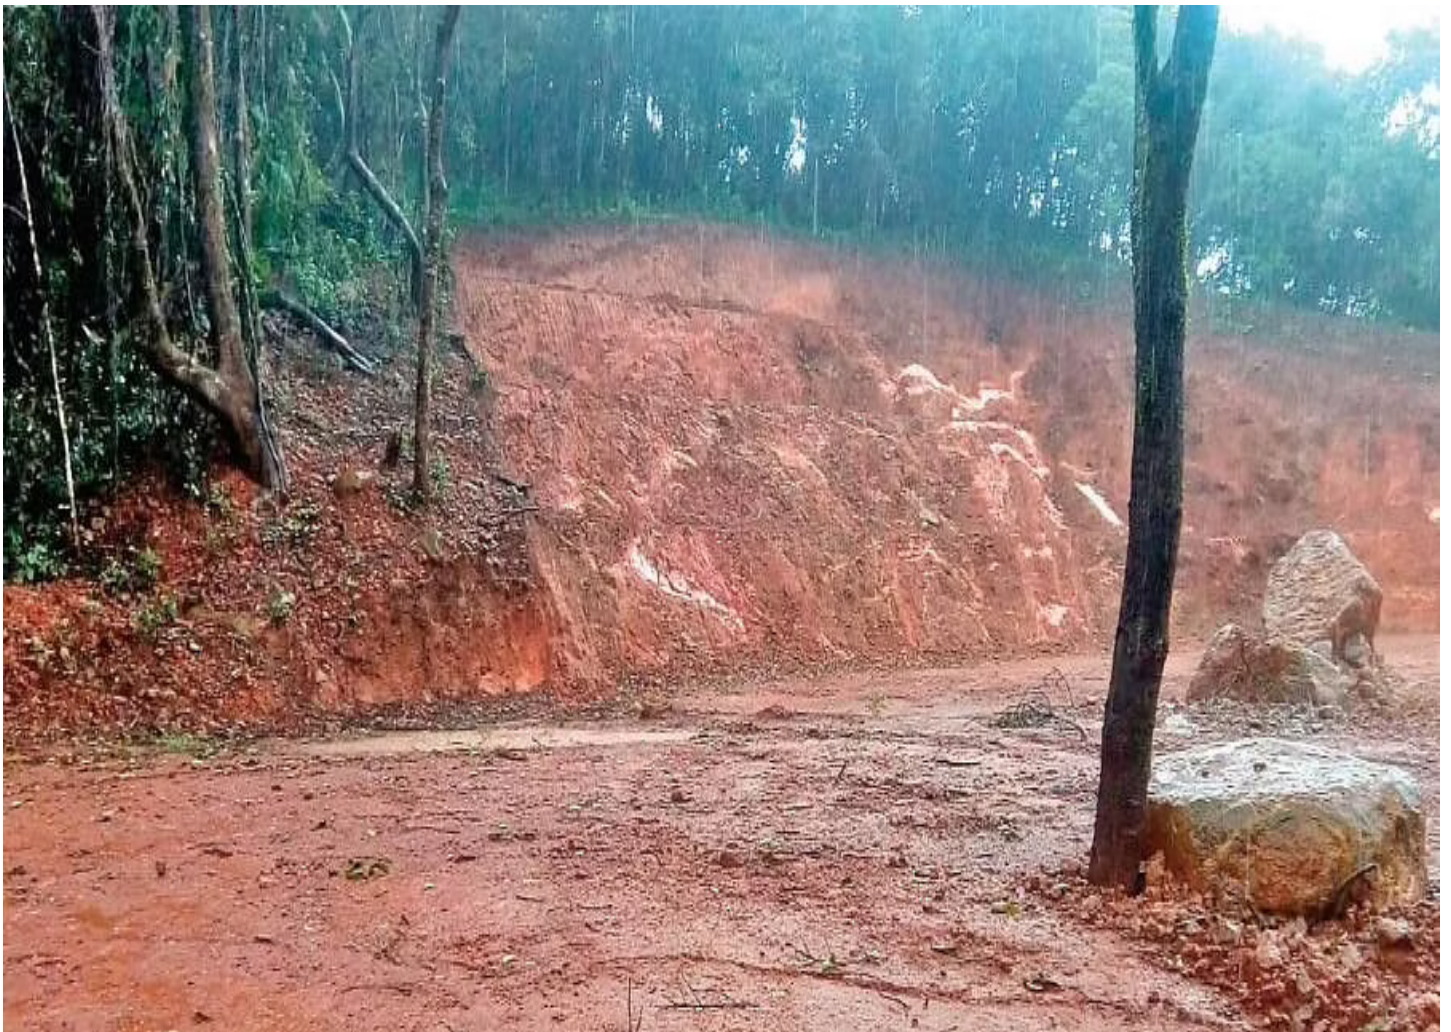
The site in the Talacauvery region where the construction work was alleged to have been carried out | EPS
