The temple tanks of Madras, India: rehabilitation of an ancient technique for multipurpose water storage

Madhavi Ganesan

Centre for Water Resources, College of Engineering Guindy, Chennai, India
madhaviganesan@yahoo.com

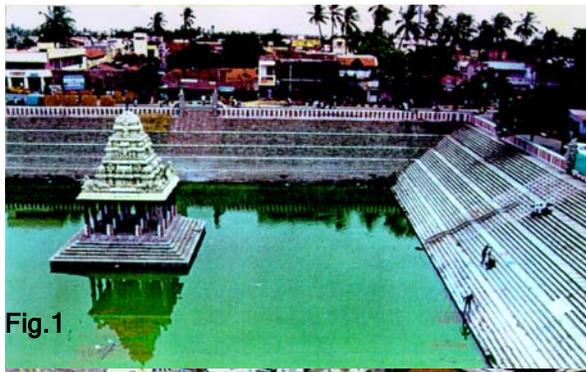
Fig.1

Temple tanks are either square or rectangular in plan, and are truncated trapezoidal in section, being staggered from top to bottom as shown in Fig. 1. Often, temples have two tanks: one inside and the other outside the temple building. Granite slabs are used for constructing the steps on all sides. Normally, each step has a tread of one foot and a rise of half a foot (GOI, 1961). At every tenth step there is a landing of two foot width, having the same rise of half a foot as shown in Fig. 1. This gives stability to the structure.

Fig. 1. Various features of temple tank including Neerazhi Mandapam; Fig. 2. View of the major inlet situated in the south west corner of the Mylapore temple tank; Fig. 3. View of well inside the tank; Fig. 4. Location of the study area- Mylapore; Fig. 5. Plan & section of the Mylapore tank; Fig. 6. View of concrete bed at Sri Parthasarathy temple tank; Fig. 7. Sri Madhava Perumal temple tank, Mylapore; Fig. 10. View of Mylapore tank after renovation- 1992; Fig. 11. View of Thirupporur temple tank.

In Madras (now Chennai) the major inlets are usually placed in the south west or the north west corner of the tank as shown in Fig. 2. The land slopes from west to east. The major inlet is connected to its own catchment area or another water resource through storm drains. Apart from this inlet there are a few other slots like inlets on all sides of the tank. These help to link the water table and the tank laterally. Most of the temple tanks also have an inlet from the temple area. It has been observed from the original layout of tanks in Madras City, there was series of inter linkages among the tanks to allow excess flow of water to decant into the neighbouring tank. This design provided for both inlet and outlet drainage. There is a structure known as a Neerazhi Mandapam situated in the centre of the tank. The main purpose is to house the deity during the Float Festival. It is constructed with granite stone (Fig. 1).

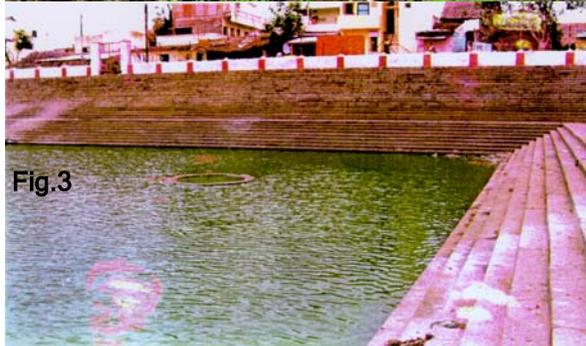
Fig.3

Most of the tanks are having wells in their bed. Their presence is relevant in the present context and one can visualize a certain functional role for them. The wells link the aquifer and tanks and are supposed to serve for natural recharge. Wells in the tank are shown in Fig. 3. Thus the design of the temple tanks is ideal from the point of view of harvesting, storing rainwater and recharges the aquifer.

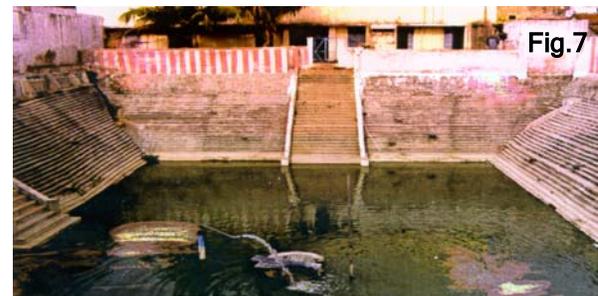
Fig.7

Sri Madhava Perumal temple tank is situated within the premises of Sri Madhava Perumal temple in Thyagarajapuram near Mylapore tank (Fig. 7). This tank has an area of 480 m². As stated earlier, this tank could not retain any water before its renovation. Renovation commenced in June 1990. The tank bed was covered with puddle clay to a depth of one foot. Over this, half a foot depth of silt sand was laid. A bore was sunk at the centre of the tank. Water pumped from this bore was used to fill the tank to a height of two meters yielded about 13 m³ per hour. Daily evaporation from the tank is compensated by pumping water from the bore for one hour daily. The open well situated at the centre of the tank is closed with a concrete slab during summer seasons and is opened during rainy seasons.
