Landslides in coastal Uttara Kannada: Management towards risk reduction

Abstract

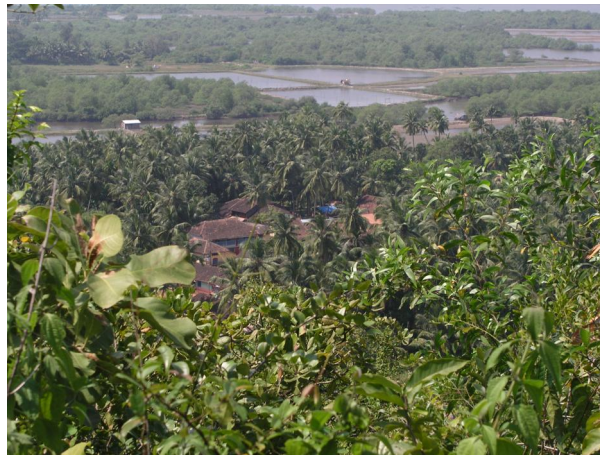
**Figure 3:** Kadwad village on the bank of Kali estuary

An understanding of laterite formation is required to explain some of the Karwar landslides, especially of Kadwad hills. Laterites are formed by the decomposition of rock, removal of the bases and silica and formation of oxides of iron and aluminium at the top of the soil profile. They are soft when wet but harden with age. Laterites are of two types. Primary laterite is found *in situ*. The original rock structures, joints and quartz material are in tact and the laterite deposit overlies the bedrock. Primary laterite is found at higher altitudes. The Indian south-west coast

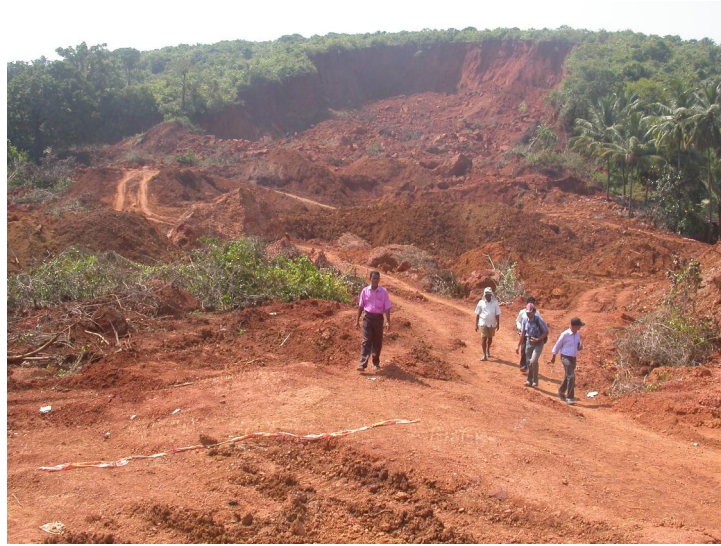
Jariwada (Kadwad-2) had the worst landslide in the history of Uttara Kannada district which buried alive 19 people, and destroyed several houses and property. The slide happened on a mound of 65 m, to the south of Kali estuary. The slide material volume of approximately 750,000 cu.m, traveled a distance of 300 m, burying people and destroying houses and entering the estuary, its further advance stopped by the Konkan Raliway embankment (Figures 3-5). Kadwad -1 slide happened in another mound of 78 m. About 400,000 cu.m of debris and soil travelled a distance of 300m from the slide, crossing a road there was no human casualty from this slide (Mishra, 2009). Interaction of a variety of factors caused the landslides. Of these important are geological factors, excessive rainfall and anthropogenic pressures.

Figure 4: Kadawd – 2 (Jariwada landslide)

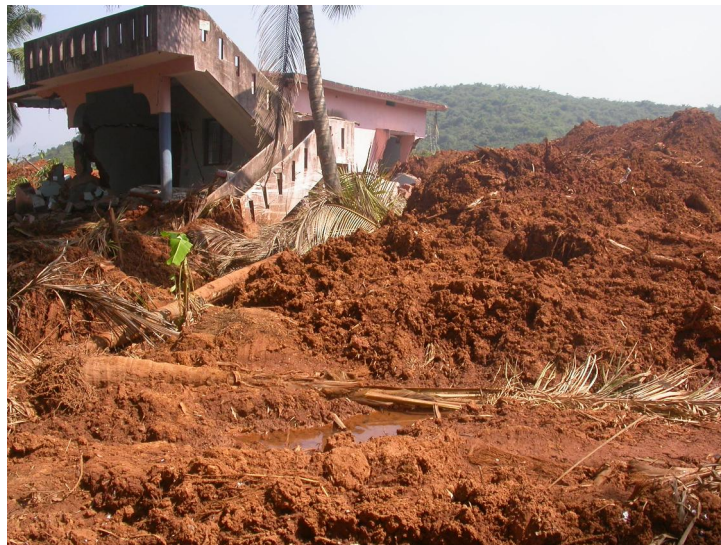
Figure 5: A house that was drifted and destroyed in the Kadwad-2 landslide

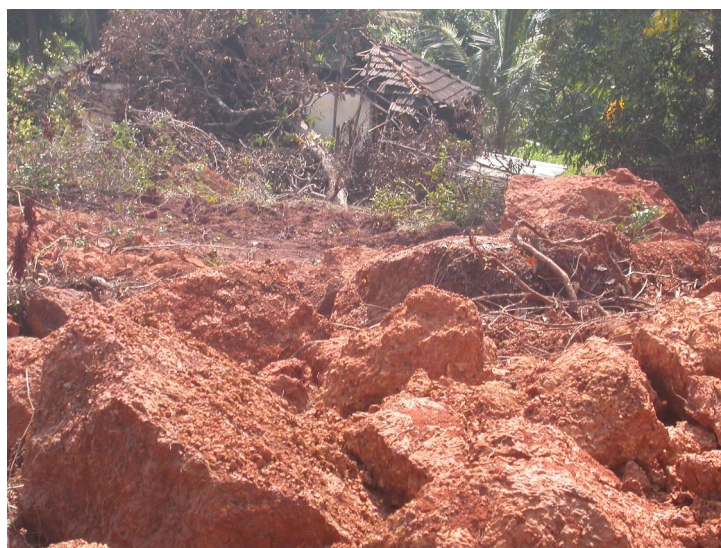
characteristic of the southern hills of Uttara Kannada coast are scanty in the Kadwad hills. Laterisation process is incomplete inside the hill also (Figure-6) mainly due to insufficient soil drainage due to the closeness of the estuary and the hills themselves being formed on palaeo river courses as springs exist in these hills to this day. 'Jariwada' in local language means hamlet situated on 'jari' or spring. Water table is high in the Kadwad village and it is expected also for the water to rise through the soil by capillary force from below. Soil samples from the bottom of Kadwad-2 showed 88.3% sand revealing its weak foundation. Such dampness in the interior of these clayey soils with high mix of sand especially towards the base would have been considerably aggravated by the heavy rains of late September and the first two days October. Water would have percolated through the thin mantle of laterite as well as through crown cracks developed on the hills, understandably due to swelling of the clayey soil in the interior.

Figure 6: Incompletely formed laterite due to water logging in Kadwad-2 landslide

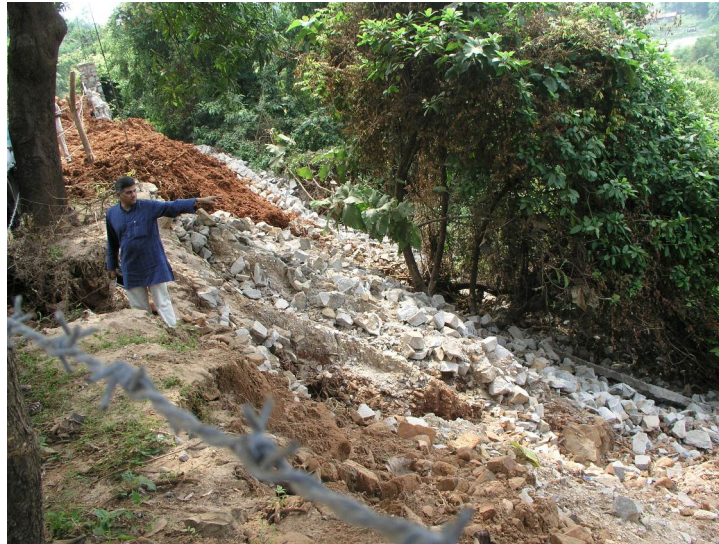
Figure 8: Landslide along NH-17, the slide material entering INS Kadamba Naval Base breaking through the compound wall

Stone quarrying and soil removal: In Zariwada there was reported excavation of soil in front of the slope that failed for the construction of the Konkan Railway embankment, increasing vertical slope height, inducing slope instability due to the volume and weight of material above the toe (Mishra, 2009). Granite quarries in the hills adjoining NH-17 would have also destabilized the hill sides as rocks came tumbling down from near a quarry site towards the highway and damaging the wall of the naval base.

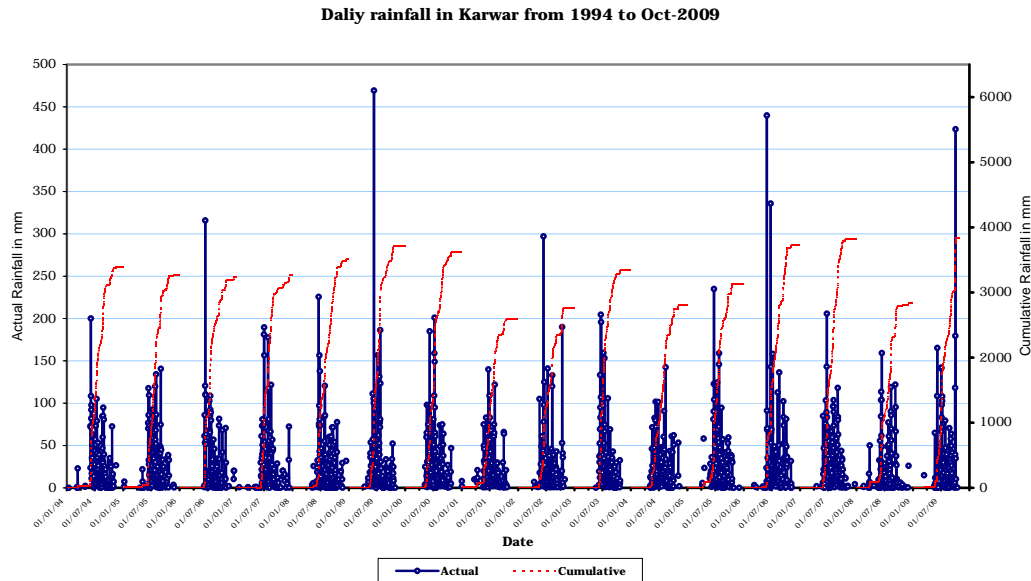
Recurrence of heavy rainfall: As the hill slopes of coastal Karwar remain heavily deforested slope failures could happen on any day of incessant rains, the threshold for this important triggering factor will depend on the previous rainfall during the season, the state of tree cover in the hills and the degree of slope. A look at the daily rainfall history of Karwar for the 1994-2009 period (Figure-7) shows that heavy rainfall (> 200 mm a day) events happen periodically. If the site-specific threshold value is crossed the landslides could happen on any day in vulnerable slopes. October 2, 2009 episodes of 21 landslides indicate that on the recurrence of similar events slope failures are likely to return.

Figure 7: Sixteen years (1994-2009) of daily rainfall records for Karwar showing frequent recurrence of heavy rainfall events (>20 cm a day)

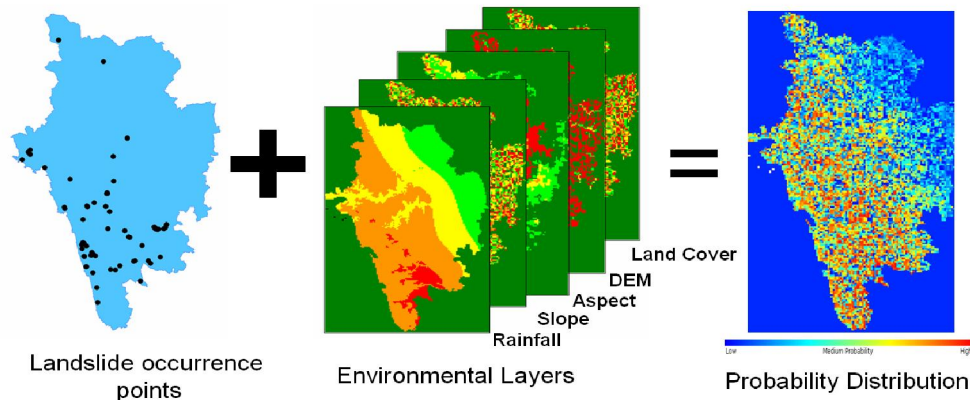
experiment can be carried out. It includes facilities for reading landslide occurrence and environmental data, selection of environmental layers on which the model should be based, creating a fundamental niche model and projecting the model into an environmental scenario using a number of algorithms as shown in Fig. 9.

Figure 9. Methodology used for landslide prediction in openModeller.

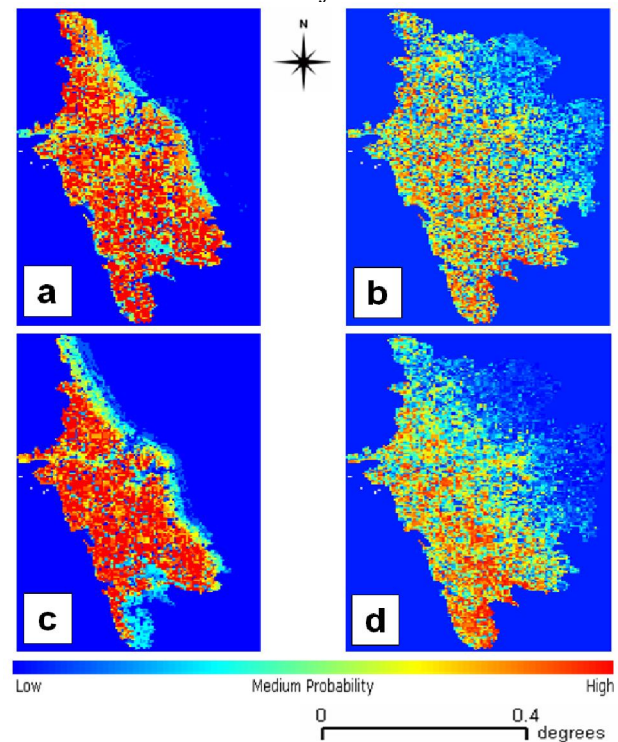
Fig. 10. Probability distribution of the landslide prone areas.

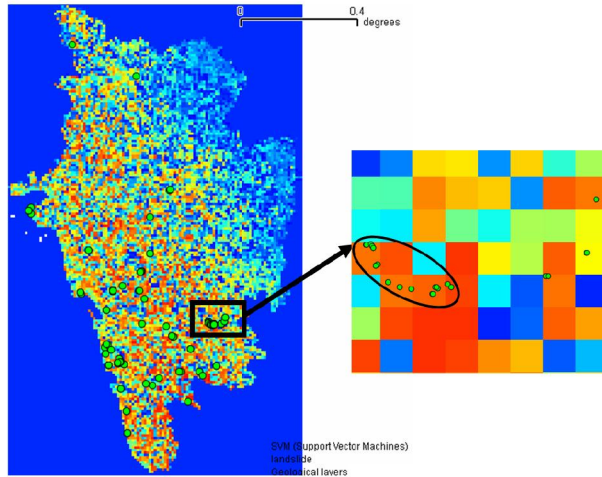
Fig. 11. Validation of the probability distribution of the landslide prone areas by overlaying landslide occurrence points.

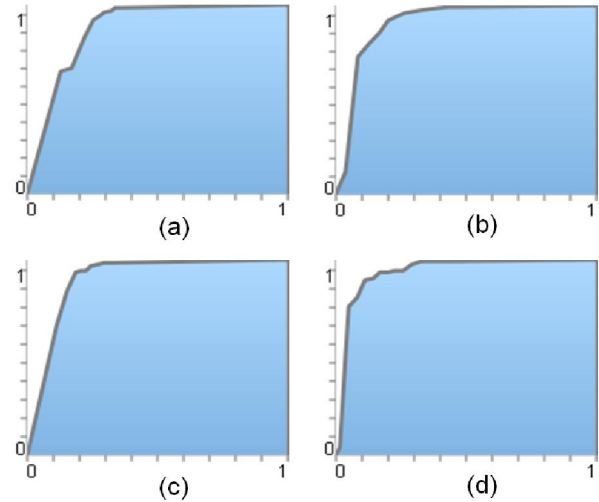
ROC curves in figure 12 (c) and (d) show AUC as 0.90 and 0.94. Various measures of accuracy were used to assess the outputs. Table 3 presents the confusion matrix structure indicating true positives, false positives, false negatives and true negatives.

Fig. 12. ROC curves for landslide prone maps (a) GARP (b) SVM on precipitation of wettest month; (c) GARP and (d) SVM on precipitation of wettest quarter.

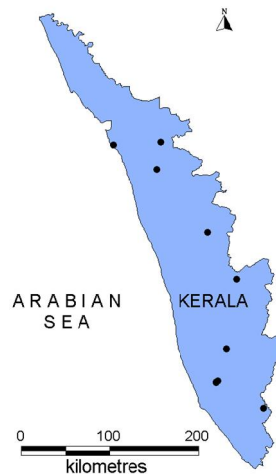
Another case study of Kerala state, India was carried out with the same environmental layers along with 10 landslide occurrence points as shown in Fig. 13. The predicted output for precipitation in the wettest month is

Fig. 13. Landslide occurrence points in Kerala.

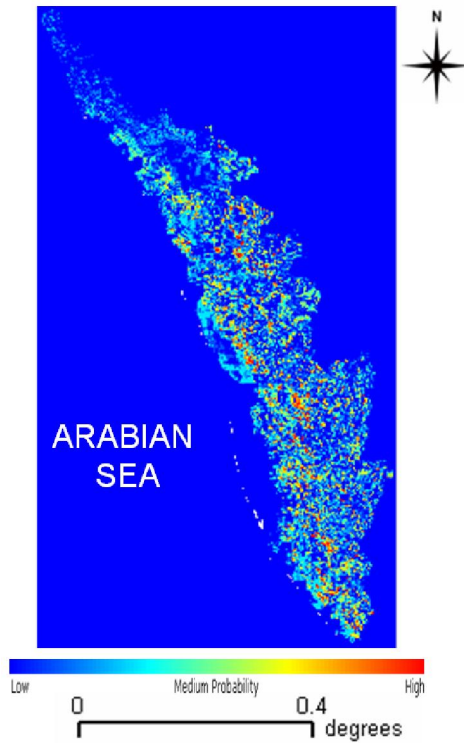
shown in Fig. 14 and precipitation in the wettest quarter is shown in Fig. 15 with an overall accuracy of 60%. The Kappa values for two cases were 0.966335 and 0.96532. The ROC curves are shown in Fig. 16 (a) and (b) with 0.97

Fig.14. Probability distribution of the landslide prone areas in Kerala using precipitation in the wettest month data.

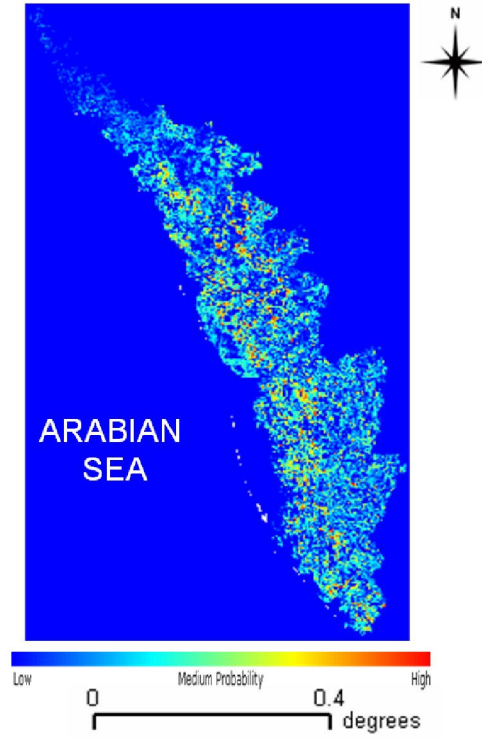
Fig. 15. Probability distribution of the landslide prone areas in Kerala using precipitation in the wettest quarter data.

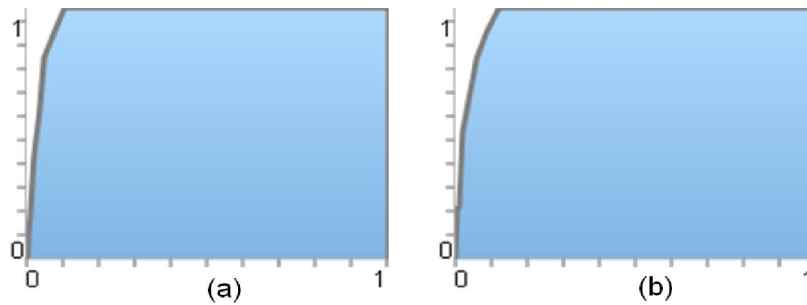
Fig.16. ROC curves for the predicted landslide prone maps of Kerala. (a) using precipitation of the wettest month, (b) using precipitation of the wettest quarter.
