UNABATED VIOLATIONS IN AGARA BELLANDUR WETLAND

Mismanagement of Landscape: Abuse of Bellandur-Agara wetlands, Narrowing and Concretising Rajakaluve and encroachment of storm water drains, Dumping of solid waste & building debris, buildings in the buffer zone, Apathy of Civic Agencies

ENVIS Technical Report: 134

December 2017

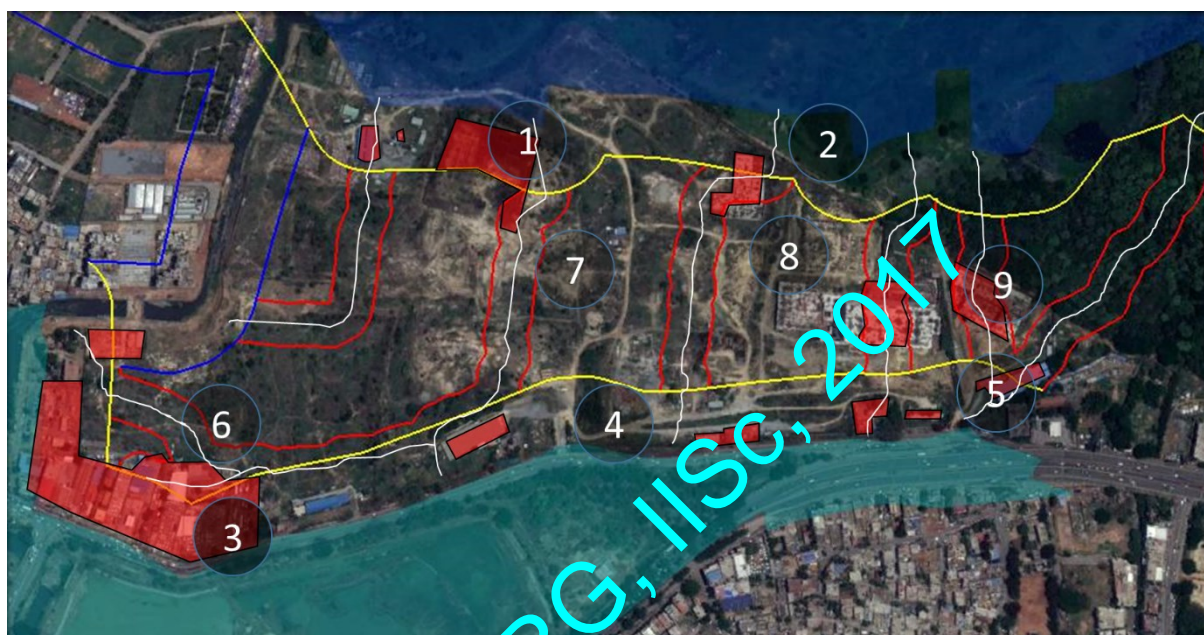
Figure 1: Lakes, Streams, Buffer zones, Violations and Sections (1, 2, 3,...9)

Note: Yellow lines (75 m buffer zone of Lakes), Blue lines (50 m buffer zone of Rajakaulves), Red line (25 m buffer zone from streams)

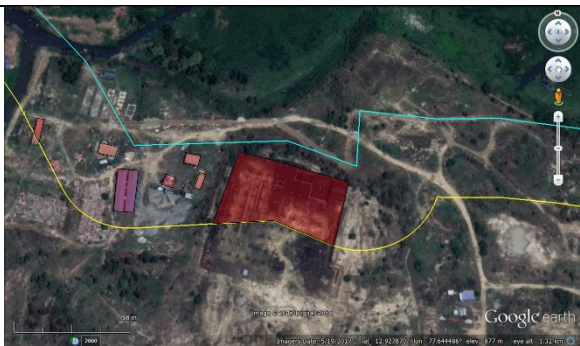
12.927669 ⁰ N 77.644392 ⁰ E	Existing Structures and Buildings in the buffer zone of Bellandur lake (75m)

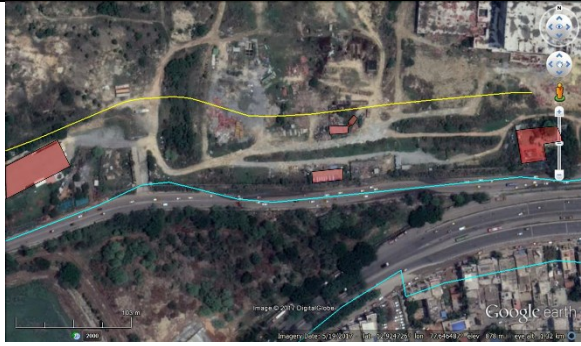
12.924938 ⁰ N 77.646224 ⁰ E	Buildings Existing in the buffer zone of Agara Lake
5

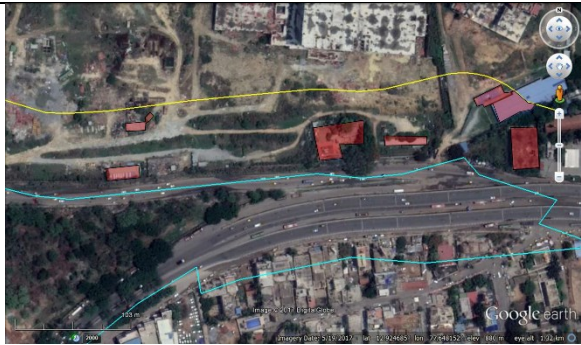
12.924945 ⁰ N 77.648460 ⁰ E	Buildings Existing in the buffer zone of Agara Lake
6

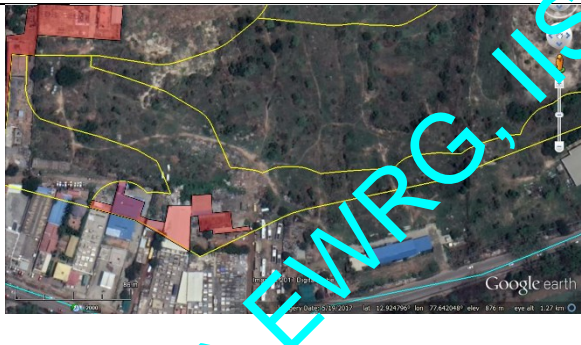
12.927567 ⁰ N 77.647227 ⁰ E	Buildings Existing in the buffer zone of Stream connecting Agara and Bellandur Lake
7

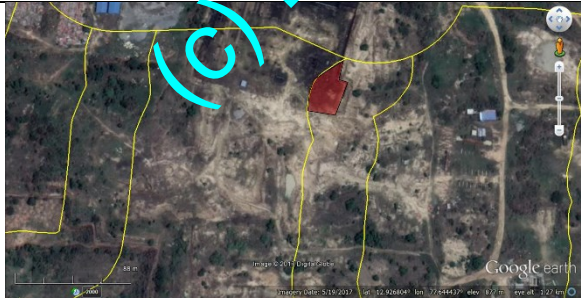
12.927016 ⁰ N 77.644686 ⁰ E	Structure Existing in the buffer zone of Stream connecting Agara and Bellandur Lake

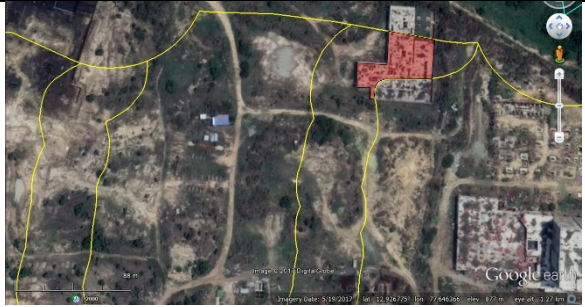
<p>12.927266⁰N 77.647219⁰E</p>	<p>Structure Existing in the buffer zone of Stream connecting Agara and Bellandur Lake</p>
<p>9</p>

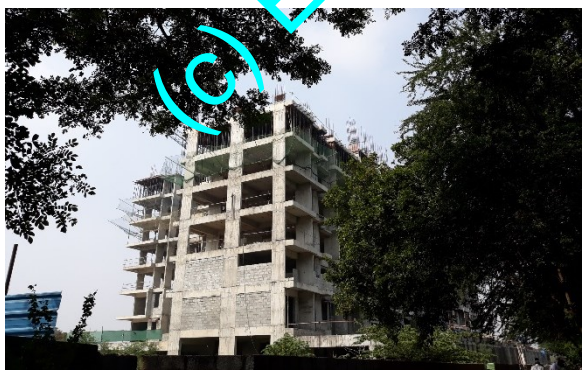
<p>12.926025⁰N 77.649508⁰E</p>	<p>Buildings and Structures Existing in the buffer zone of Stream connecting Agara and Bellandur Lake</p>

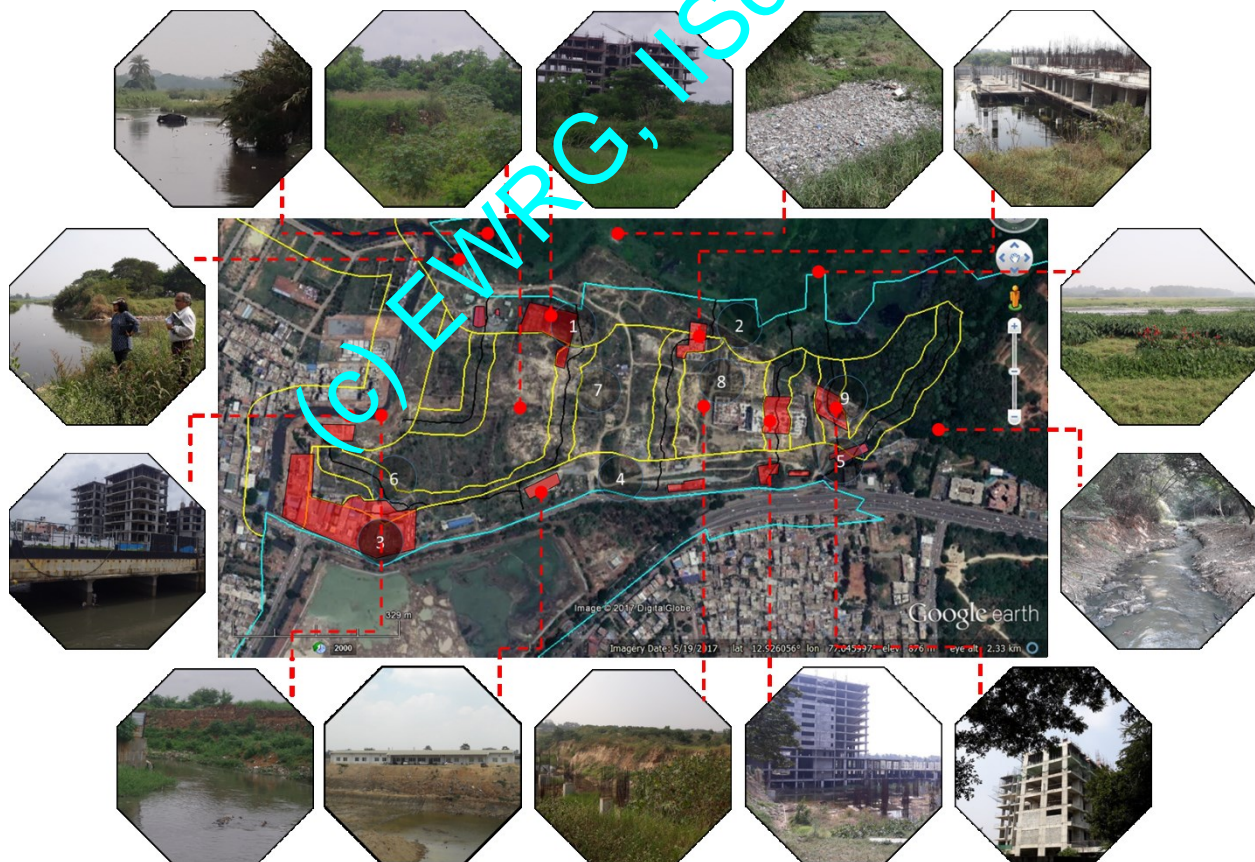
Figure 3: Field visit (GE + Photographs)

Field work photographs (12 December 2017) – Violations Galore (where are law abiding citizens?)

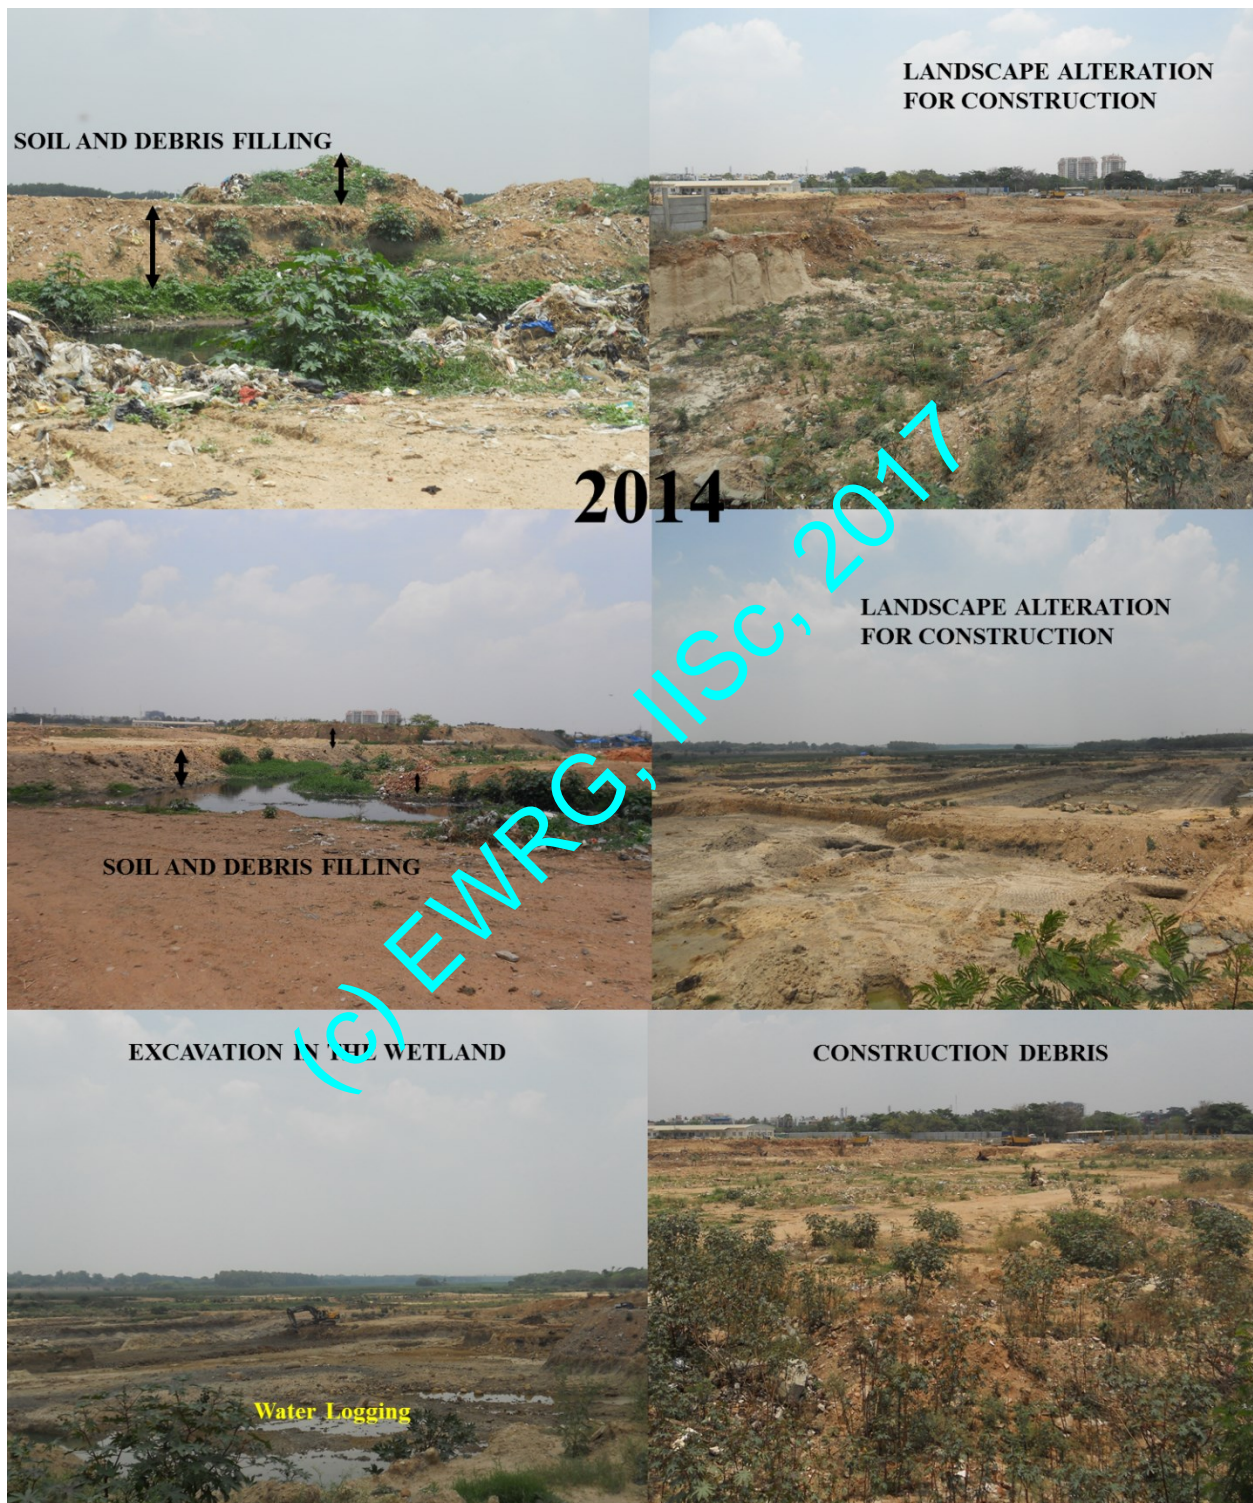
Figure 3: Land status in 2014

Figure 3 and Figure 4 demonstrates the alterations in the wetlands region observed at the site at sites in 2014 and 2017 field visits. Large scale construction debris, Soil and Solid waste filled, over which construction activity was under progress. Figure 4 also depicts the concretized channel

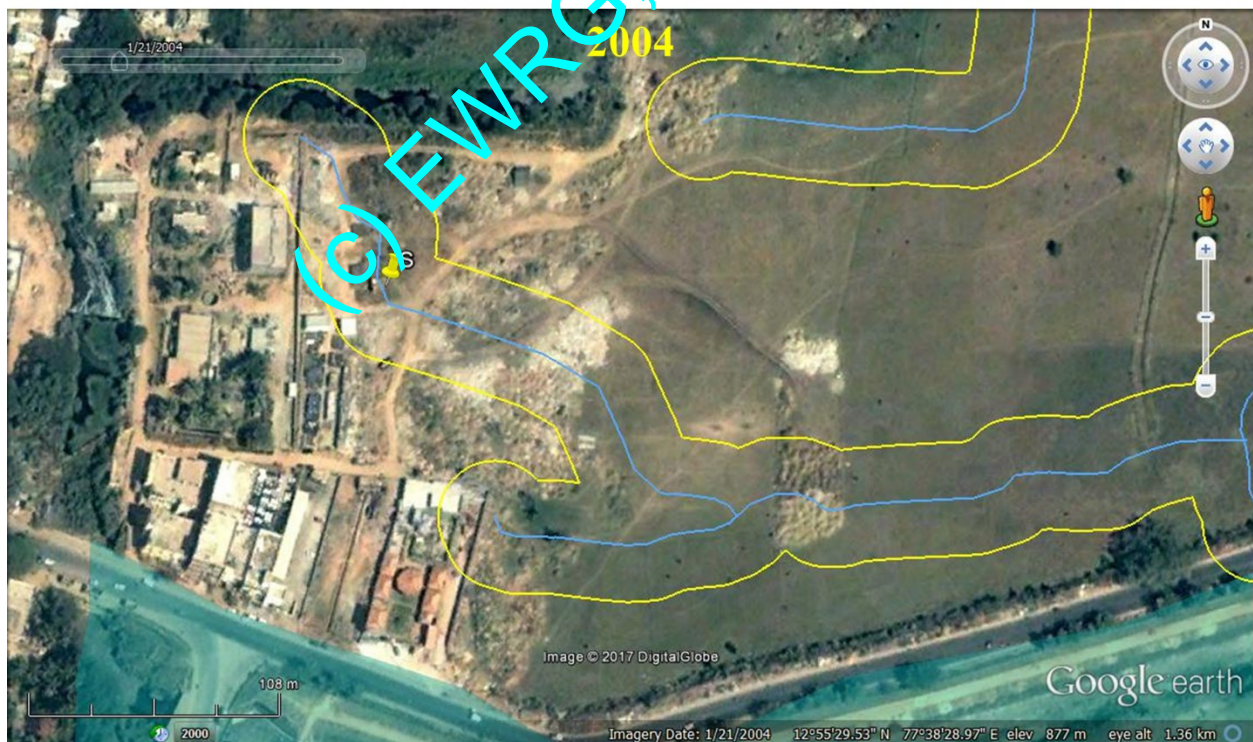
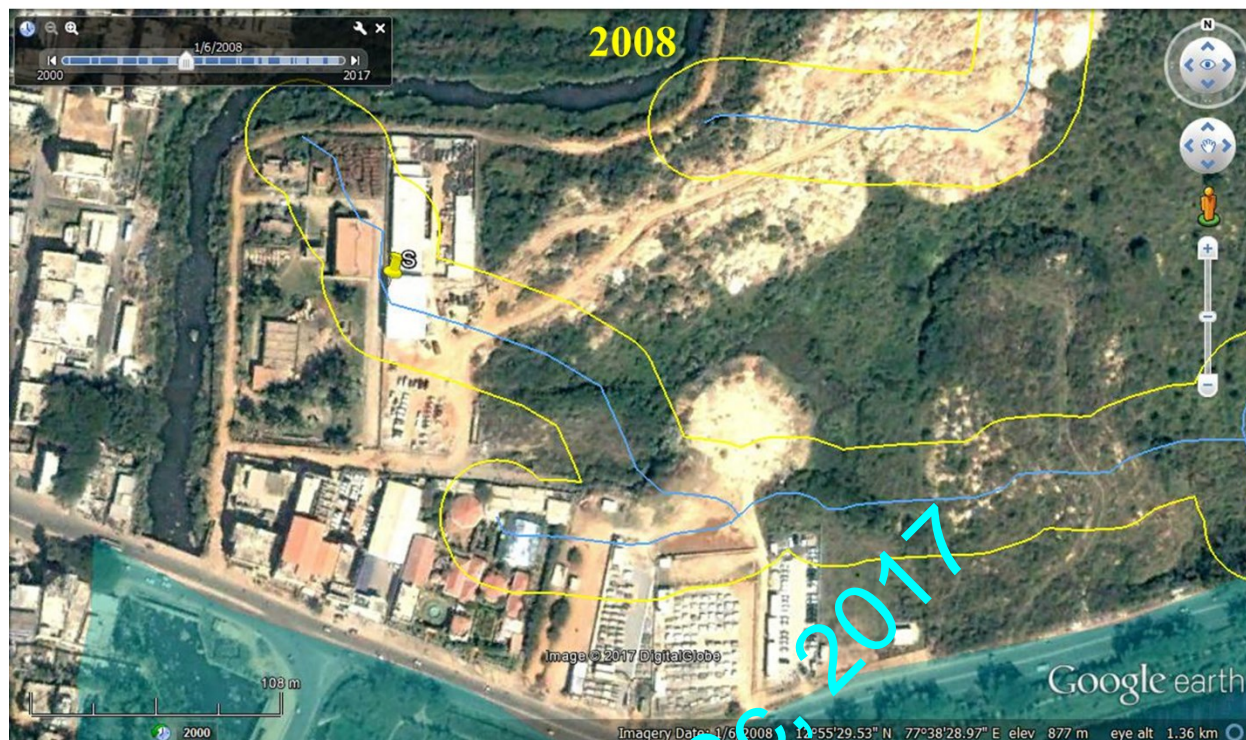
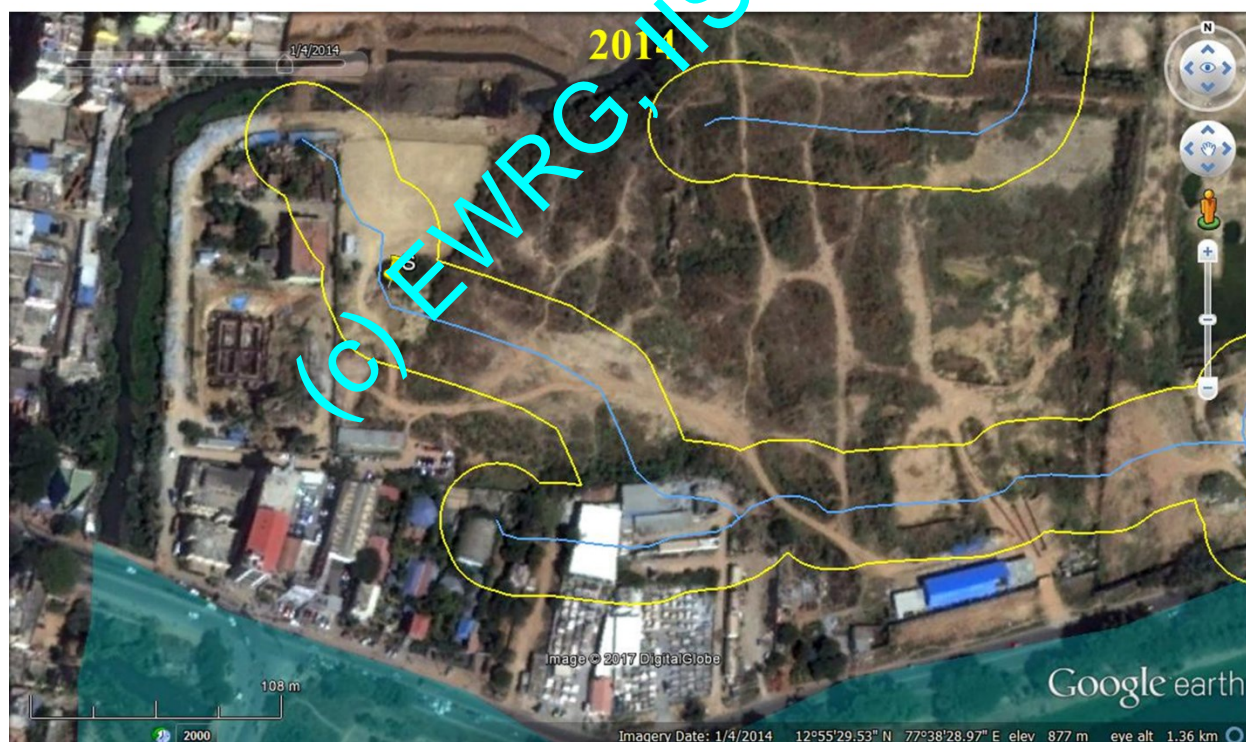
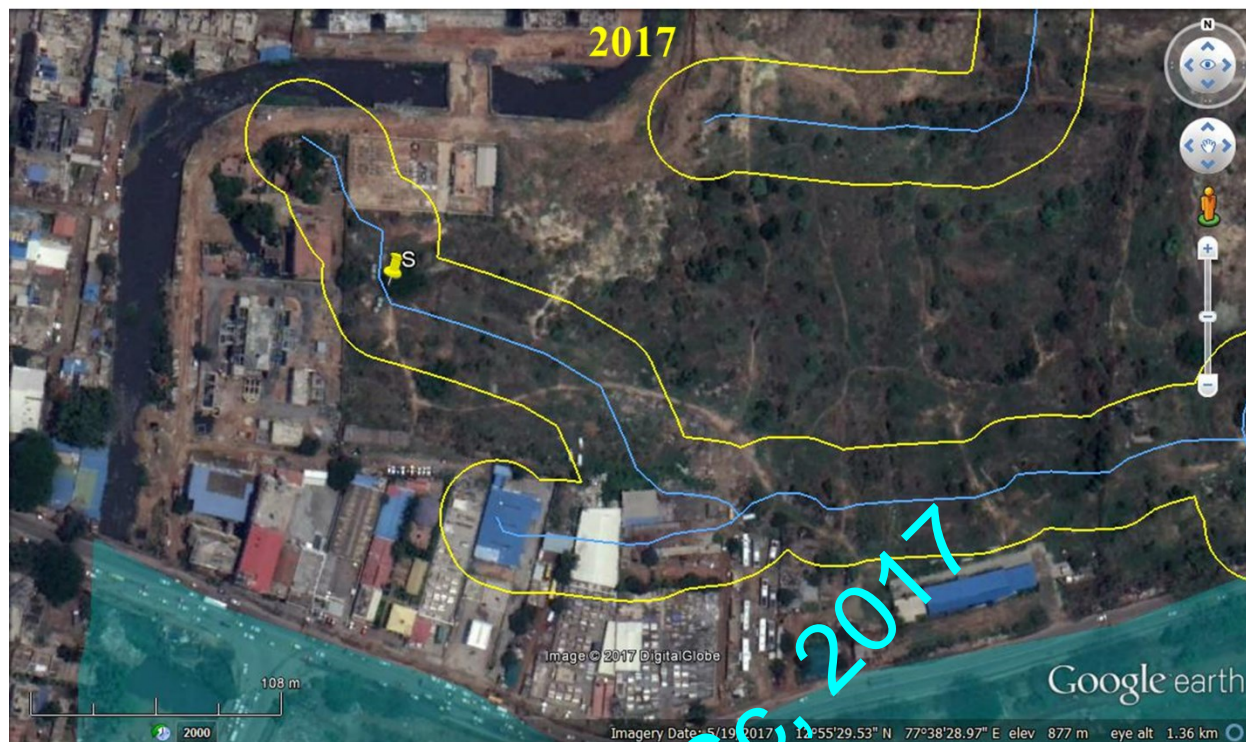
Figure 6: Status of Channel across time

Figure 6 indicates the status of one of the connecting channel during the field visit on 1st September 2017. The channel continued to be filled with construction debris (since 2004). Figure 7 depicts the current status of one of the connecting channel.

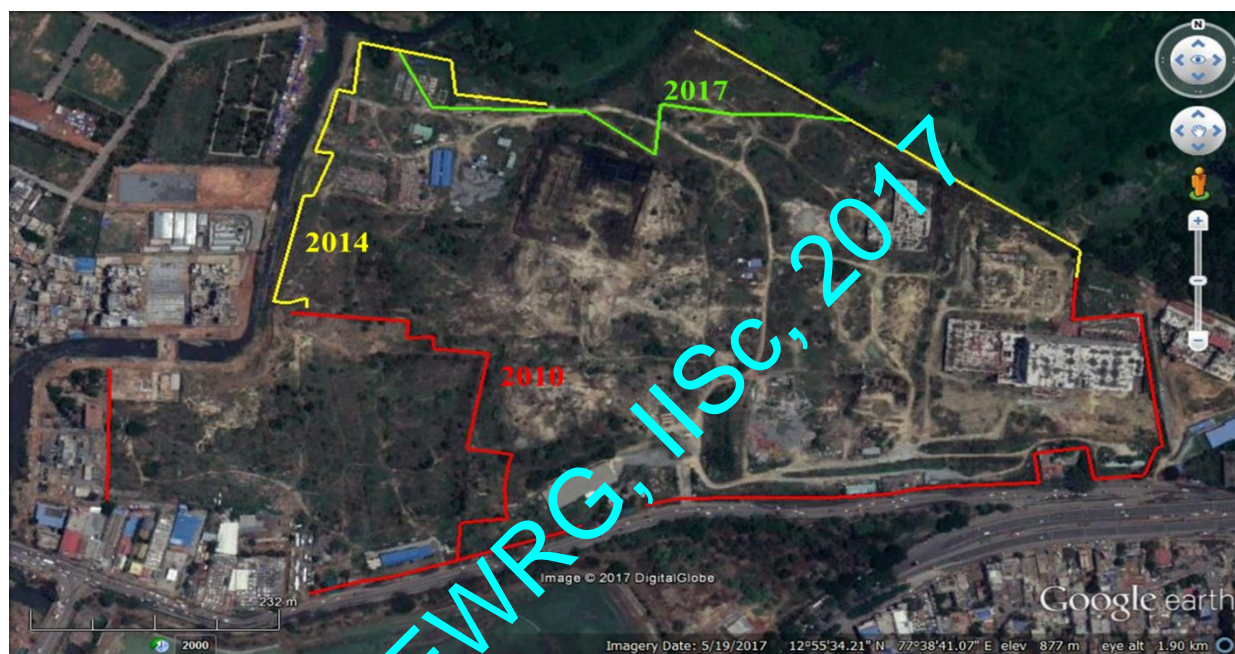
Figure 8: Compound Wall on Google Earth

The compound walls were erected in the wetlands region, hindering flow of water. These structures violating the hydrologic regime as (i) the compound walls inside wetlands restrict the movement of water from upstream to downstream, (ii) compound wall is being built (after filling and altering the topography) altering the wetlands physical integrity. Figure 8 depicts the Compound walls on Google earth. Figure 9 depicts the status of compound walls in 2014 and 2017. IT can be observed that a new boundary has been erected in 2017, but the land is seeming not be rejuvenated to the original status.

6. Stop narrowing and concretising natural drains
7. Remove the compound wall altering the hydrologic regime - leading to escalation of flooding impact
8. Penalise decision makers for violation of norms – acquiring wetlands (valley zone) for industrial activities, narrowing and concretising natural drains, allowing constructions in lake (wetlands) bed and in drains, deliberating violating NGT guidelines of buffer zone for lakes and Rajakaluves (narrowing drains to help encroachers).

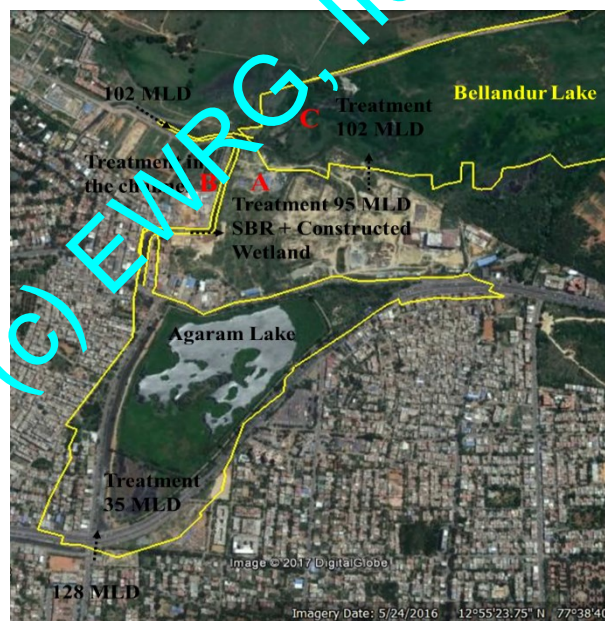
Figure 3.3.1: Proposed Sewage Treatment with wetlands

Bellandur lake, located in south eastern part of Bangalore city along the Koramangala Challaghatta valley, that joins Dakshina Pinakini river flowing to the Bay of Bengal. Bellandur lake has a catchment area about 279 sq.km, while the lake being the largest in Bangalore has an area about 366.9 hectares. The lake has three major inlets from i) Agaram ii) ST bed iii) HAL, sides respectively receiving at least 400 MLD water. Inlet from Agarma side contributes nearly 128 MLD of sewage and inlet from ST bed side of the lake contributes to 102 MLD of sewage (Figure. 3.2), which can be biologically treated at the inlets of the lake. RMP of 2015 indicates a treatment facility at the Agaram Bellandur side of the lake, whereas the same area is now being used for SEZ (Figure 3.3). The under construction SEZ has encroached the lake bed, violated the norms of minimum buffer zones with respect to the drainage networks, altered the drainage lands (encroached kharab lands). As per NGT, the encroached lake bed has to be recovered by the government. The SEZ is being built in the valley zone (contrary to RMP 2015) is to be shifted elsewhere and the recovered wetlands area will aid in creating integrated water treatment systems (fig 3.3.1).

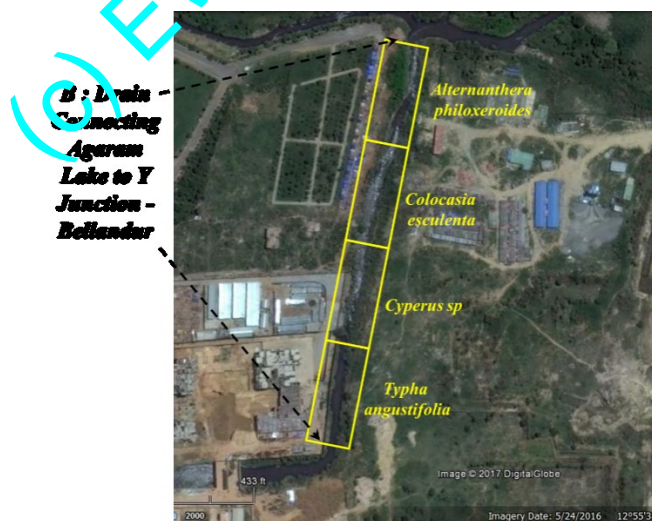
Figure 3.5: Treatment model along channel connecting Agaram Bellandur Lakes (B)

A bund like structure could be constructed to divert 95 MLD of water in to the SBR-wetland treatment system. The excess water at inlet of 95 MLD treatment plant can be partially treated at the channels joining Agaram and Y junction of Bellandur (Figure 3.5).

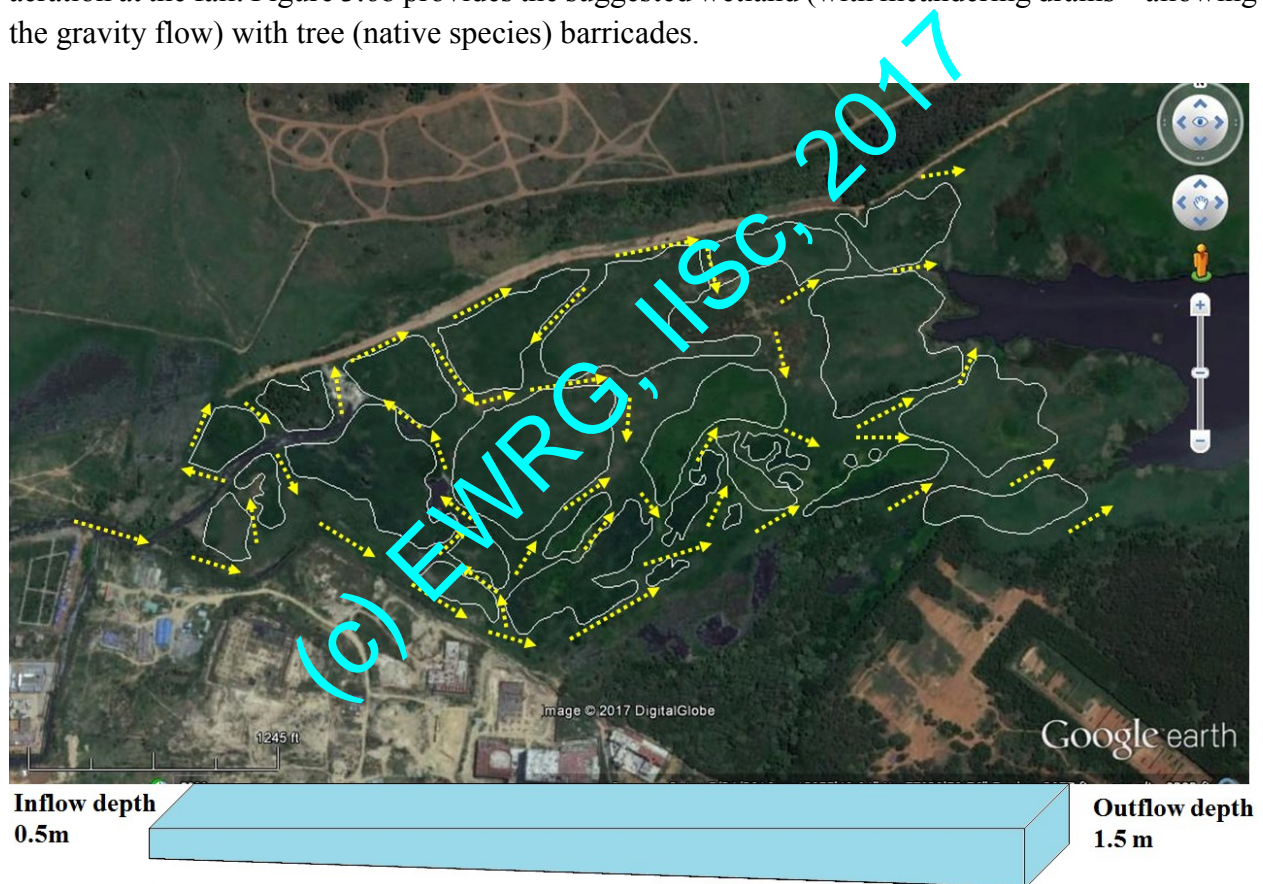
Figure 3.6a: Treatment model at Bellandur Lake (C)

About 102 MLD of untreated sewage water comes into the Bellandur lake from ST lake bed side catchment. The area of the wetland is nearly 105 acres in the Bellandur lake upstream, and the depth varies between 0.5 m to about 1.5 m with an approximate average depth of 0.8 m. With the existing area and depth, volume of water that can be stored in the wet land is nearly 340 Million Liters. With respect to the discharge of Sewage at 102 MLD, residence time of 3.3 days is available at the wetland portion of the lake. The existing macrophyte pockets in the wetlands is as depicted in Figure 3.6a (white coloured polygons). These macrophyte clusters needs to be retained in the system in order to treat the incoming sewage. The flow of sewage can be regulated (Figure 3.6a – yellow arrows) through planned channels without disturbing the existing clusters of macrophyte cover, and providing more residence time, and contact with the macrophytes. A broad crested weir at the outlet of the planned wetland would also help in increasing the residence time and improving aeration at the fall. Figure 3.6b provides the suggested wetland (with meandering drains – allowing the gravity flow) with tree (native species) barricades.

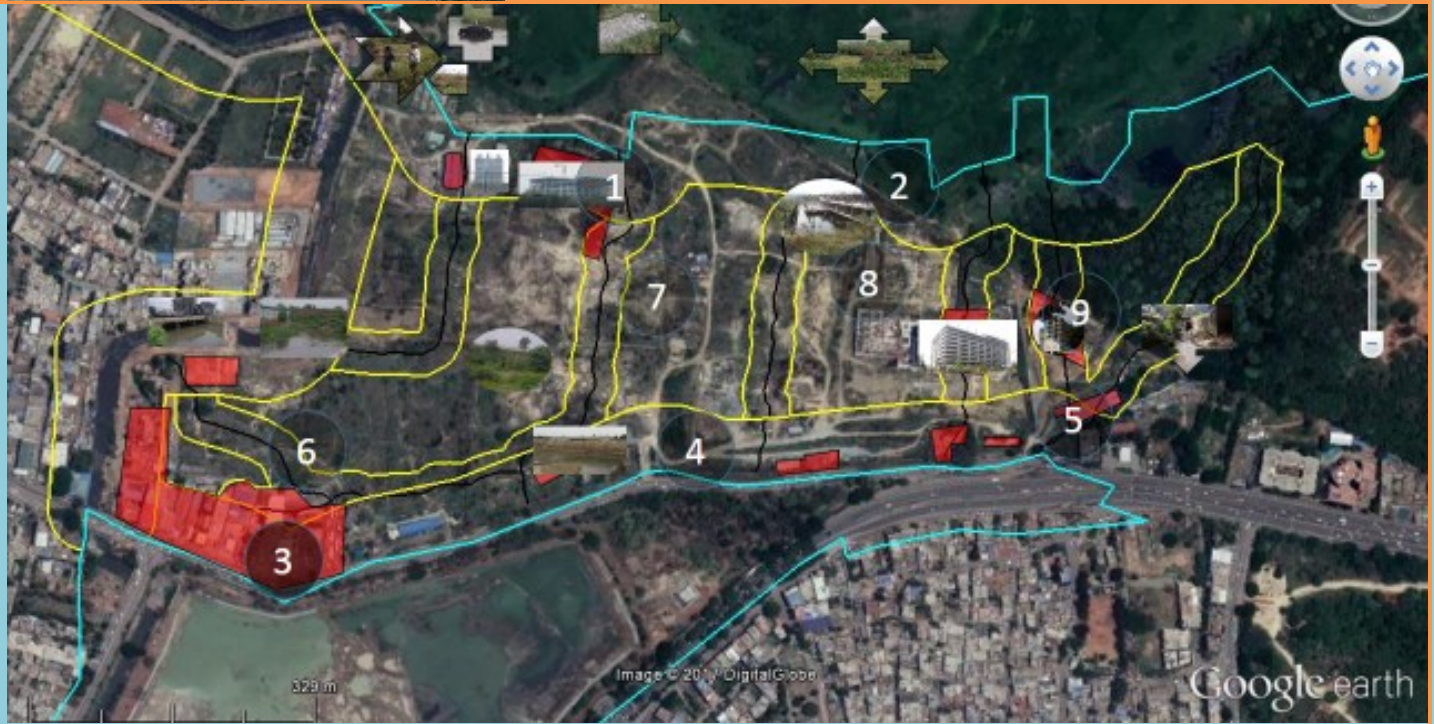
Agara-Bellandur (Buffer zones)

Buffer from edge : 75 m from Lakes, 50 m from Rajakaluvay and 25 m from streams as per NGT
