ENVIRONMENTAL AUDITING OF BANGALORE WETLANDS

ENVIS Technical Report 72

January 2015

**Energy & Wetlands Research Group [CES TE15]
Centre for Ecological Sciences,
Indian Institute of Science,
Bangalore - 560012, INDIA**

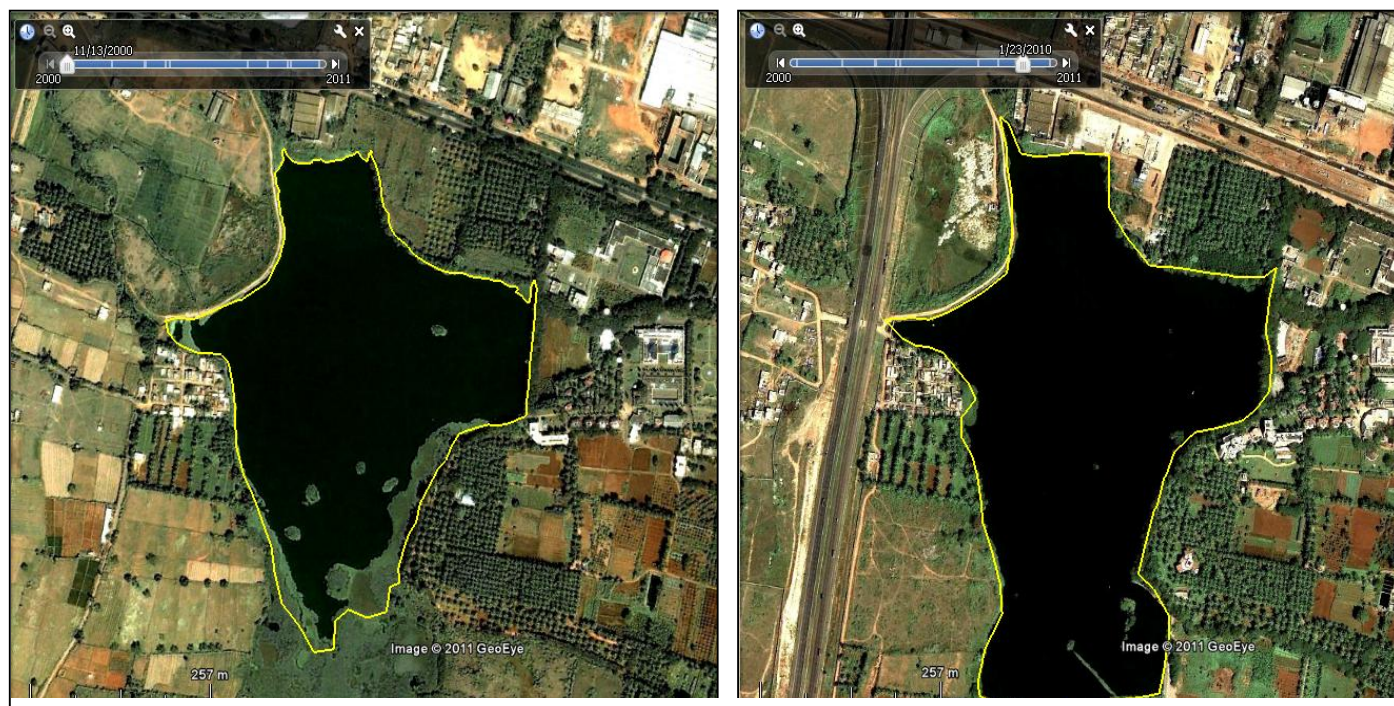
Figure 1 Google Earth map and area of Anchepalya Lake during 2000 and 2010 respectively.

NAME OF THE LAKE	ANCHEPALYA LAKE
GEOGRAPHIC DETAILS	13°3'3"N 77°28'47"
AREA (2000/2010)	18.44 / 22.66 ha
AUTHORIZATION	LDA
WARD / VILLAGE NAME	Peenya
STATUS	Highly Polluted/ Eutrophicated
RESTORATION	Under Restoration (2011)
WATER CONDITION	Poor, Green color, Eutrophication

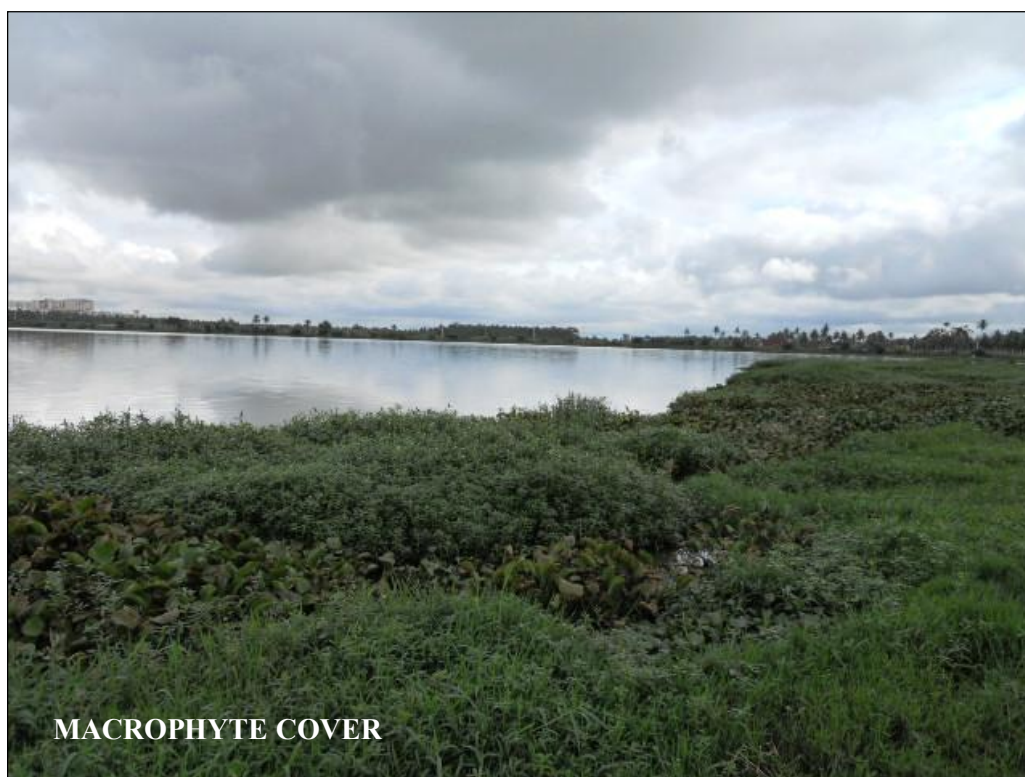
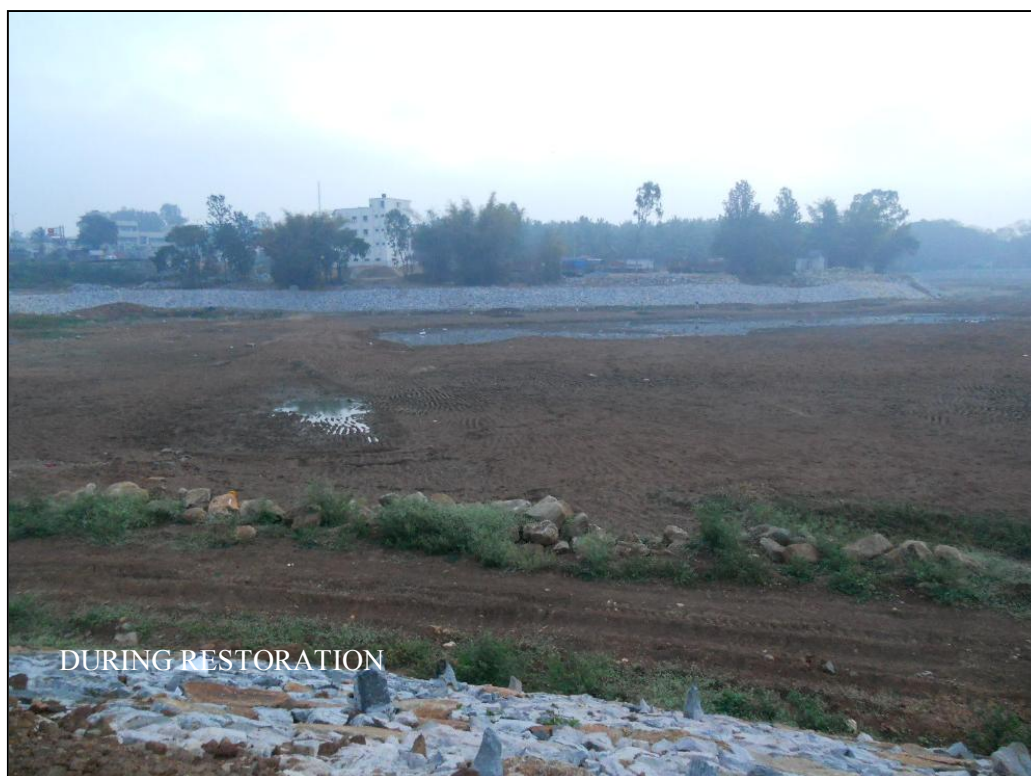
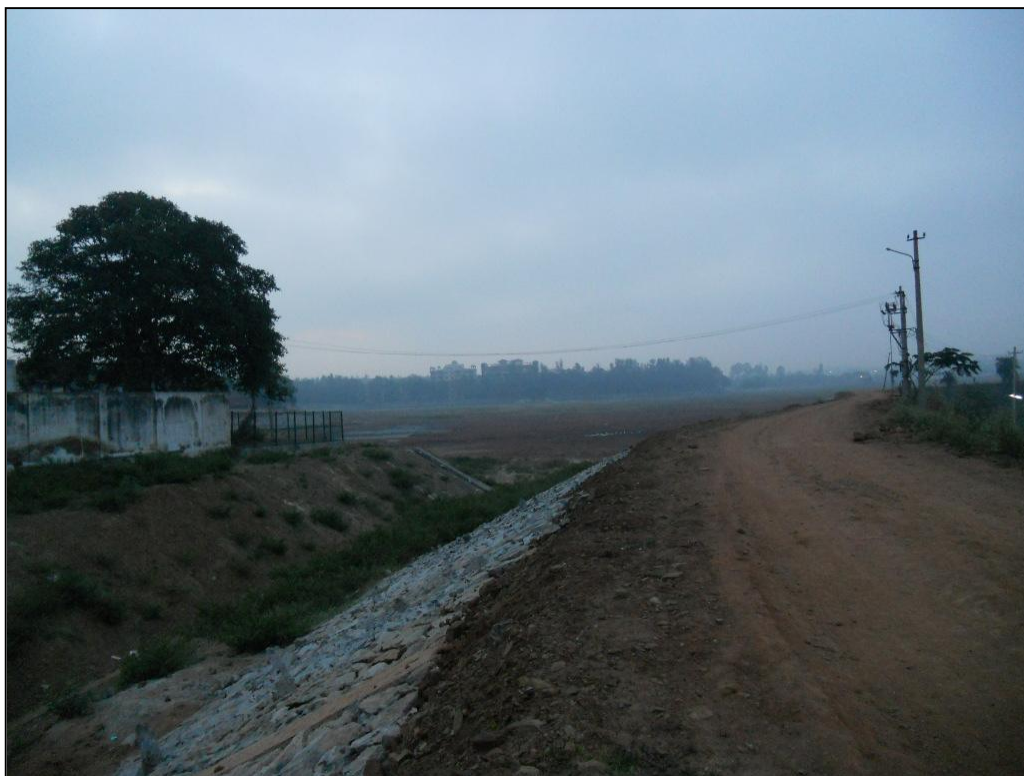
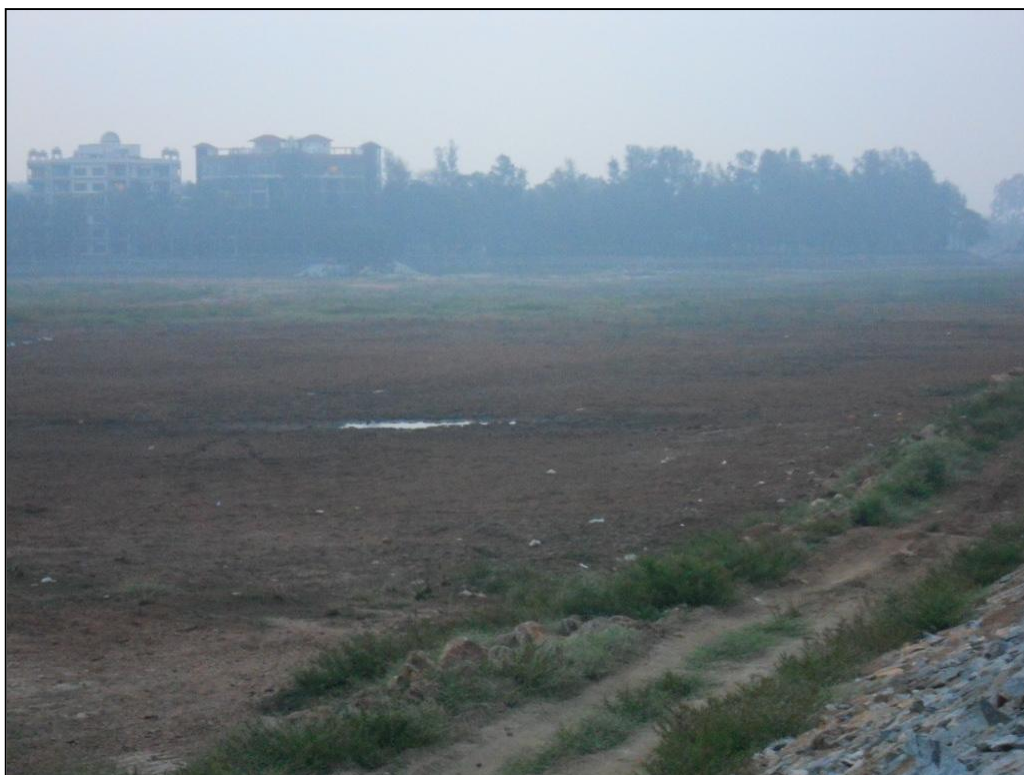
PLATE 1

- Industrial waste and untreated sewage inflow from nearby Industries and household in Peenya,
- Macrophyte cover (*Eichornia* sp.)
- Dumping of construction waste, solid waste, etc.
- Lake bed has been occupied for construction, Encroachment (filling of lake bed with construction waste).
- No shoreline
- Sludge deposition, Eutrophication.

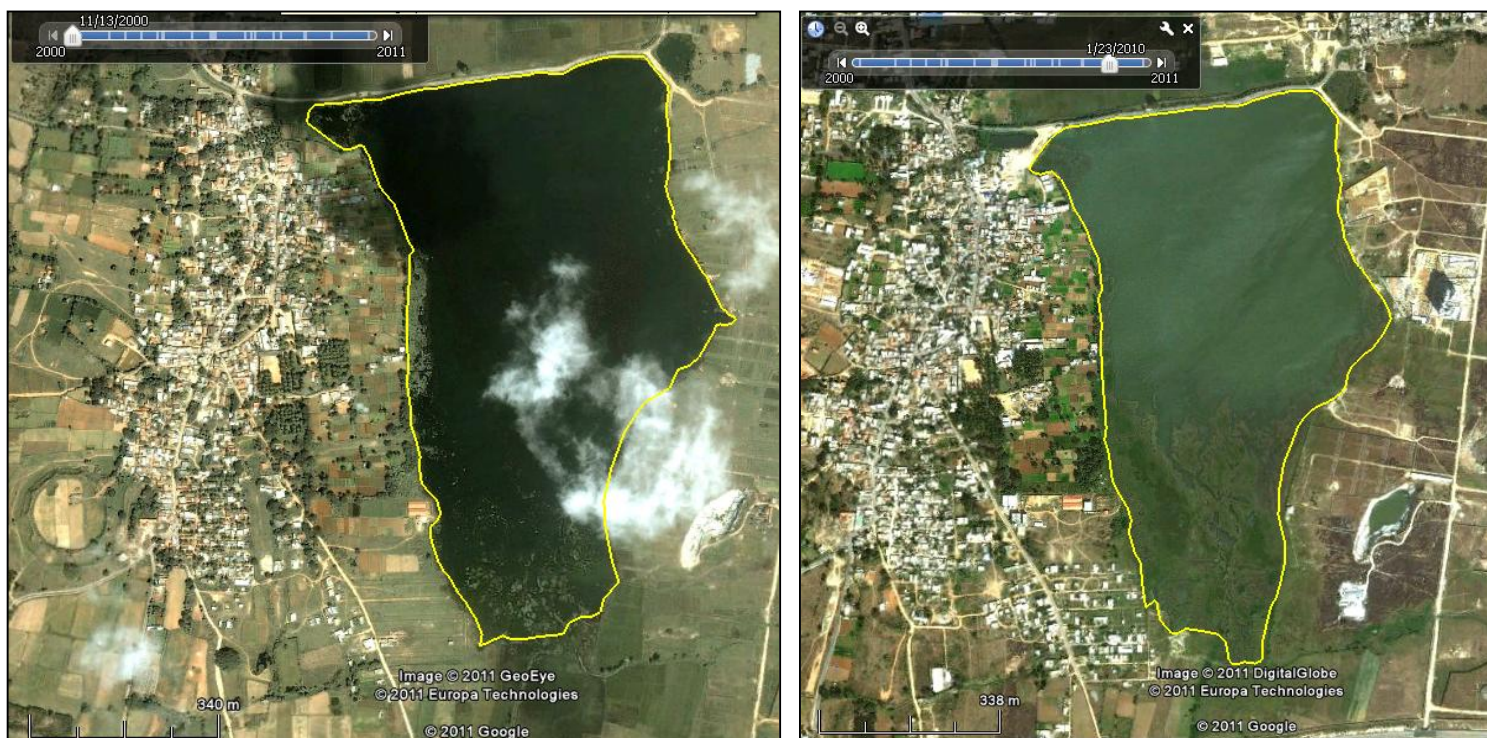
Figure 2 Google Earth and area of Begur Lake during 2002 and 2004 respectively.

NAME OF THE LAKE	BEGUR DODDA LAKE
GEOGRAPHIC DETAILS	13°2'20"N 77°2'0"E
AREA (2002/2010)	47.08/46.65 ha
ORGANIZATION	BBMP
WARD / VILLAGE NAME	192- Begur
STATUS	Moderately Polluted
RESTORATION	NO
WATER CONDITION	Moderate

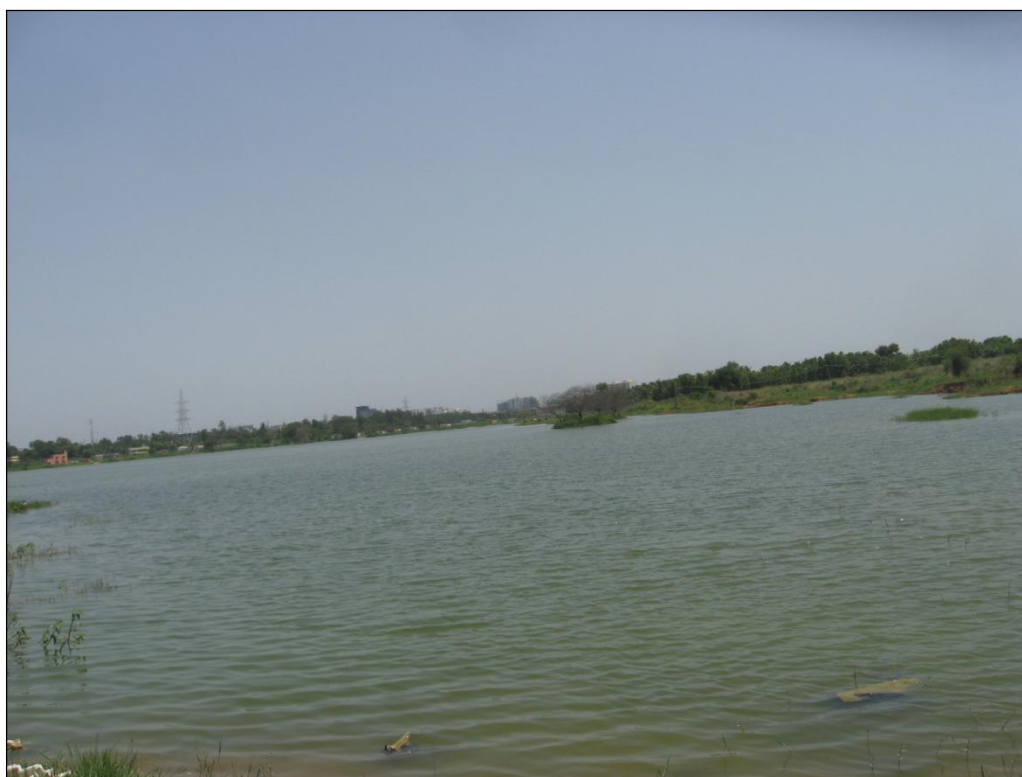
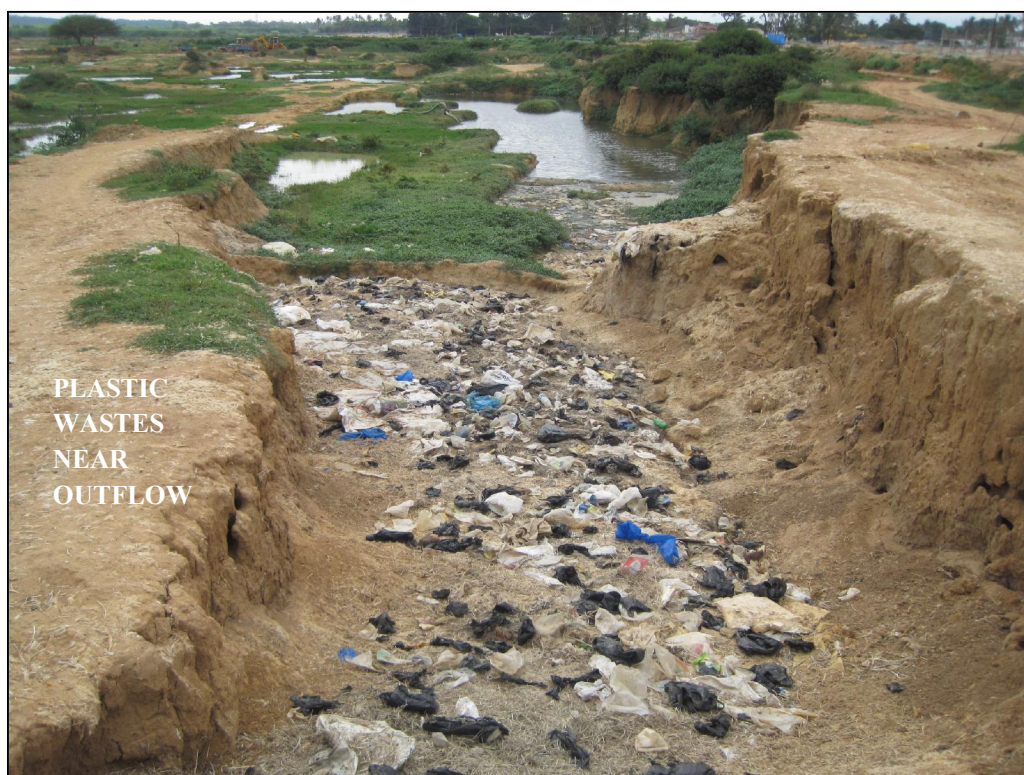
PLATE 2

- Dumping of household waste.
- Local disturbances (Washing clothes and open defecation)

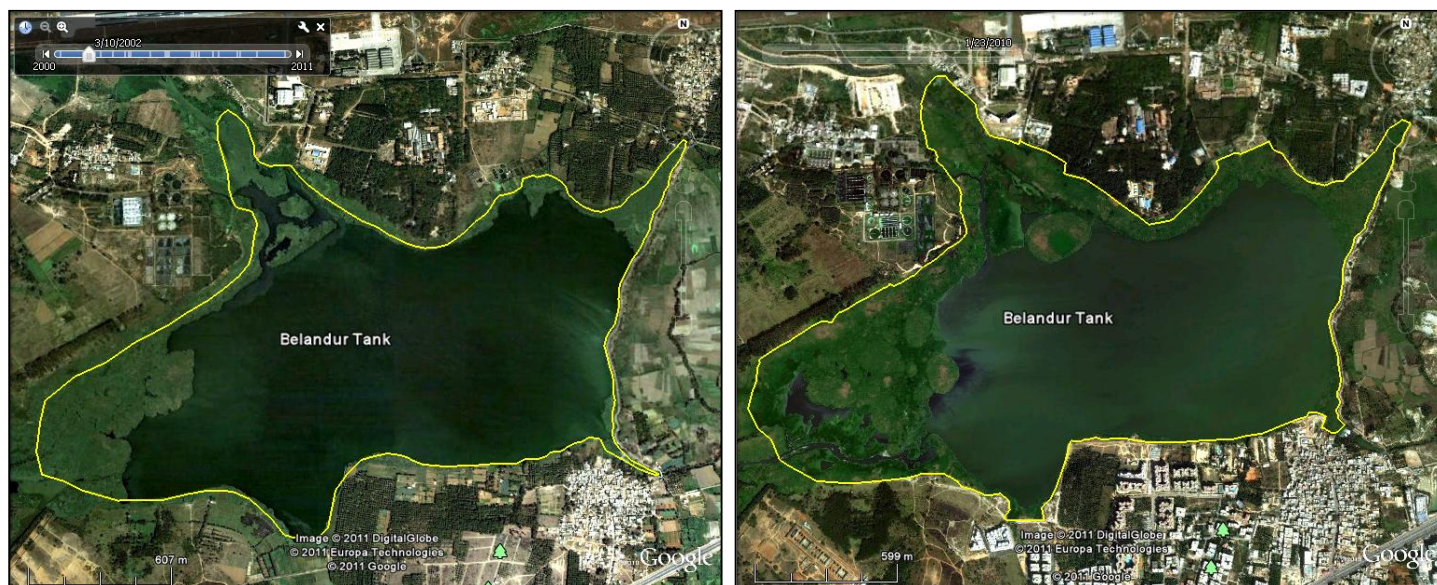
Figure 3 Google Earth and area of Belandur Lake during 2002 and 2010 respectively.

NAME OF THE LAKE	BELLANDUR LAKE
GEOGRAPHIC DETAILS	12°56'11"N 77°39'33"E
AREA (2002/ 2010)	284.6/260.2 ha
ORGANIZATION	BBMP
WARD / VILLAGE NAME	174- Mahadevapura
STATUS	Polluted
RESTORATION	NO
WATER CONDITION	Eutrophication, Green color, rotten smell

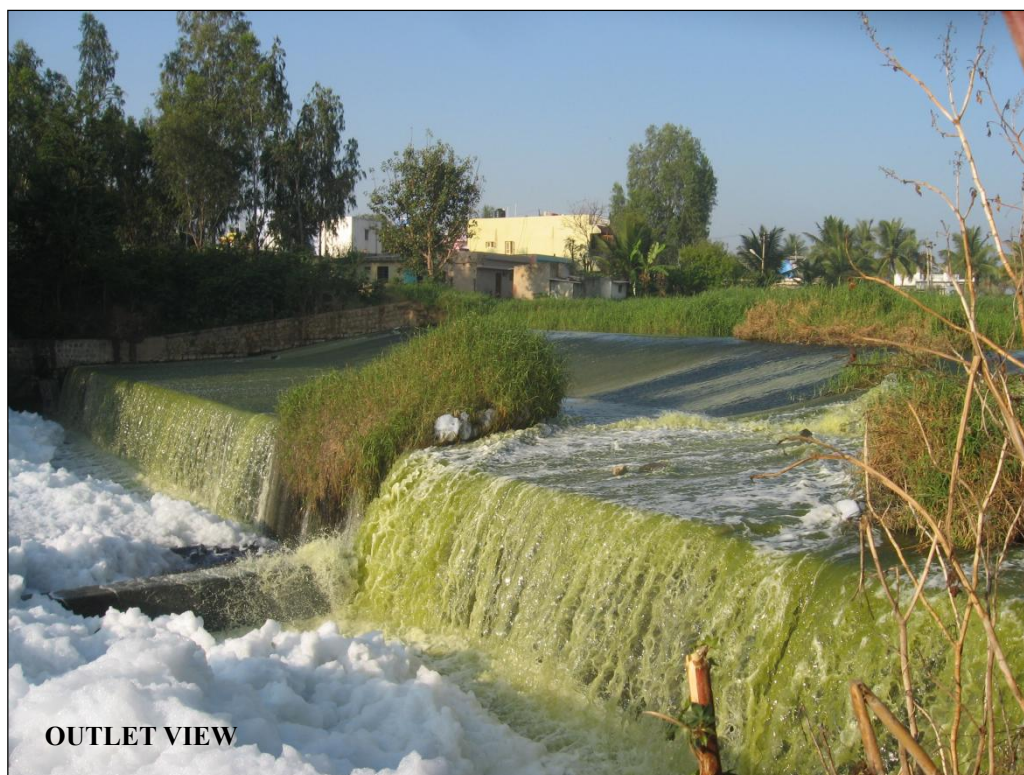
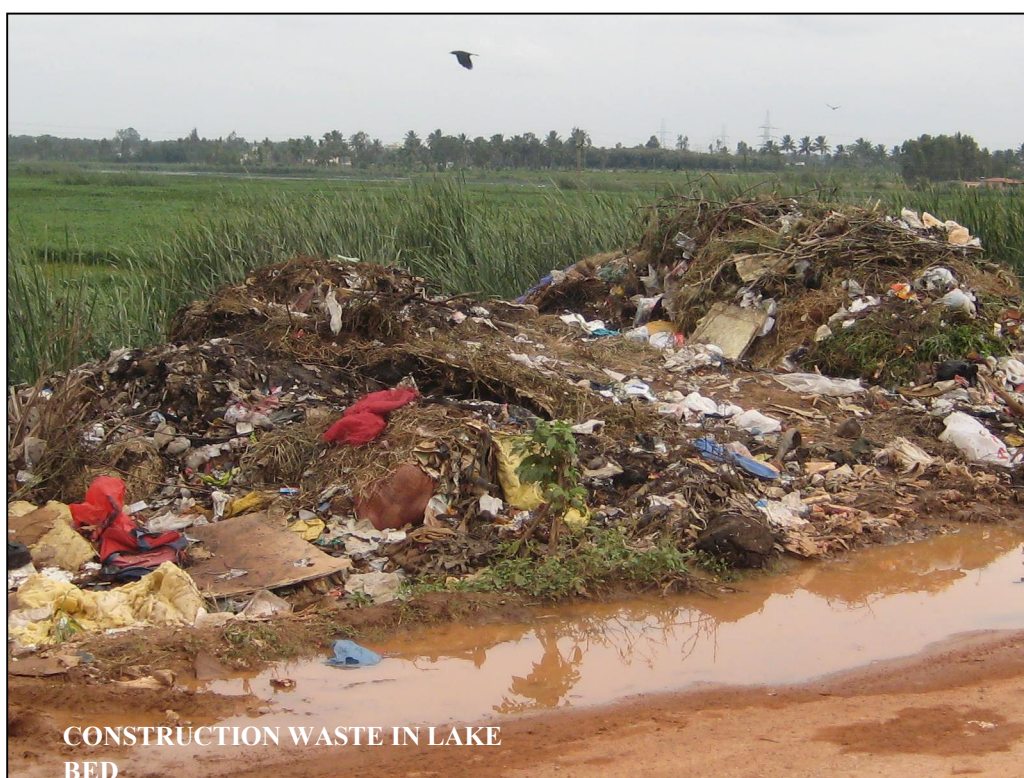
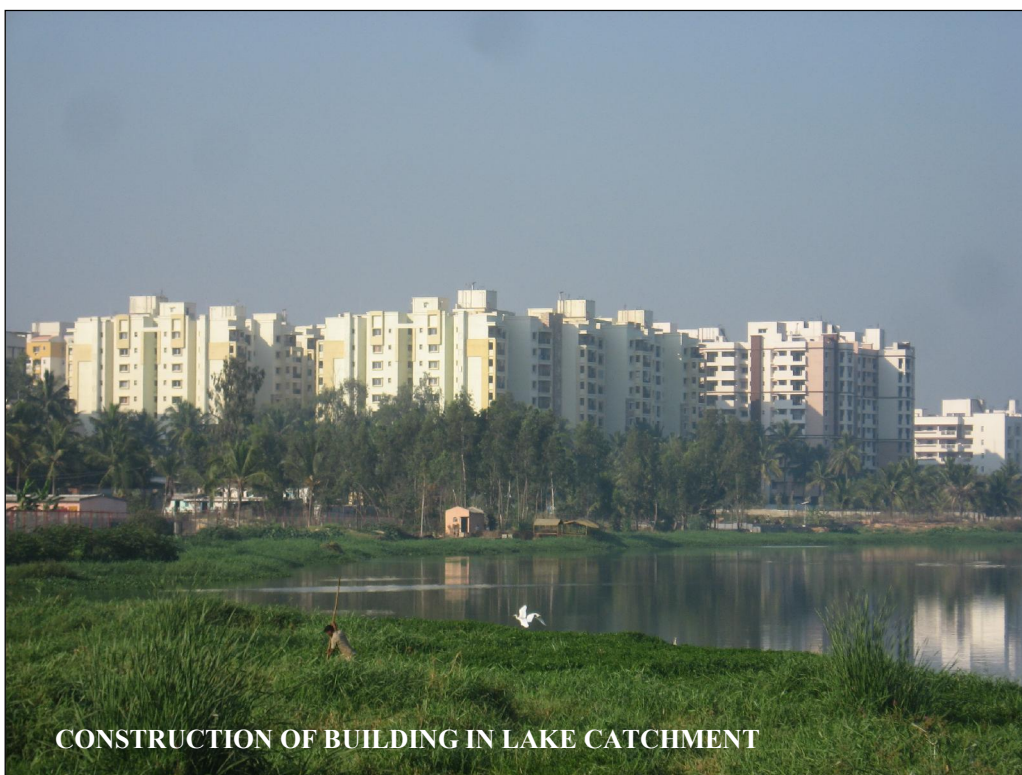
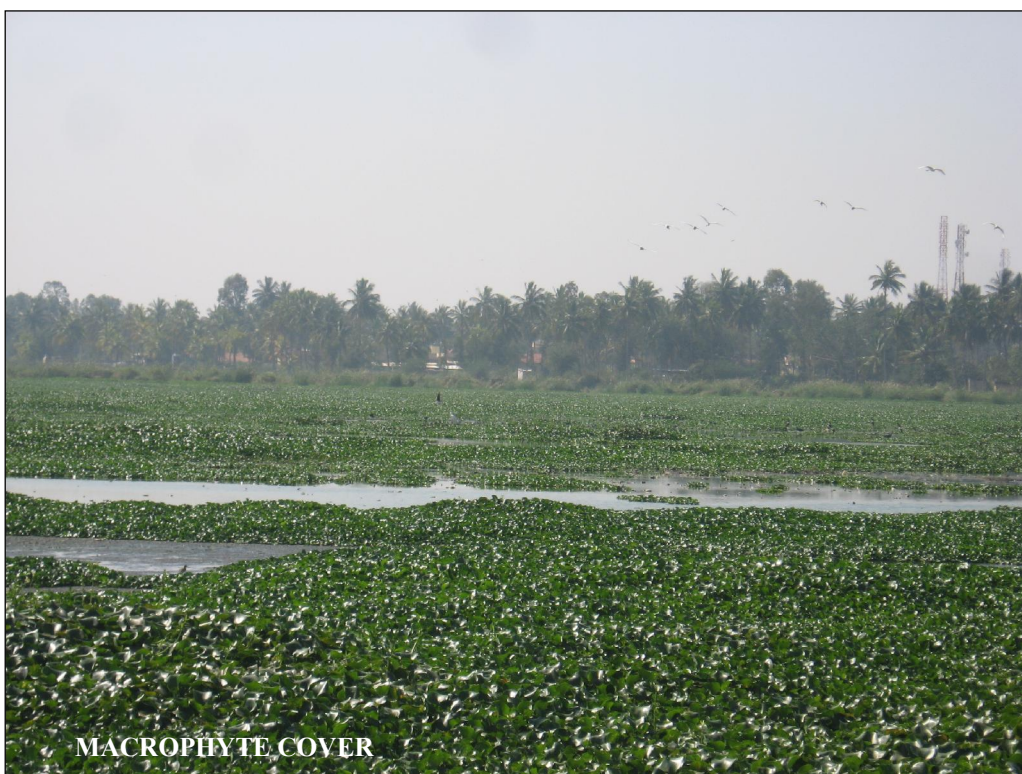
PLATE 3

- Macrophyte cover (*Eichornia* sp.)
- Dumping of construction waste, solid waste. Lake bed has been occupied for construction, Encroachment (filling of lake bed with construction waste)
- Untreated sewage inflow
- No shoreline
- Sludge deposition

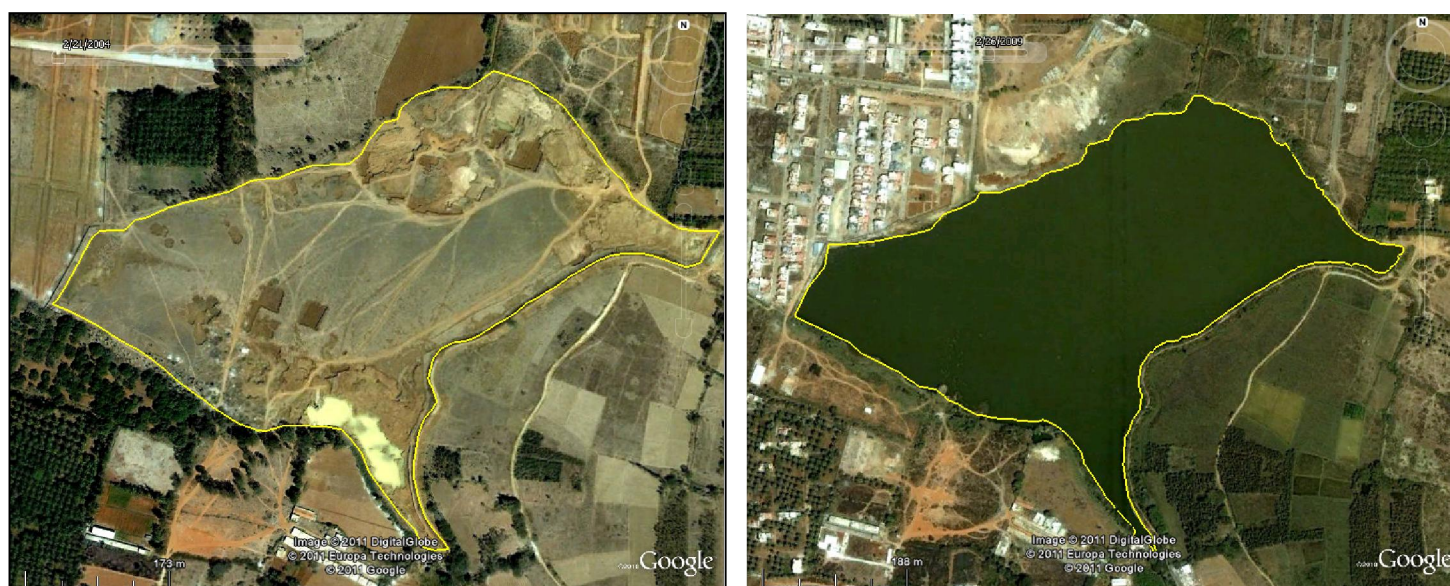
Figure 4 Google Earth and area of Bommasandra Lake during 2004 and 2009 respectively

NAME OF THE LAKE	BOMMASANDRA LAKE
GEOGRAPHIC DETAILS	12°49'30"N 77°41'41"E
AREA (2004/2009)	18.97/18.57 ha
ORGANIZATION	LDA/ Fisheries department
WARD / VILLAGE NAME	Bommasandra
STATUS	Polluted
RESTORATION	Completed (2004-2005)
WATER CONDITION	Moderate - Poor

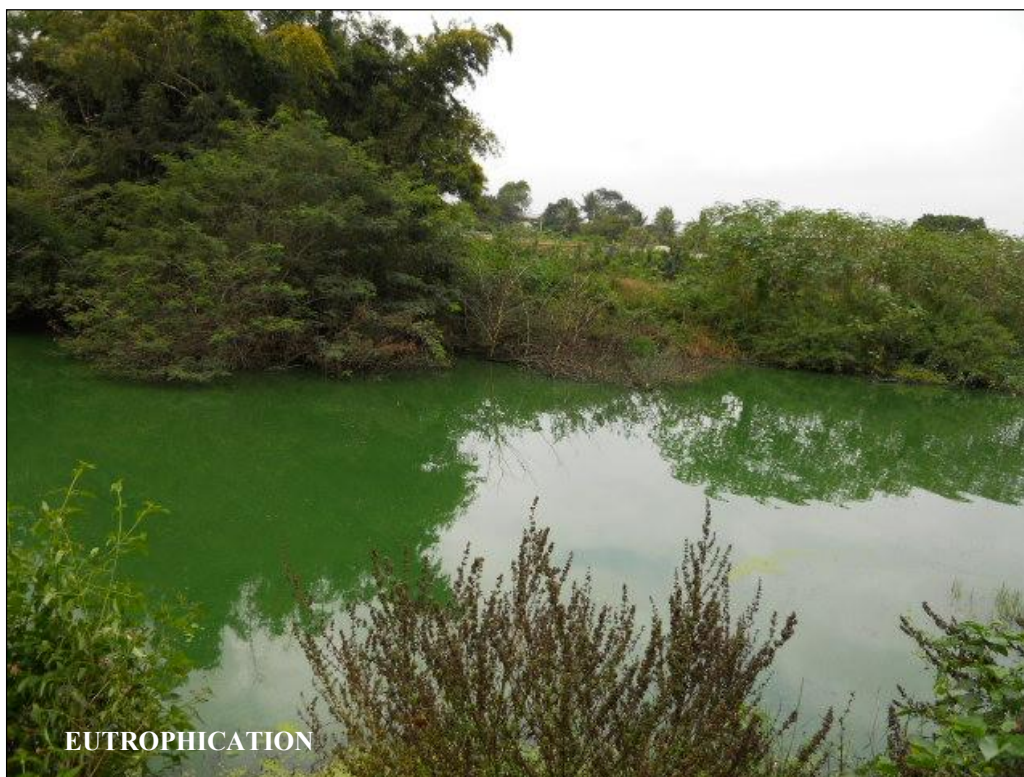
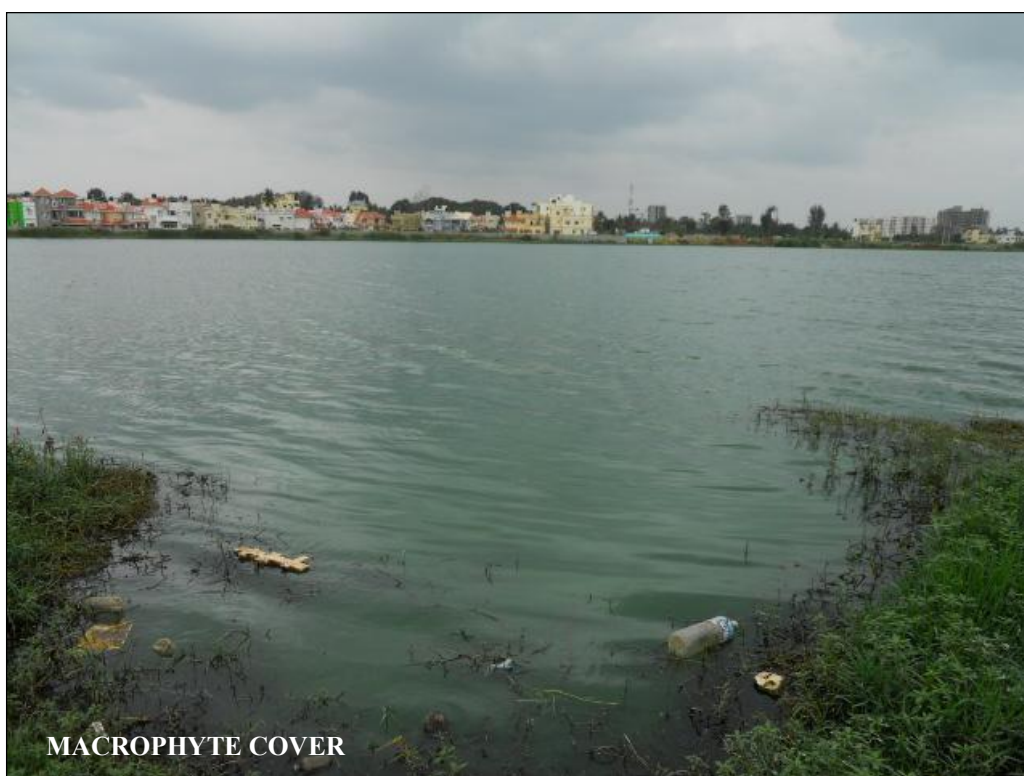
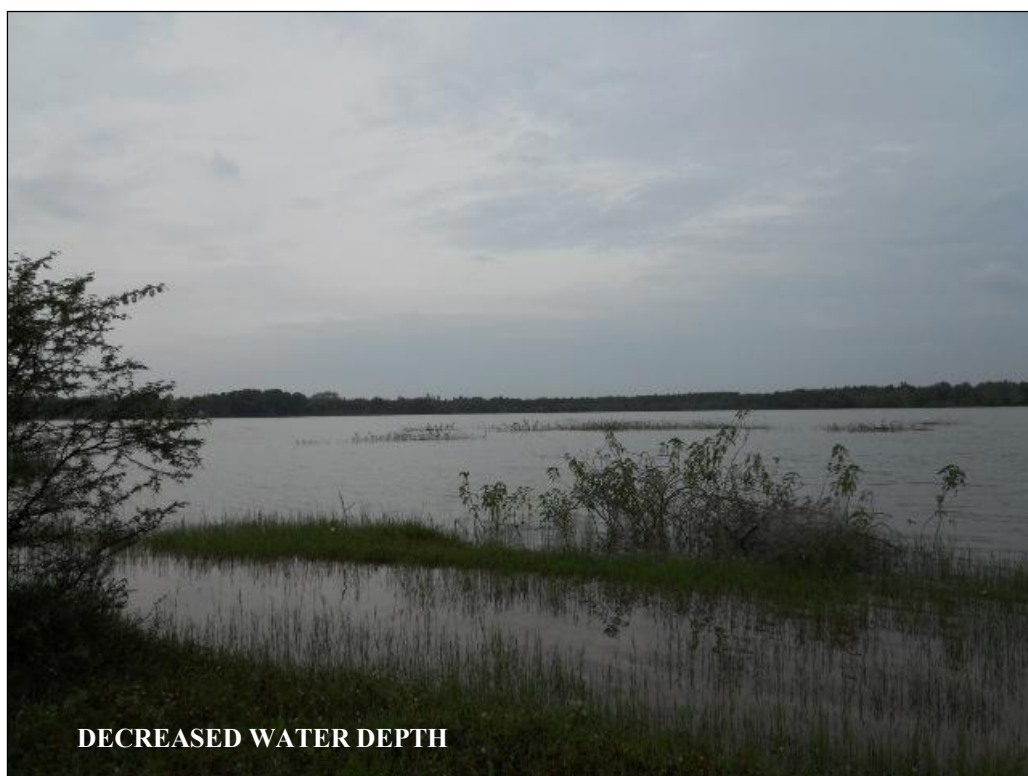
PLATE 4

- Dumping of construction waste, solid waste, etc.
- Local disturbances (Open defecation).
- Decrease in water depth due to Sludge deposition.
- Piggery waste and household waste and Fishing.

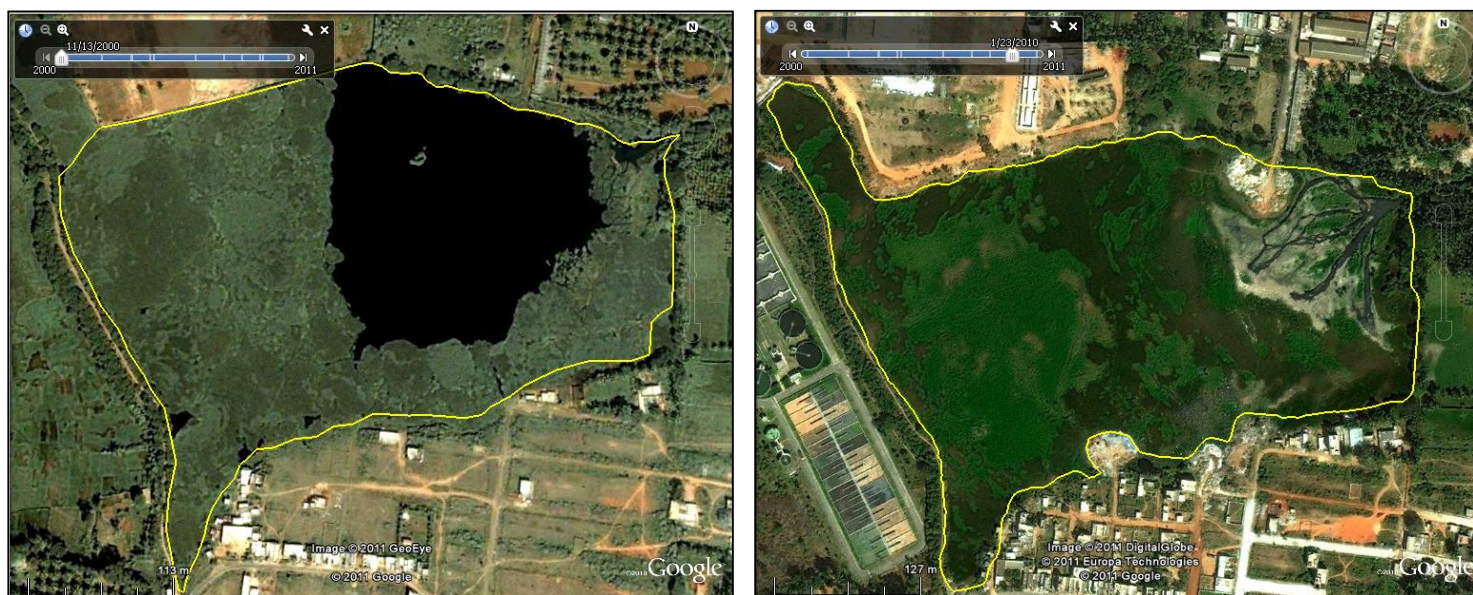
Figure 5 Google Earth and spatial extent of Doddabidarekallu Lake during 2000 and 2009 respectively

NAME OF THE LAKE	DODDABIDAREKALLU LAKE
GEOGRAPHIC DETAILS	13°2'32"N 77°29'34"E
AREA (2000/2009)	11.67/12.06 ha
ORGANIZATION	BDA/ BBMP
WARD / VILLAGE NAME	14- Bagalakunte
STATUS	Highly Polluted
RESTORATION	NO
WATER CONDITION	Eutrophication, high pollution

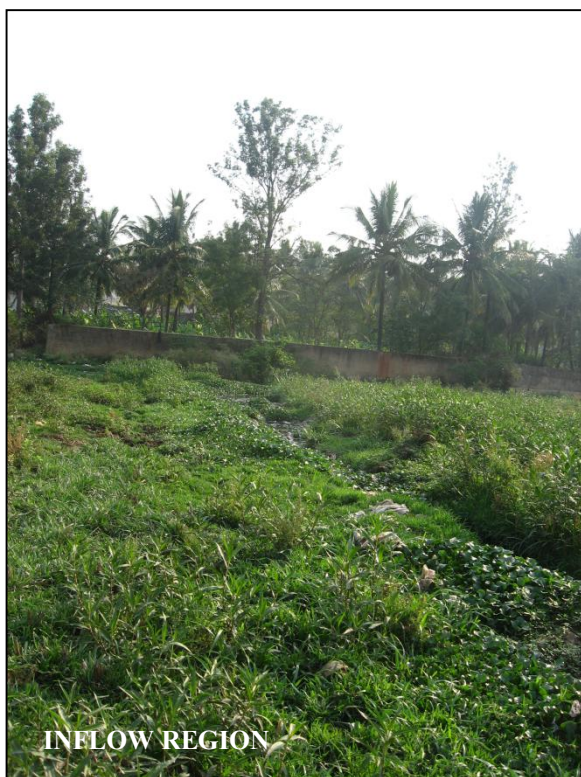
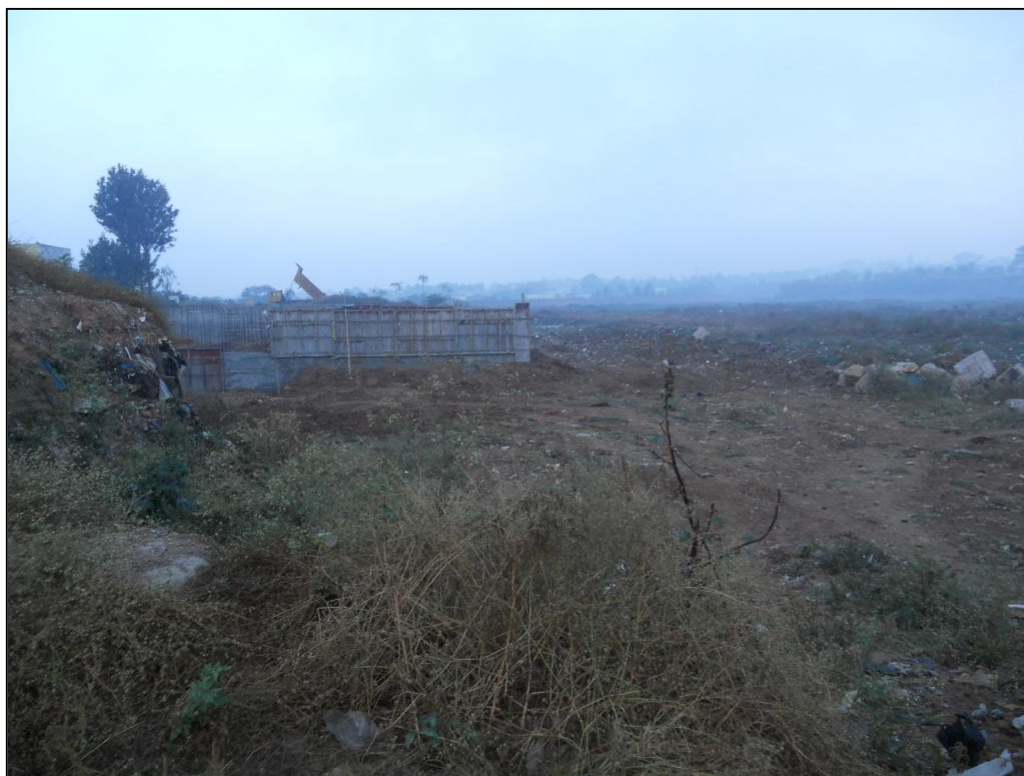
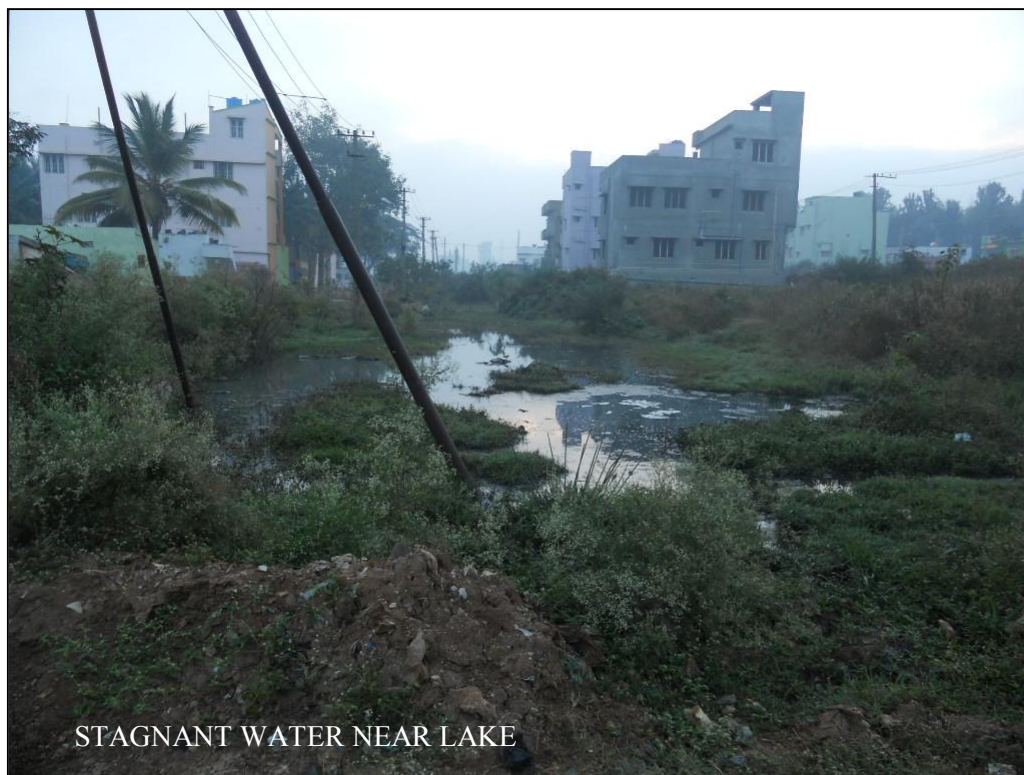
PLATE 5

- Dumping of construction waste and solid waste
- Local disturbances
- Sludge deposition
- Completely covered with Macrophyte.
- Untreated sewage and industrial inflow into the lake bed

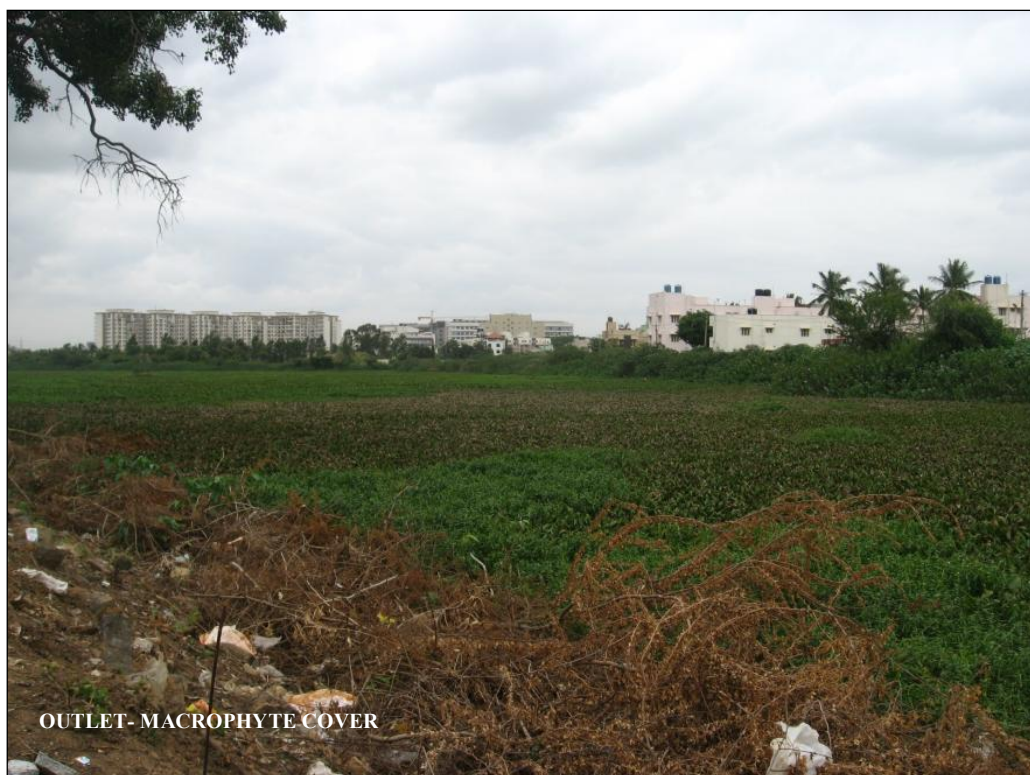
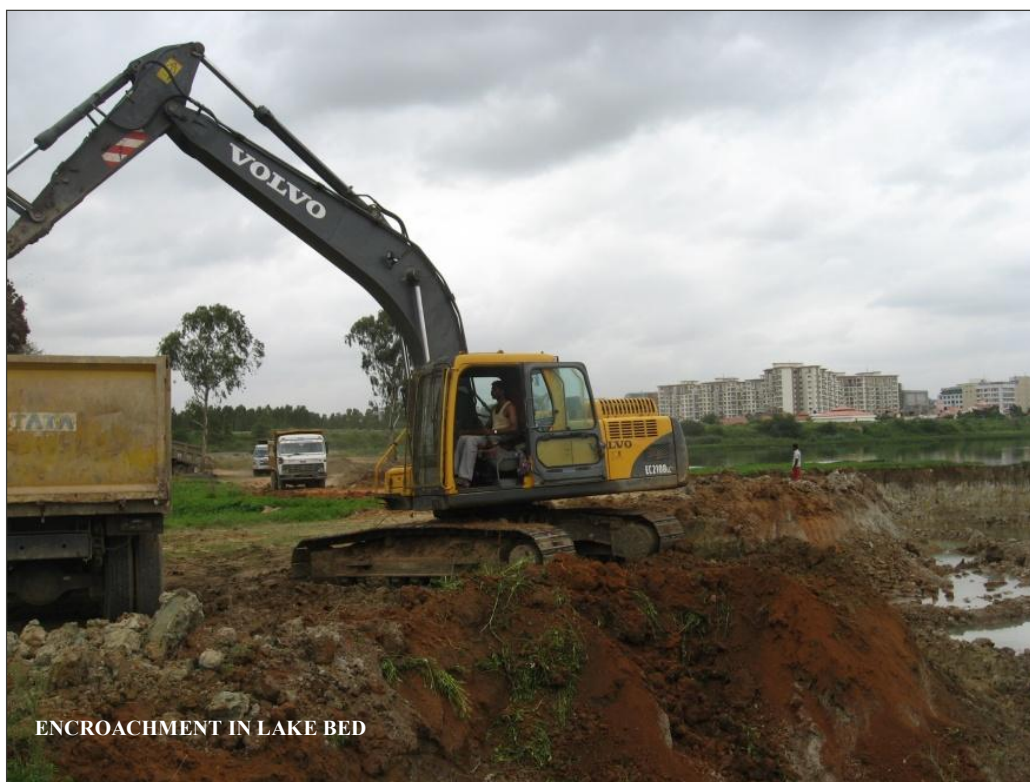
PLATE 6

- Macrophyte cover (*Eichornia* sp.),
- Dumping of construction waste, Lake bed is encroached for construction of temple, building etc.
- Encroachment (filling of lake bed with construction waste)
- Untreated sewage inflow,
- No shoreline,
- Sludge deposition.

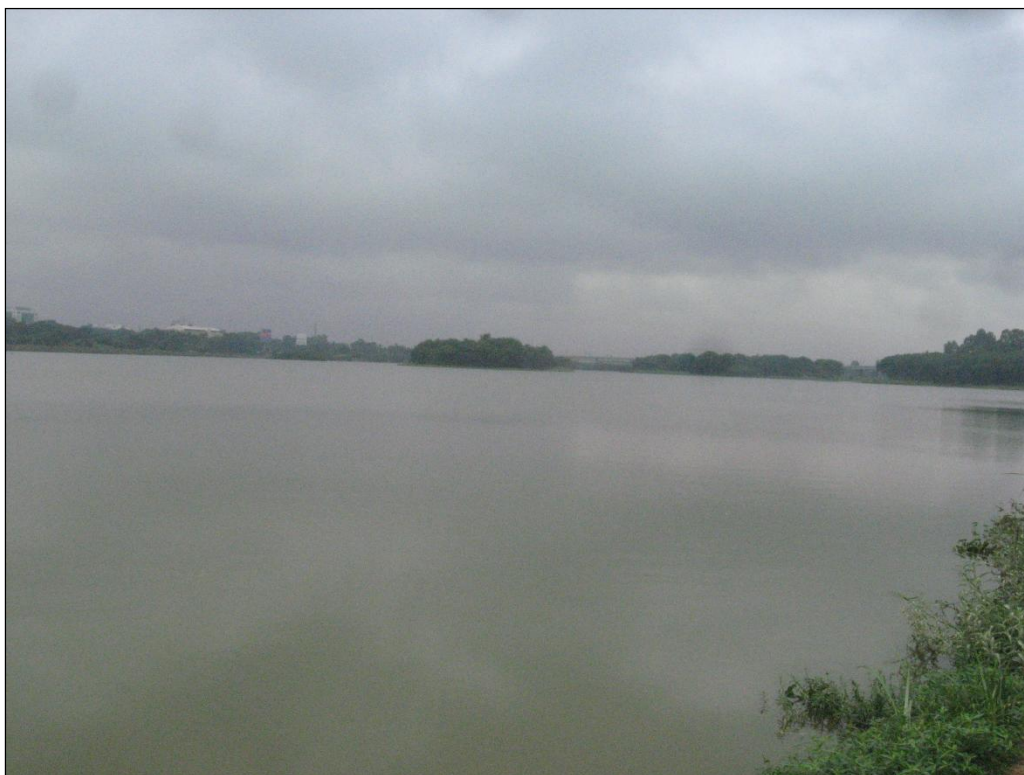
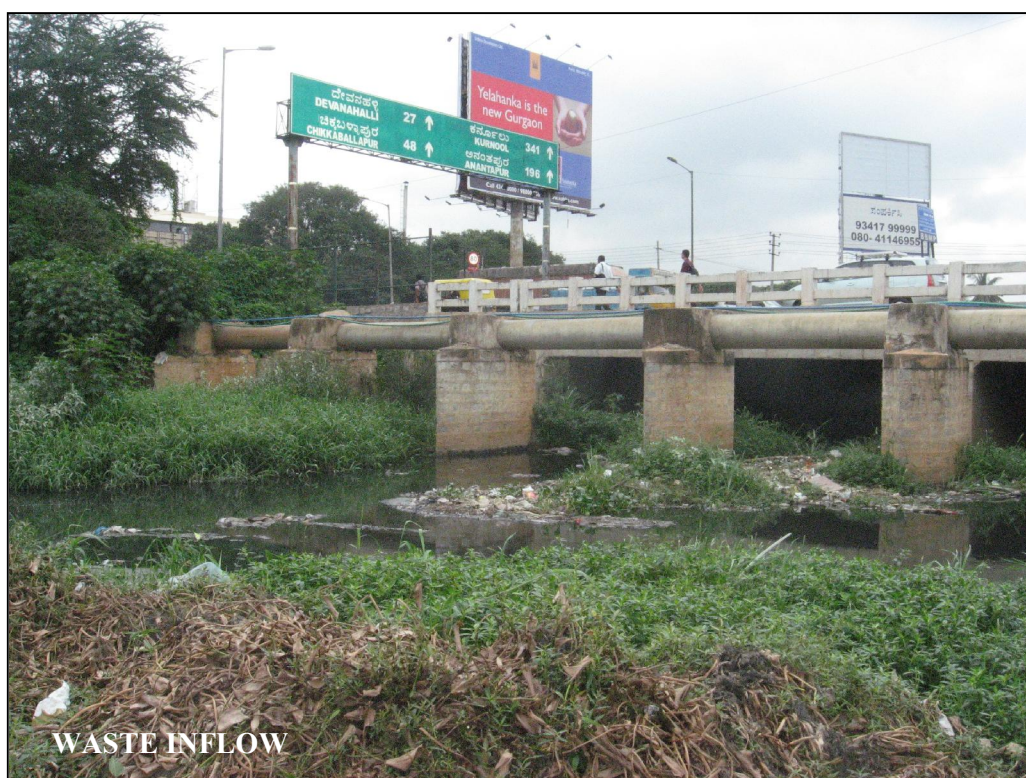
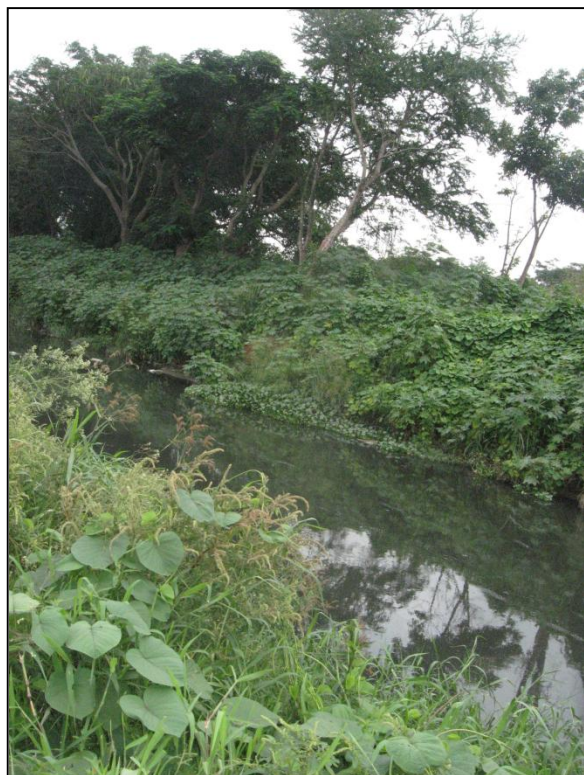
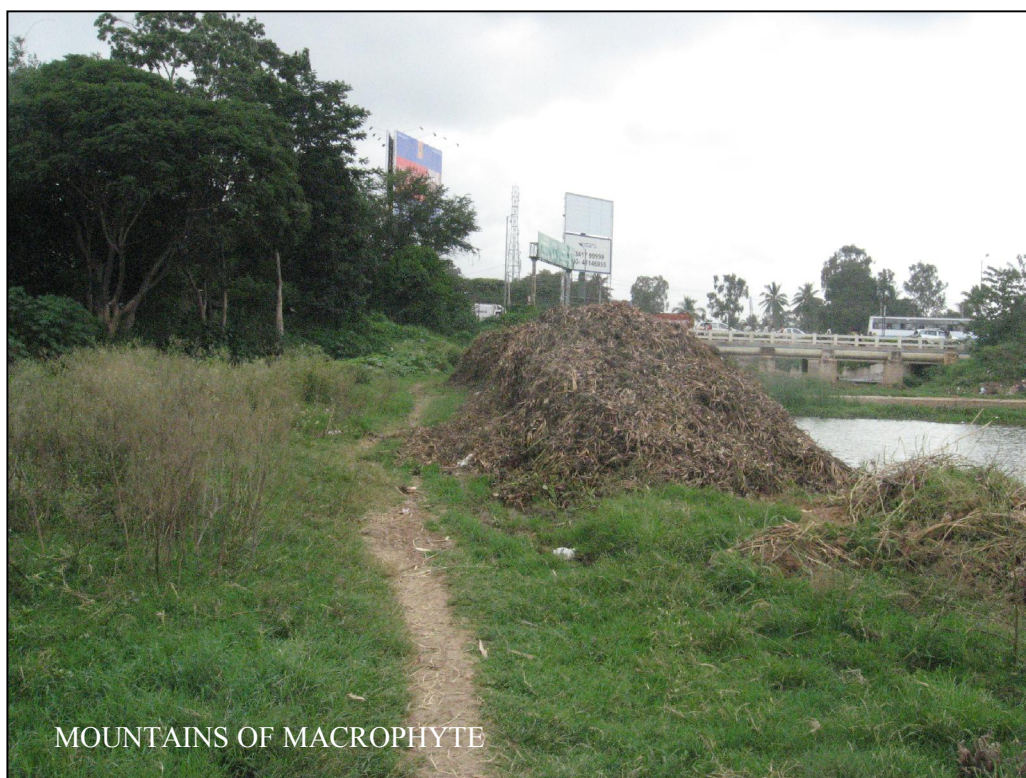
PLATE 7

- No shoreline
- Human disturbances and Fishing
- Untreated sewage inflow.

WASTE INFLOW
