ENVIRONMENTAL AUDITING OF BANGALORE WETLANDS

ENVIS Technical Report 72

January 2015

**Energy & Wetlands Research Group [CES TE15]
Centre for Ecological Sciences,
Indian Institute of Science,
Bangalore - 560012, INDIA**

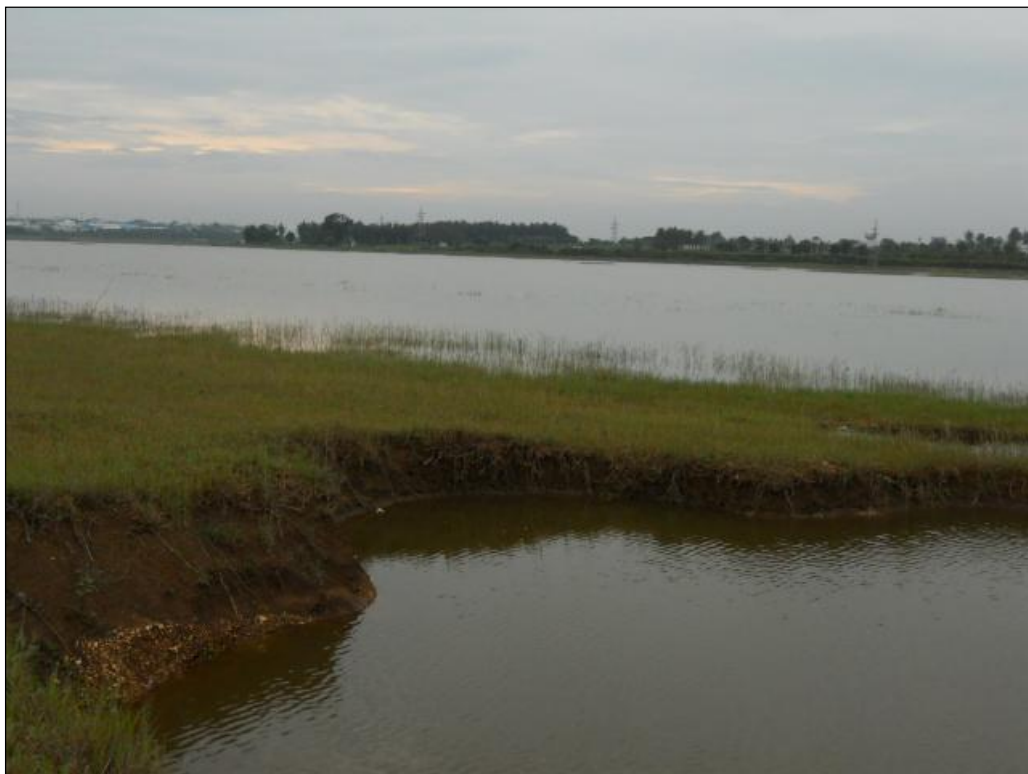
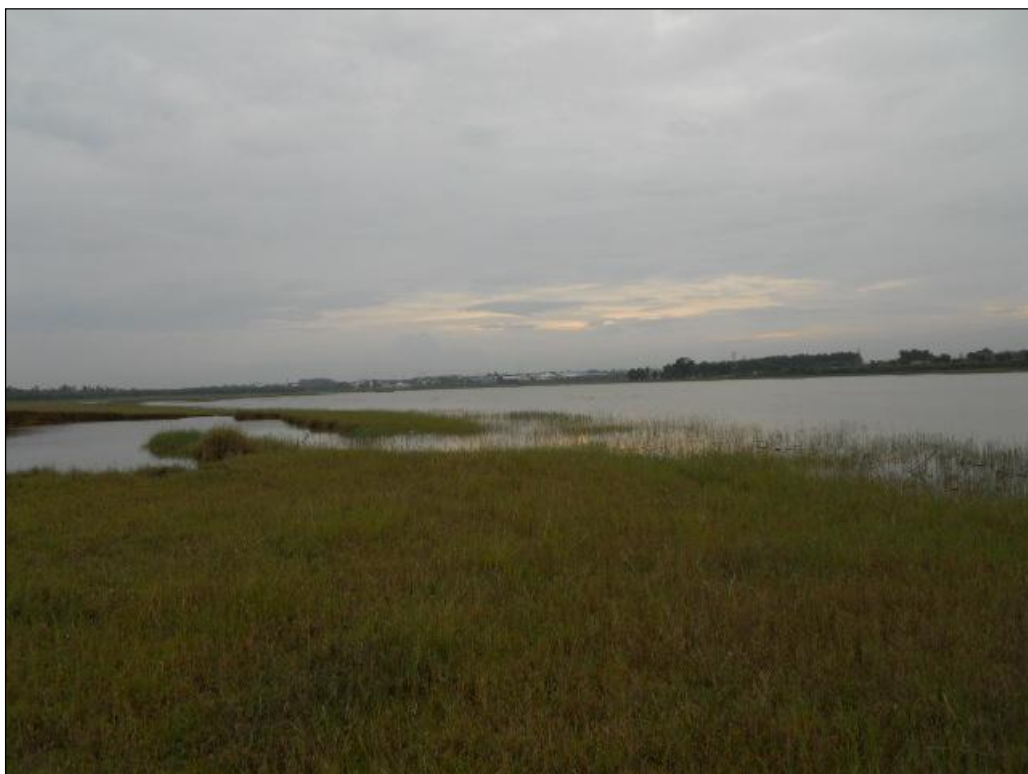
PLATE 8

- a. Local human disturbances
- b. Aquatic weeds

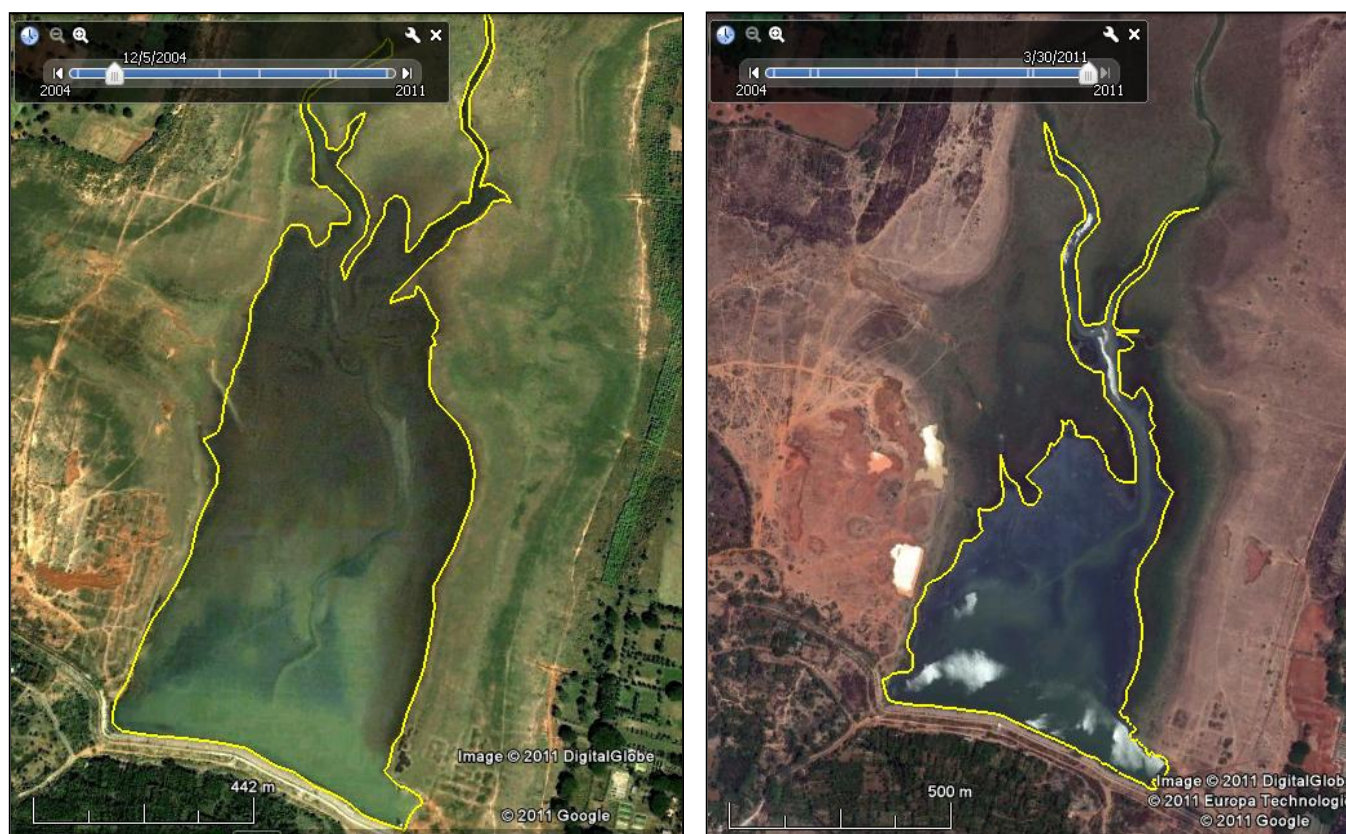
Figure 9 Google Earth and area of Hesaraghatta Lake during 2004 and 2011 respectively.

NAME OF THE LAKE	HESARAGHATTA
GEOGRAPHIC DETAILS	13°10'14"N 77°30'6"E
AREA (2004/2011)	61.88-32.37 ha
ORGANIZATION	Arkavati for drinking water
WARD / VILLAGE NAME	Hesaraghatta
STATUS	Clean
RESTORATION	NO
WATER CONDITION	Good (NO/less Water since 2010).

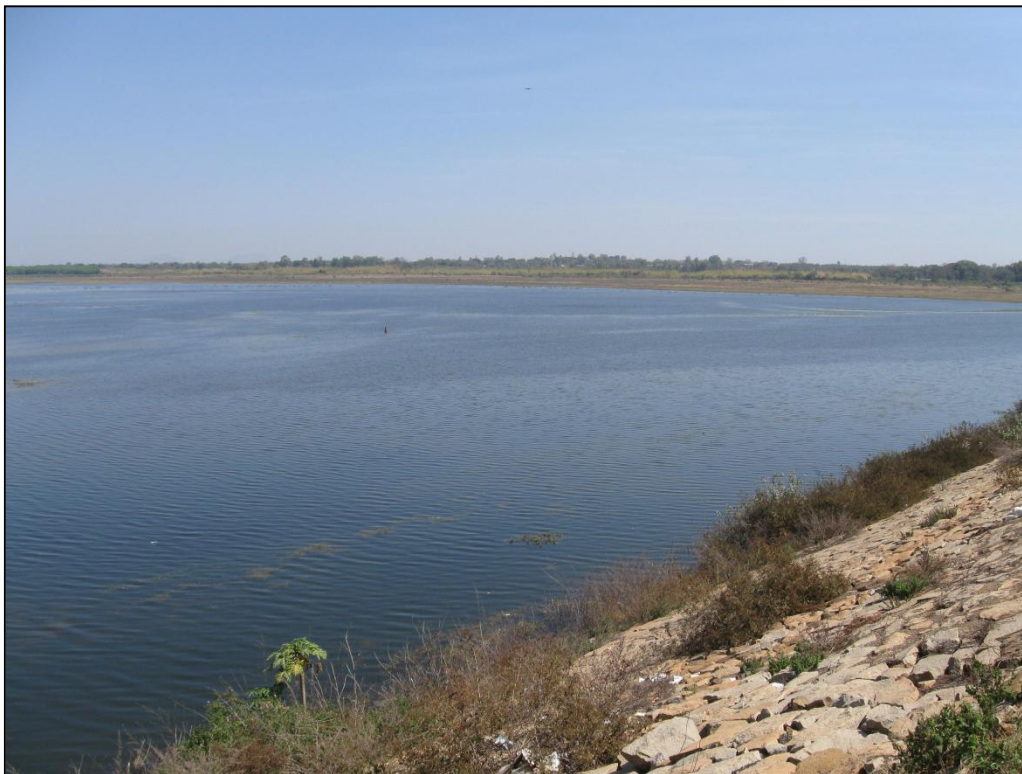
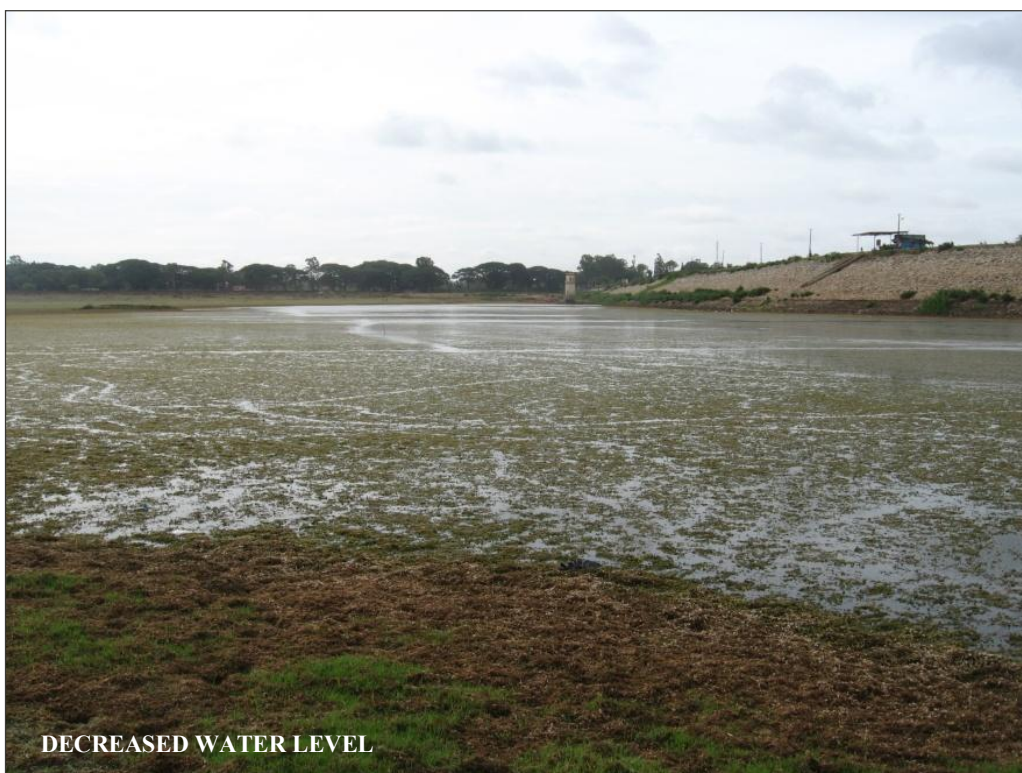
PLATE 9

- Decrease in water level
- Human disturbances, Open defecation, fishing.

DECREASED WATER LEVEL

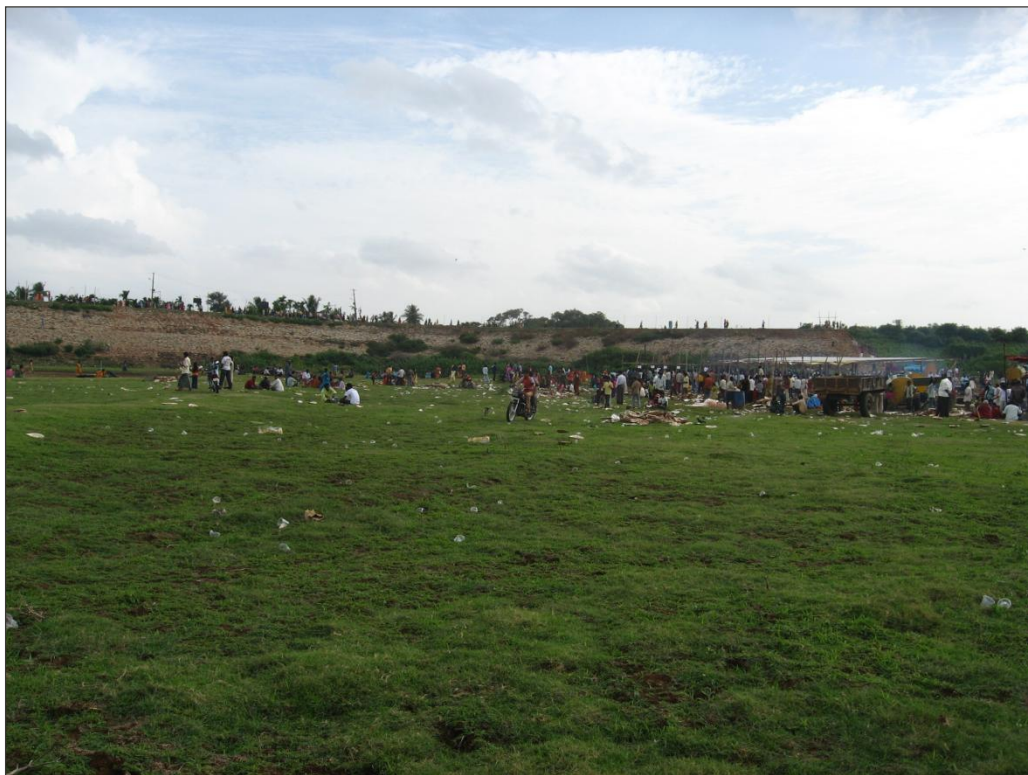
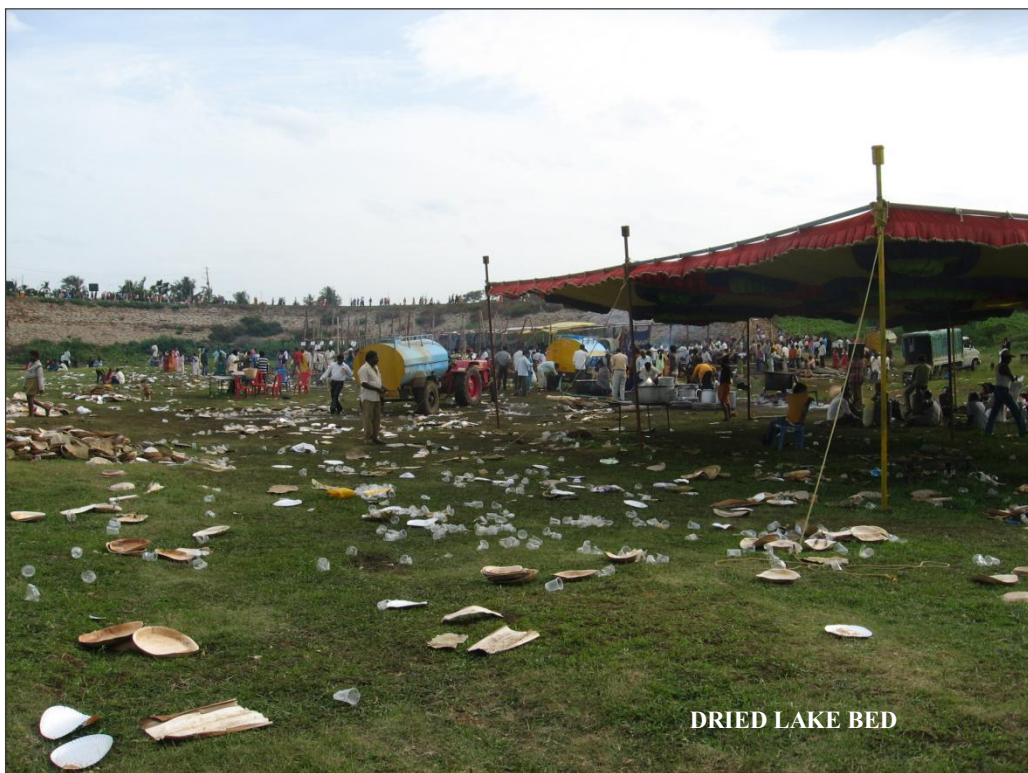
DUMPING OF PLASTIC AND PAPER WASTE IN LAKE BED DURING VILLAGE FESTIVAL

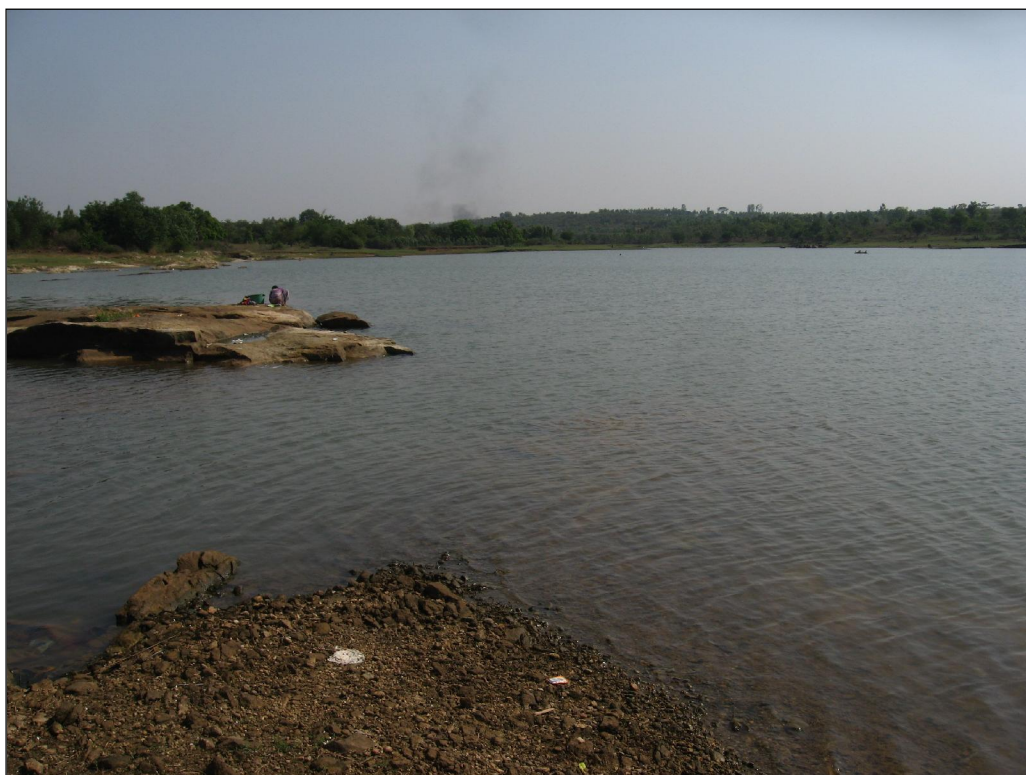
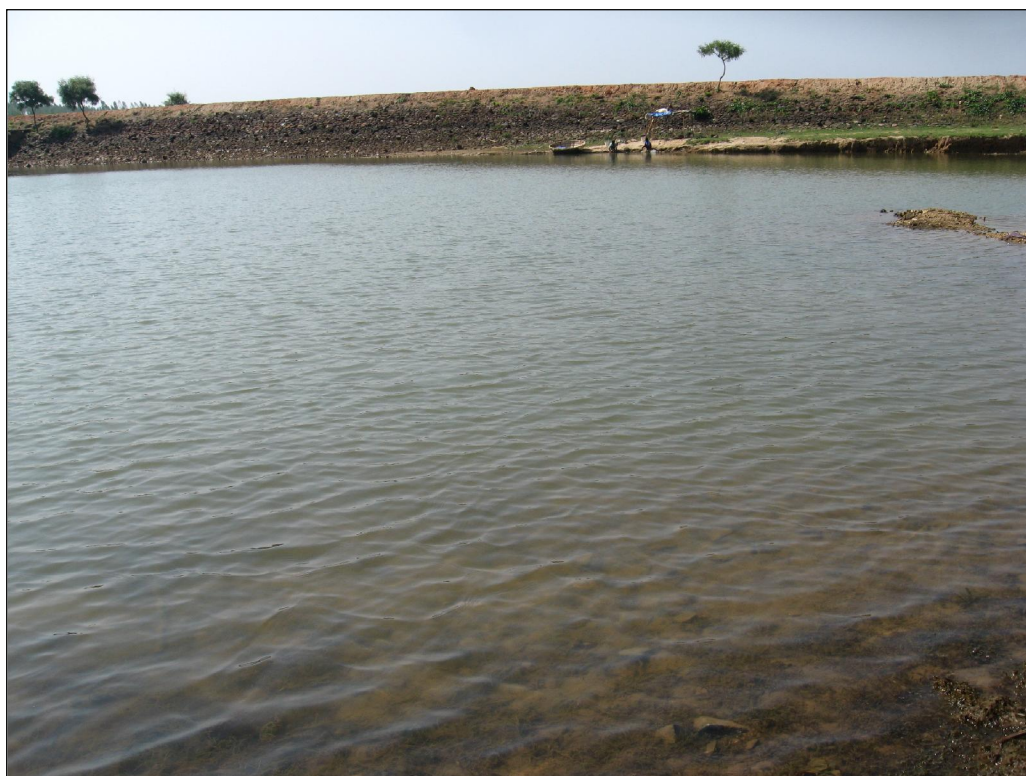
PLATE 10

Local human disturbances (Open defecation, washing clothes)

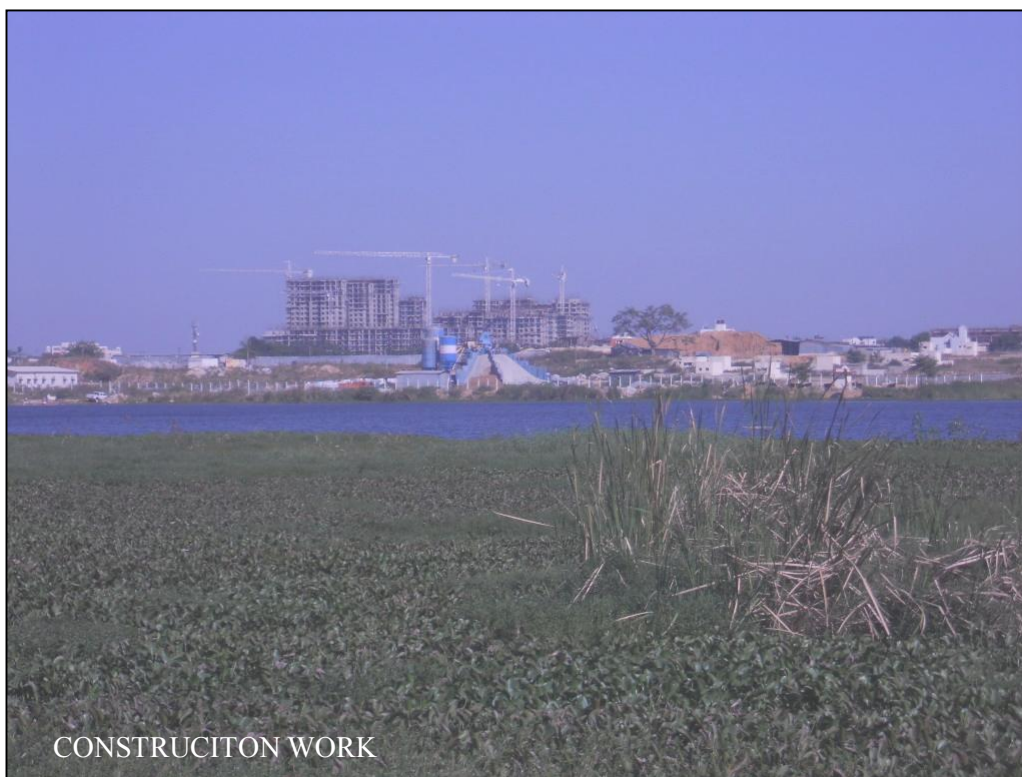
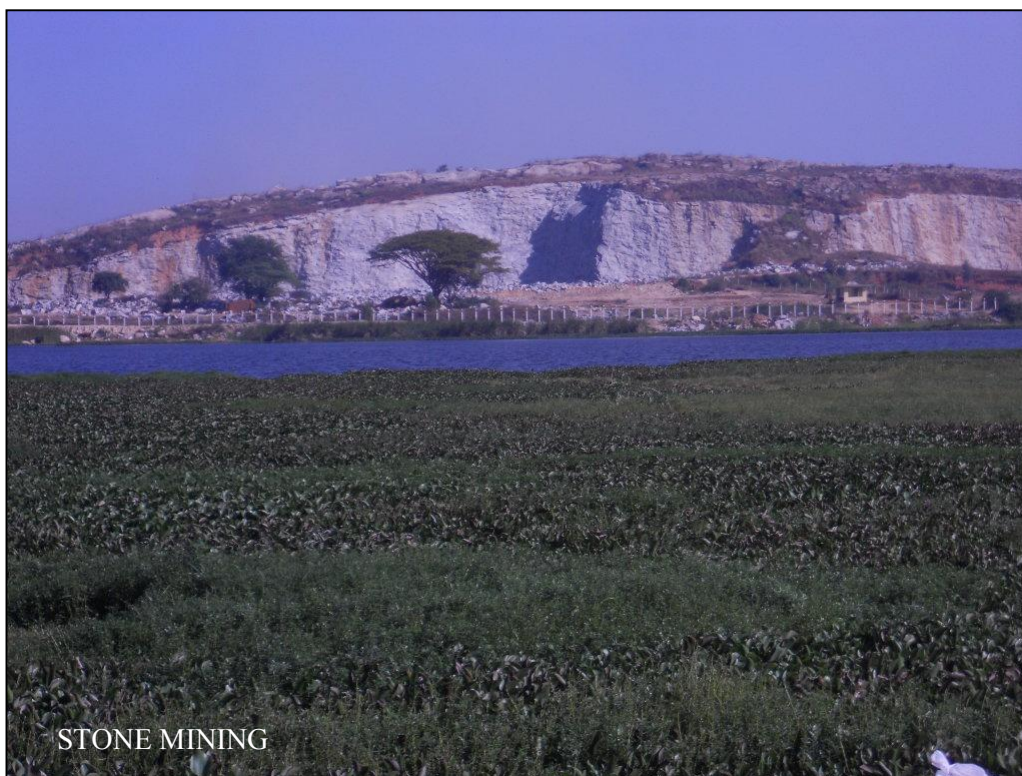
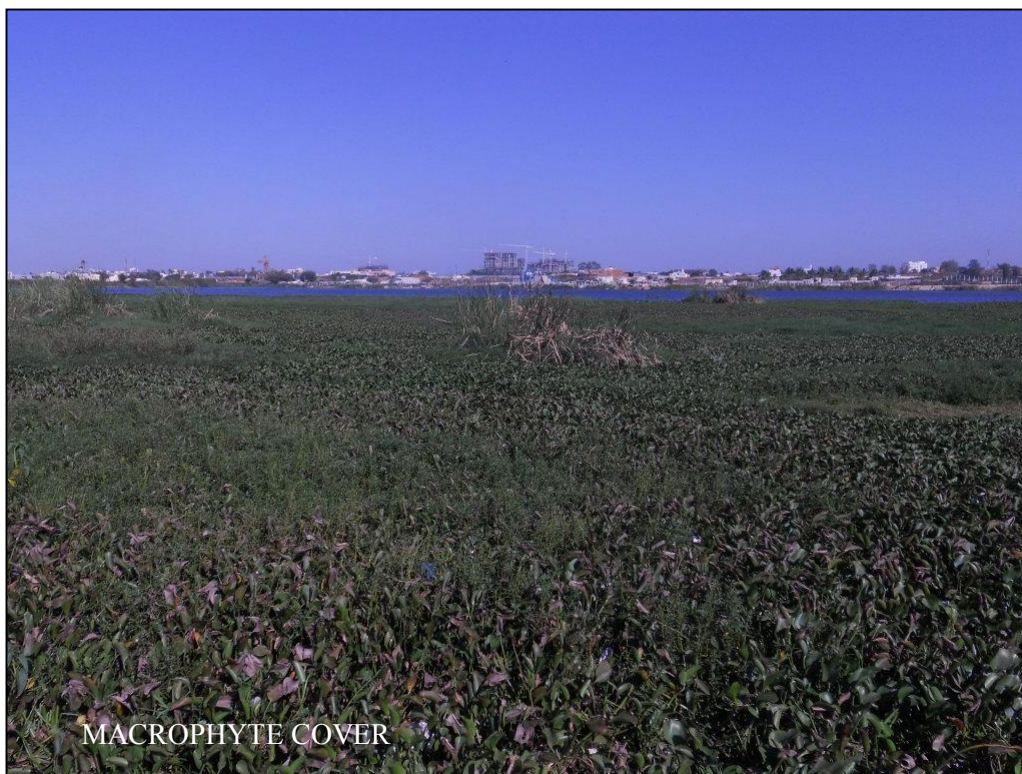
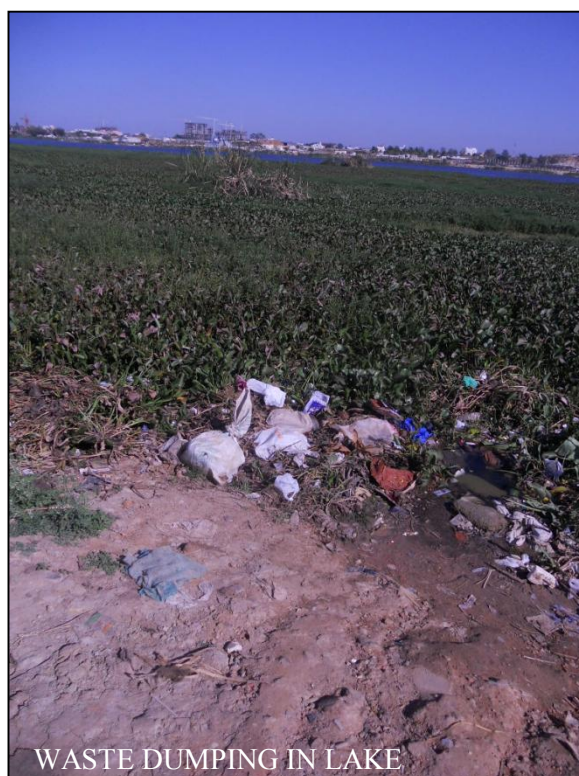
PLATE 11

- Dumping of construction waste on lake bund
- Local human disturbances such as washing clothes, open defecation, fishing
- Untreated sewage inflow into the lake

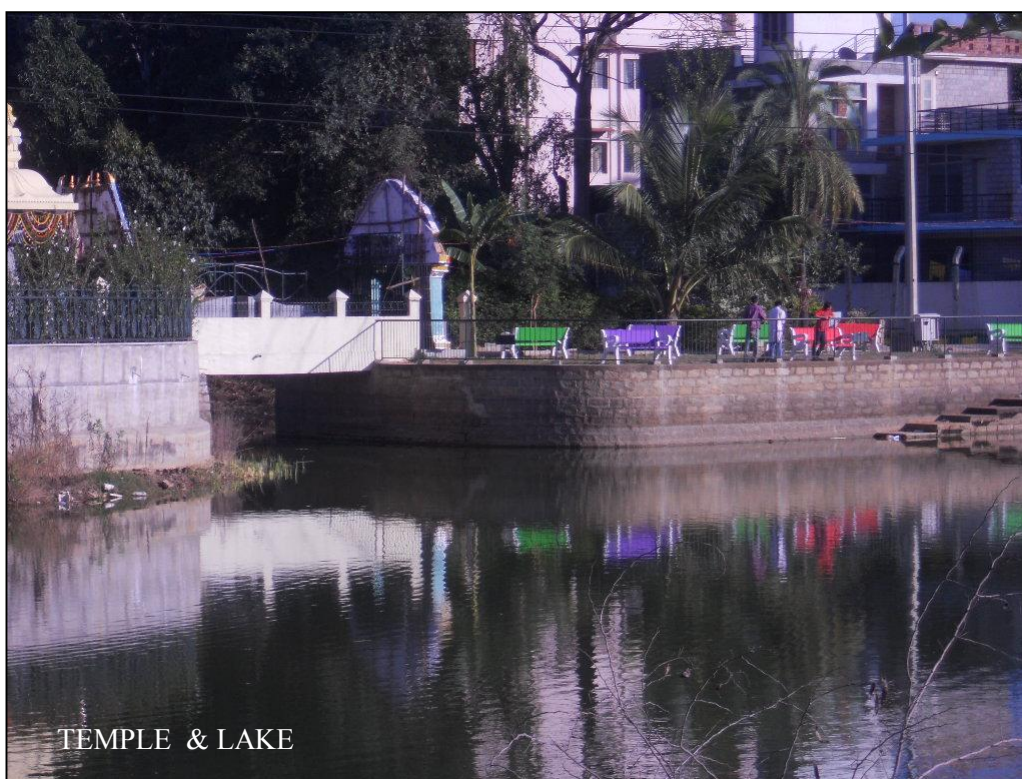
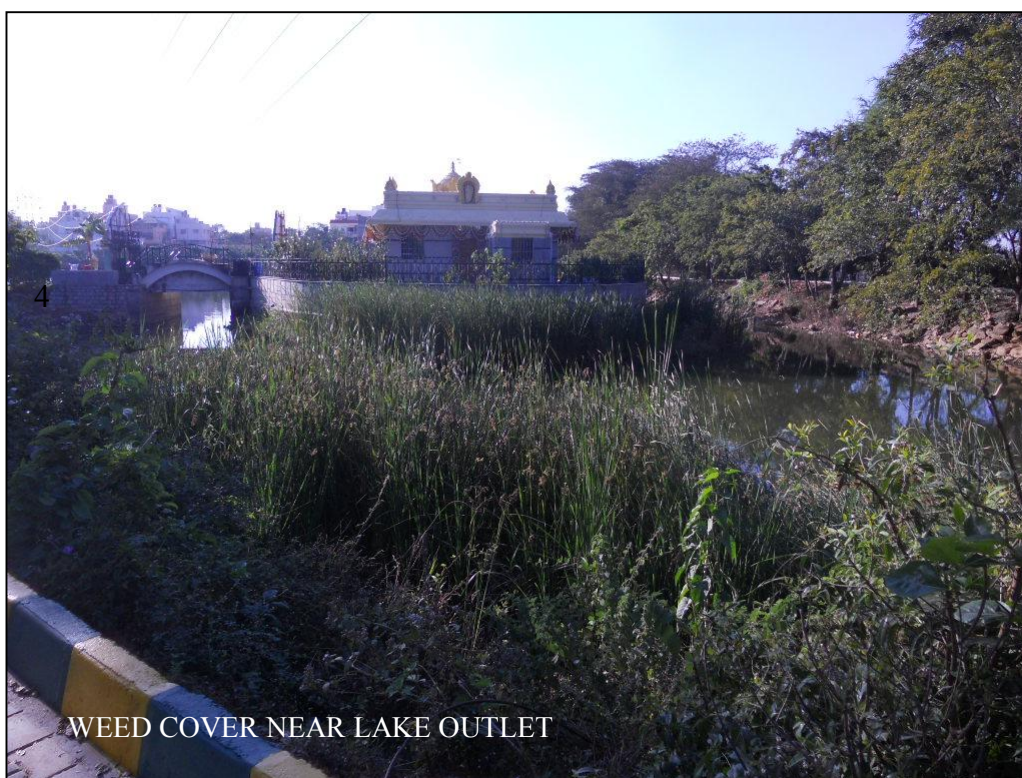
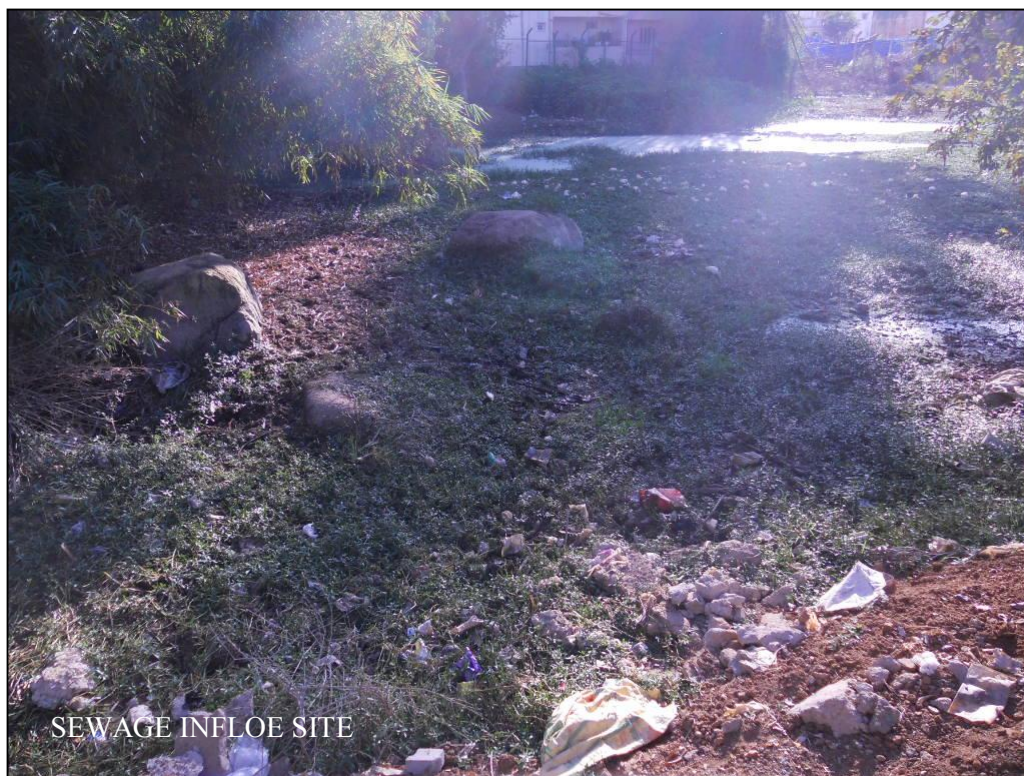
PLATE 12

- Dumping of garbage, Foul smell, Poor maintenance,
- Sewage of ISRO layout to lake inflow, Temple waste, etc.

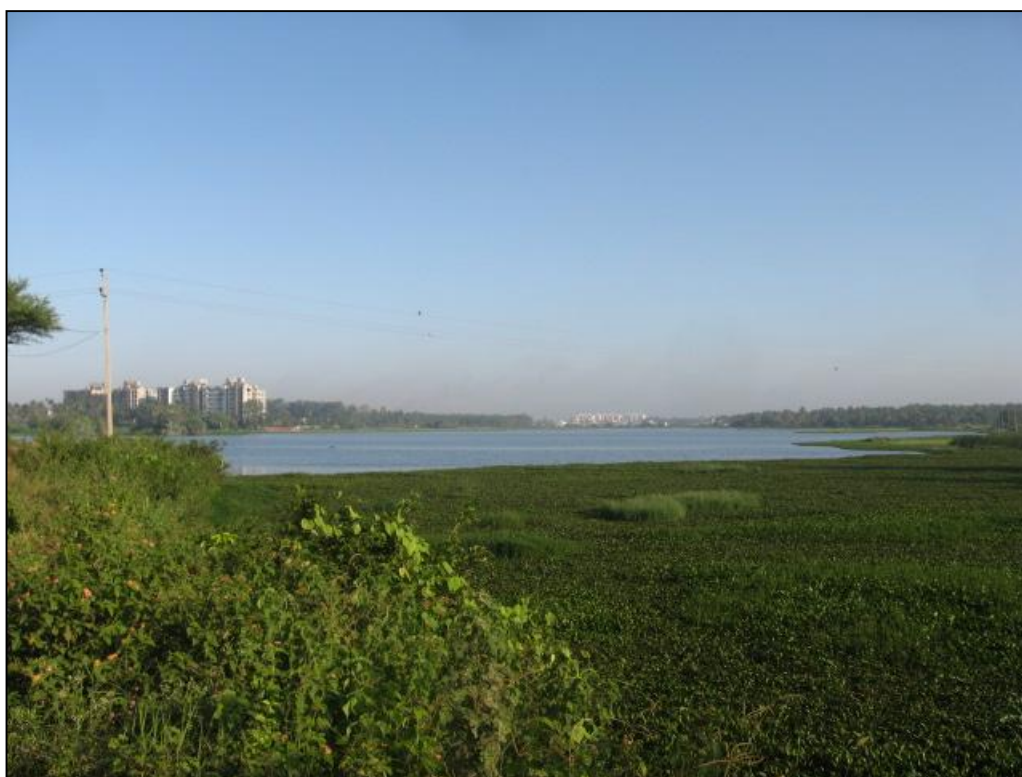
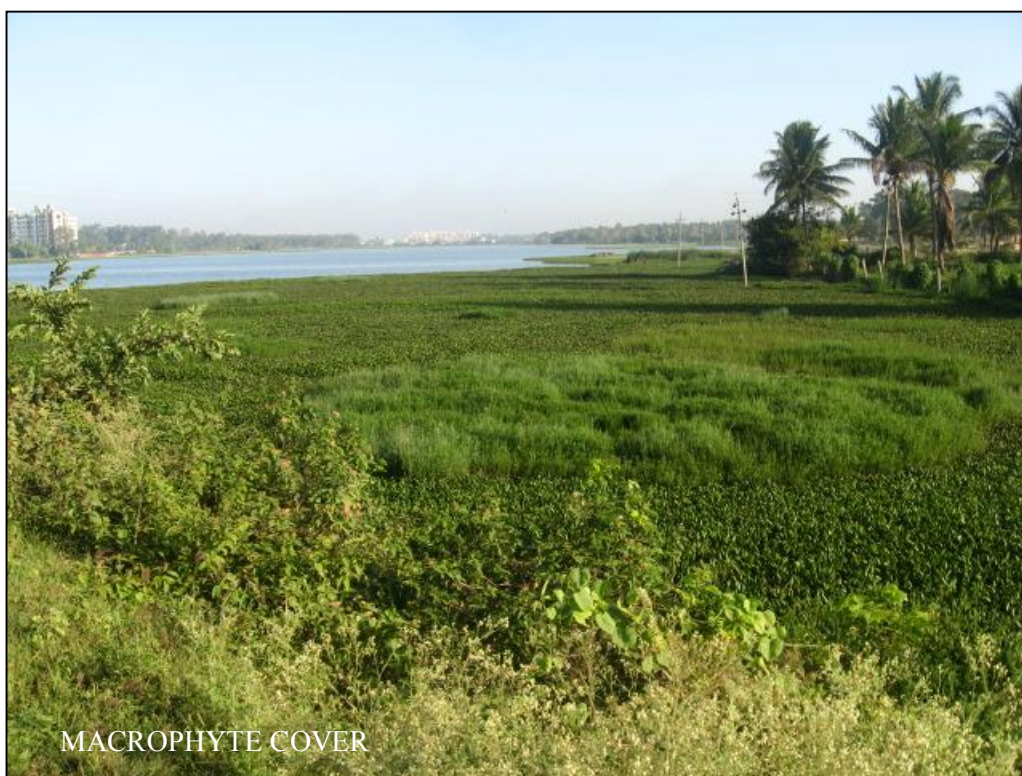
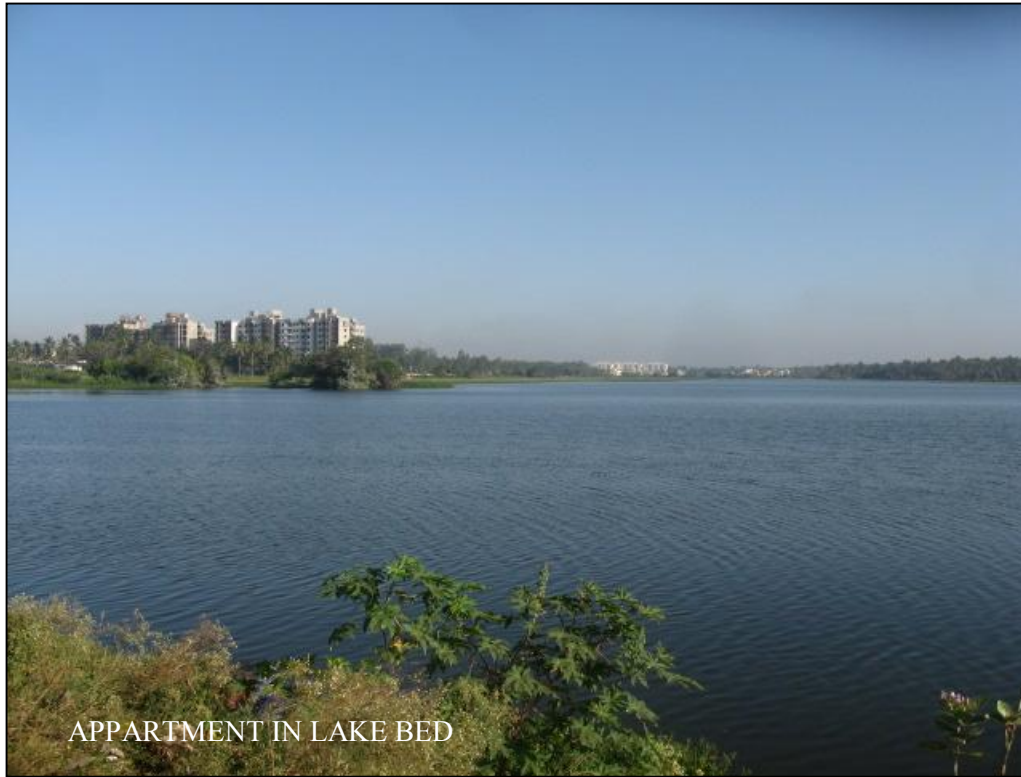
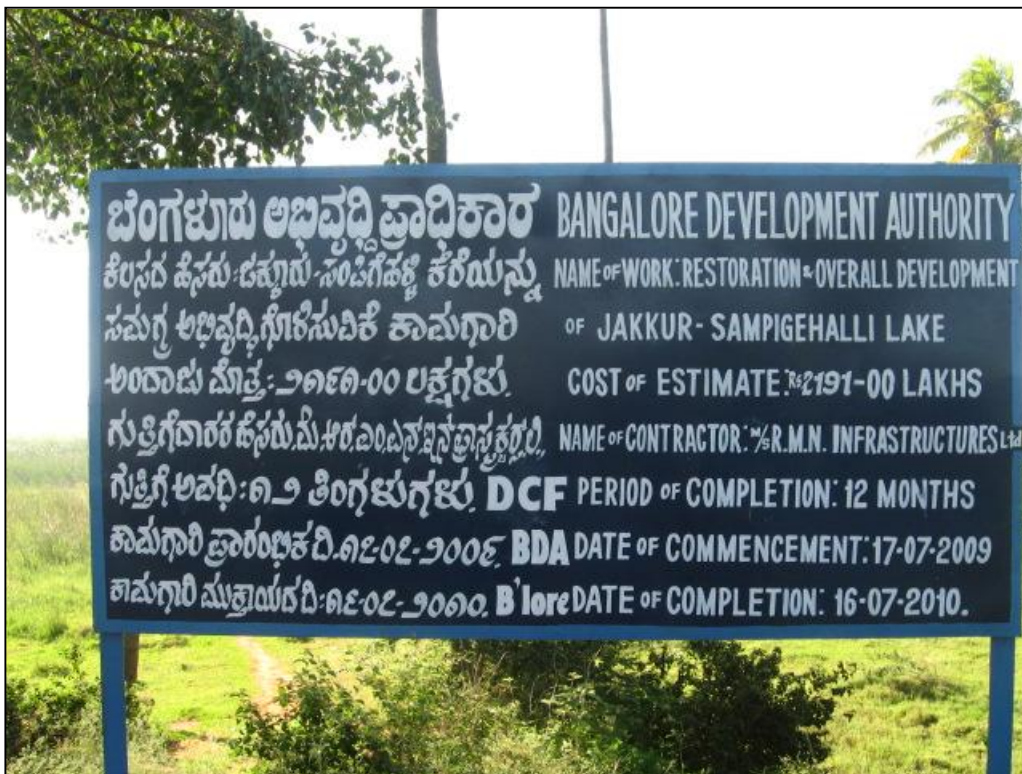
PLATE 13

- Domestic sewage run-off of Jakkur village,
- urbanization
- Inflow of fields and plantations surrounding lake

APPARTMENT IN LAKE BED

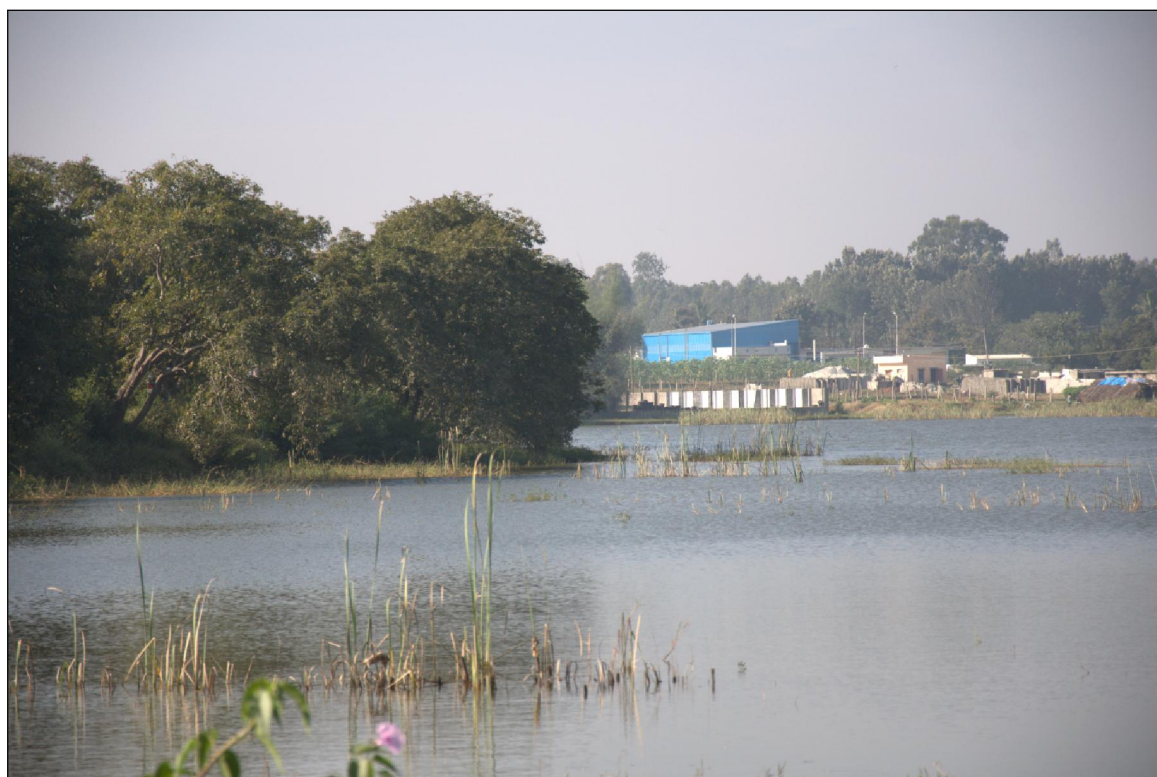
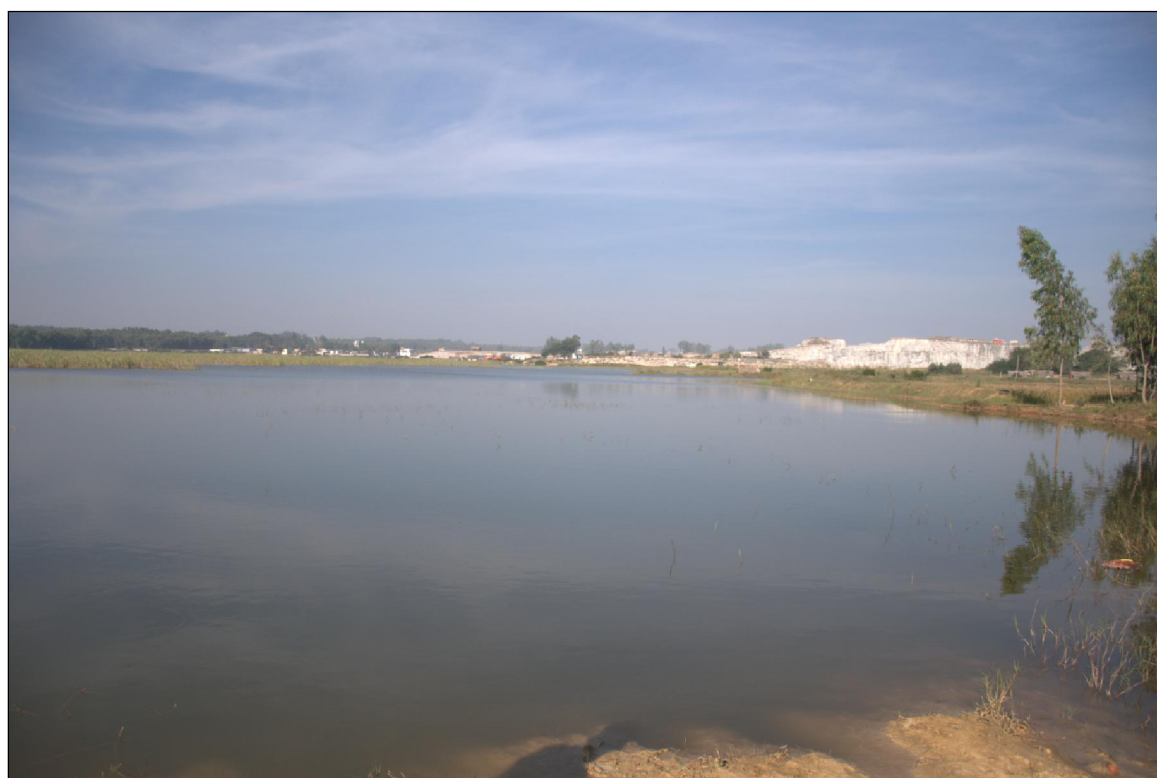
PLATE 14

- Mining
- Local human disturbances
- Agricultural run-off

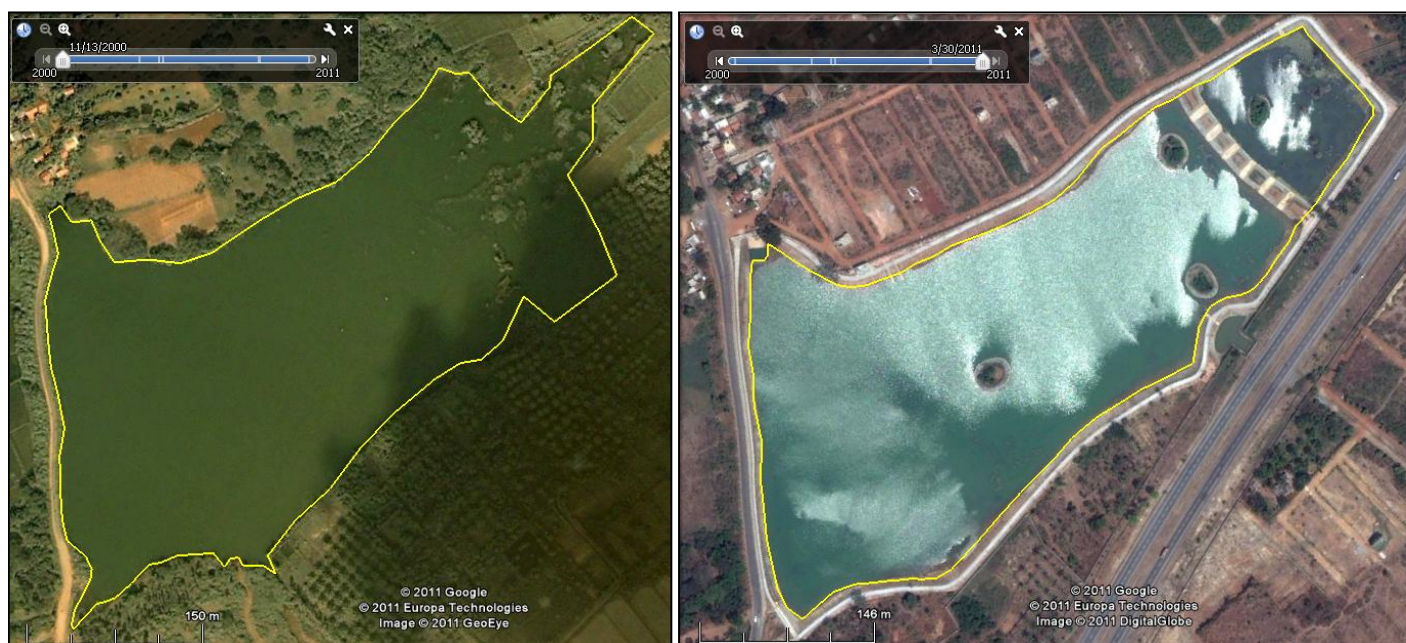
Figure 15 Google Earth image and area of Kommaghatta Lake during 2000 and 2011 respectively.

NAME OF THE LAKE	KOMMAGHATTA LAKE
GEOGRAPHIC DETAILS	12°55'48"N 77°28'2"E
AREA	ha
ORGANIZATION	BDA
WARD / VILLAGE NAME	Kommaghatta
STATUS	Clean/ No pollution
RESTORATION	September 2009- August 2010 (COMPELTED)
WATER CONDITION	Good.

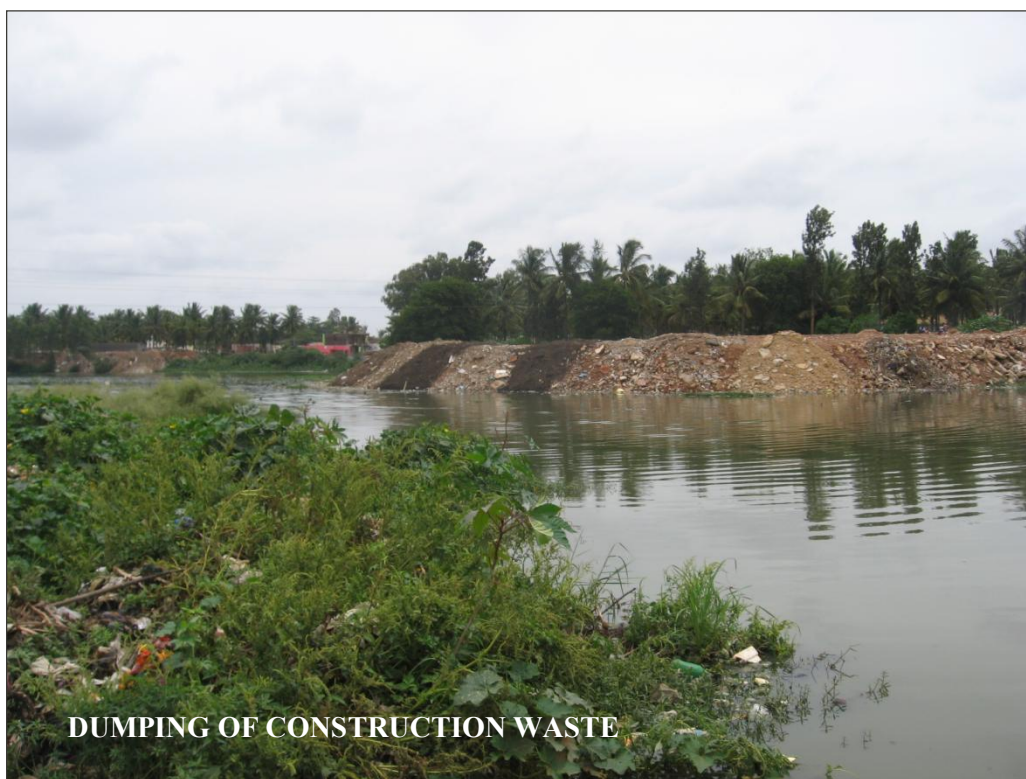
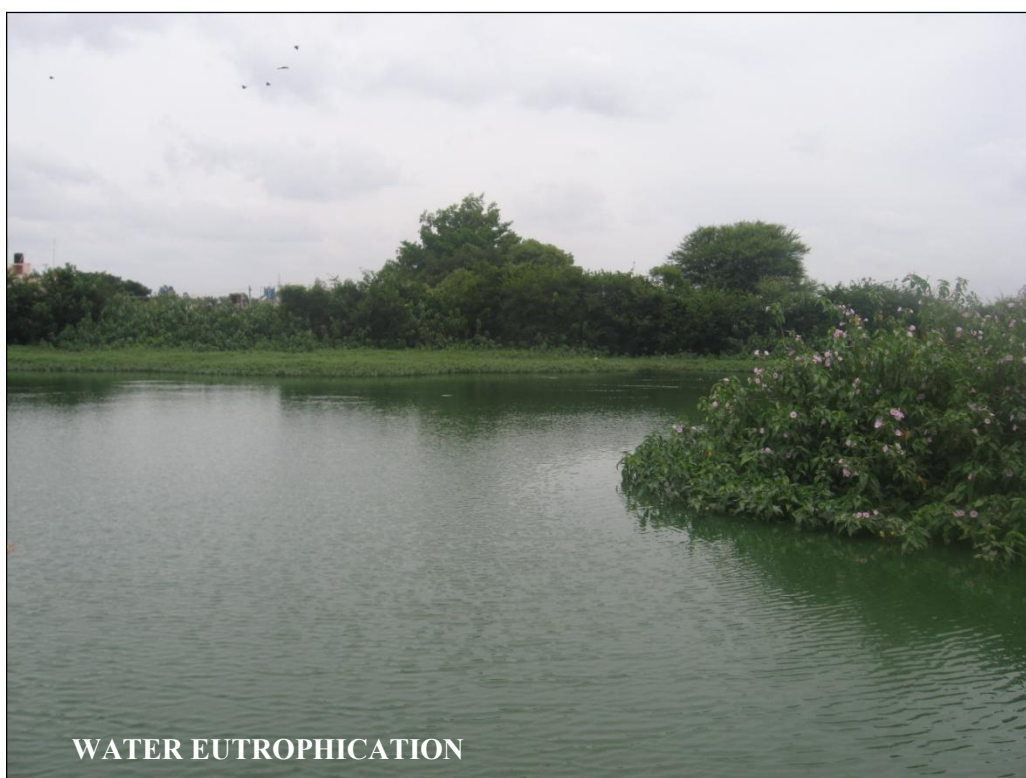
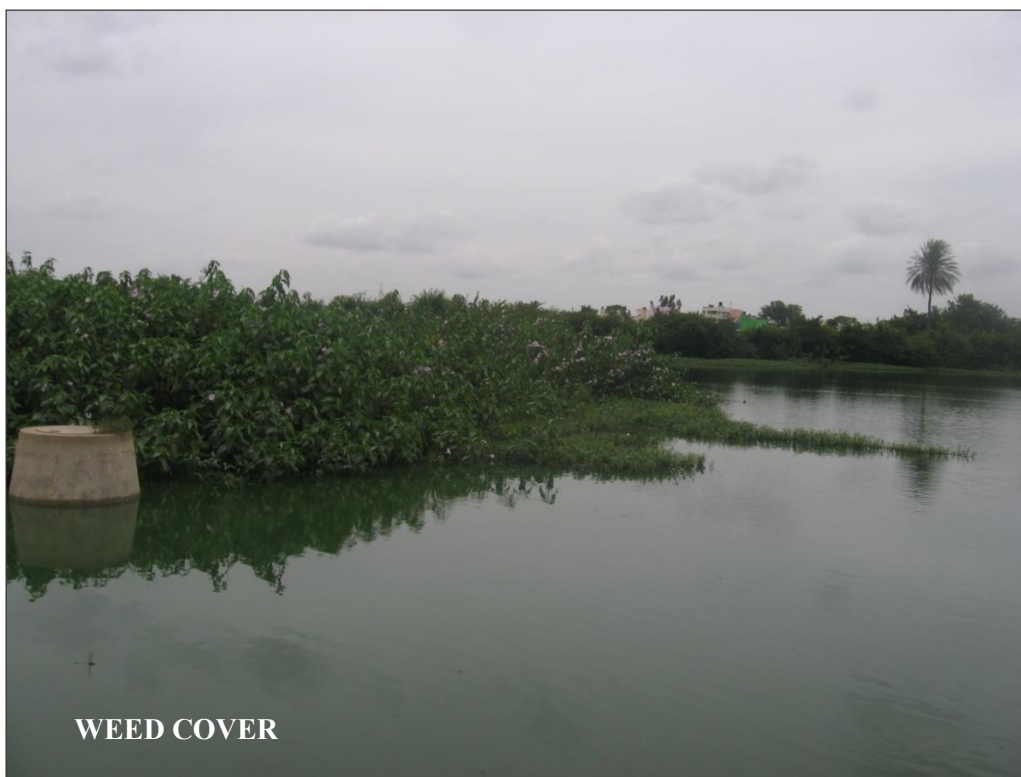
PLATE 17

- Dumping of solid and construction waste on lake bund
- Growth of macrophyte and thus Eutrophication
- Local human disturbances.

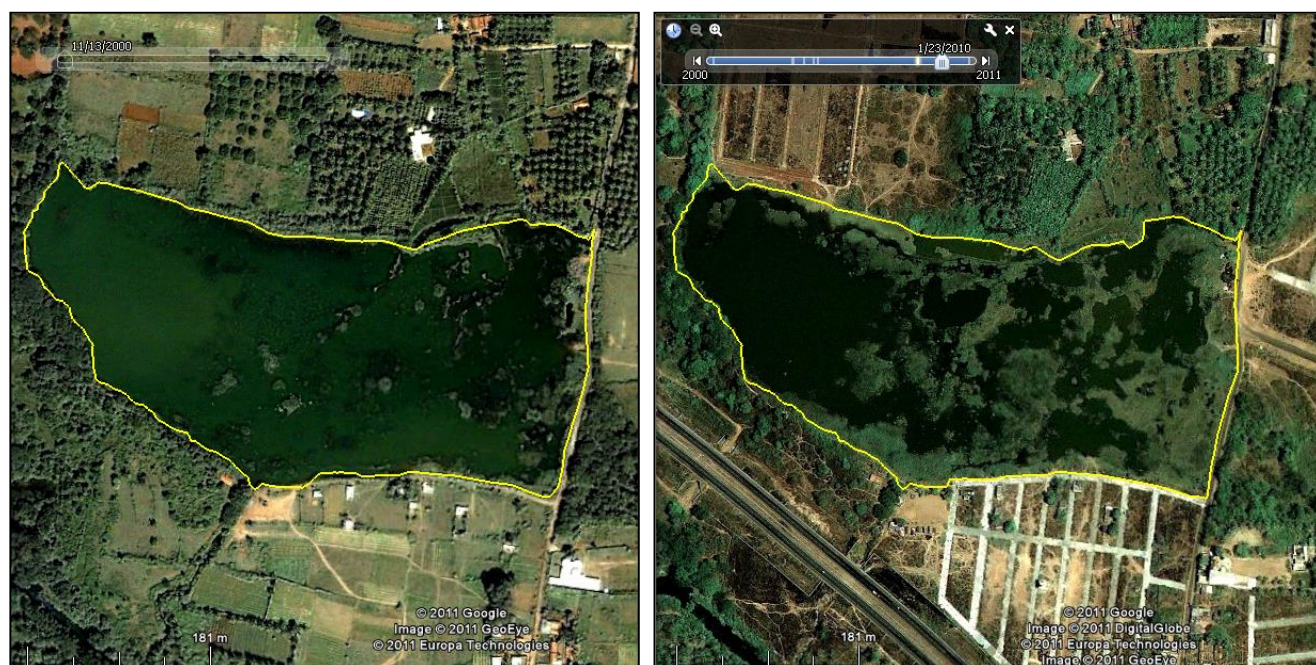
Figure 1 Google Earth image and area of Konasandra Lake during 2000 and 2010 respectively.

NAME OF THE LAKE	KONASANDRA LAKE
GEOGRAPHIC DETAILS	LAT/LONG: 12°53'32"N 77°29'1"E
AREA (2000/2010)	12.07/11.94 ha
ORGANIZATION	BDA
WARD/ VILLAGE NAME	Konasandra
STATUS	Moderately pollution
RESTORATION	2009- 2010 (Incomplete)
WATER CONDITION	Clean – Moderately polluted.
