ENVIRONMENTAL AUDITING OF BANGALORE WETLANDS

ENVIS Technical Report 72

January 2015

**Energy & Wetlands Research Group [CES TE15]
Centre for Ecological Sciences,
Indian Institute of Science,
Bangalore - 560012, INDIA**

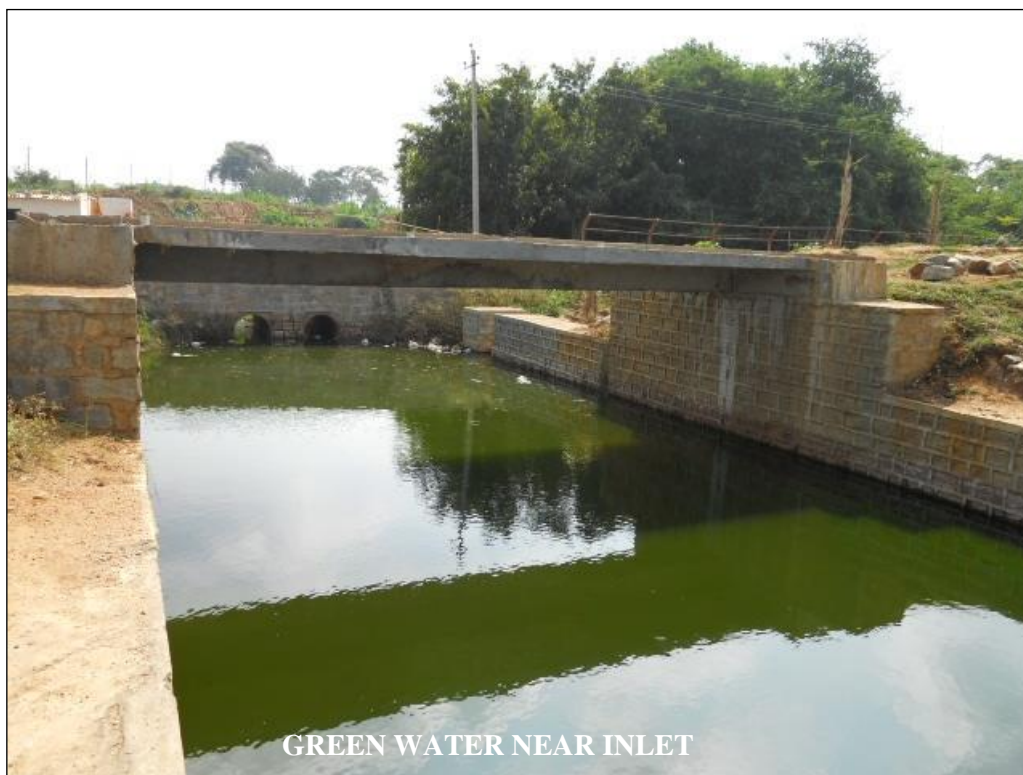
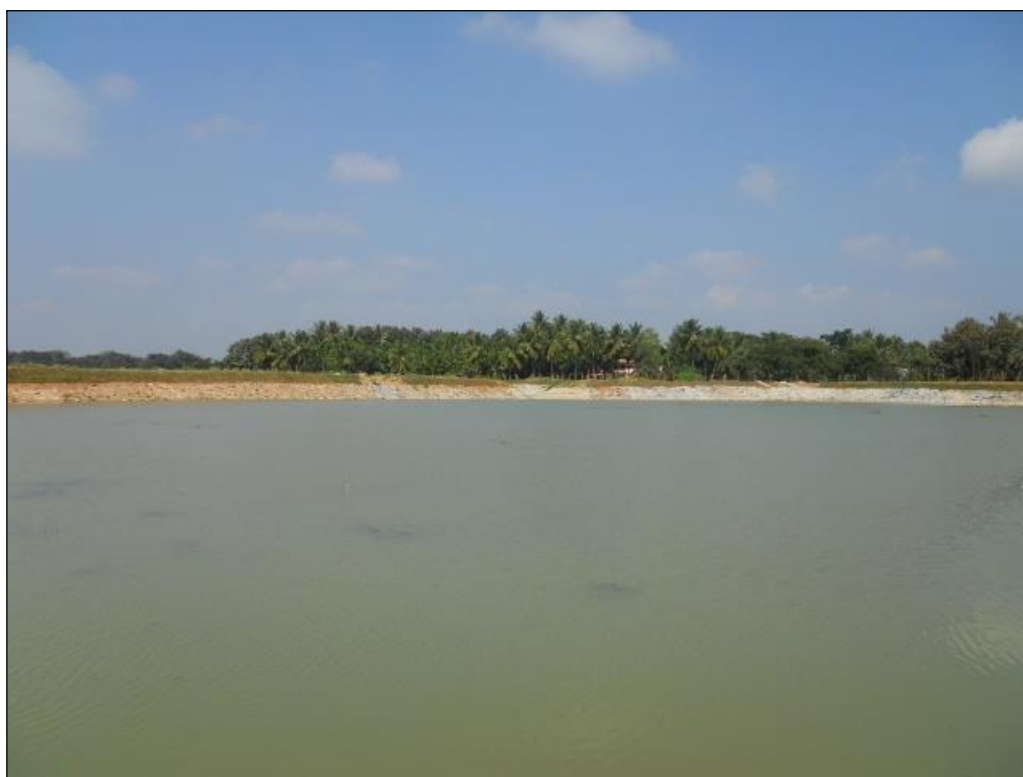
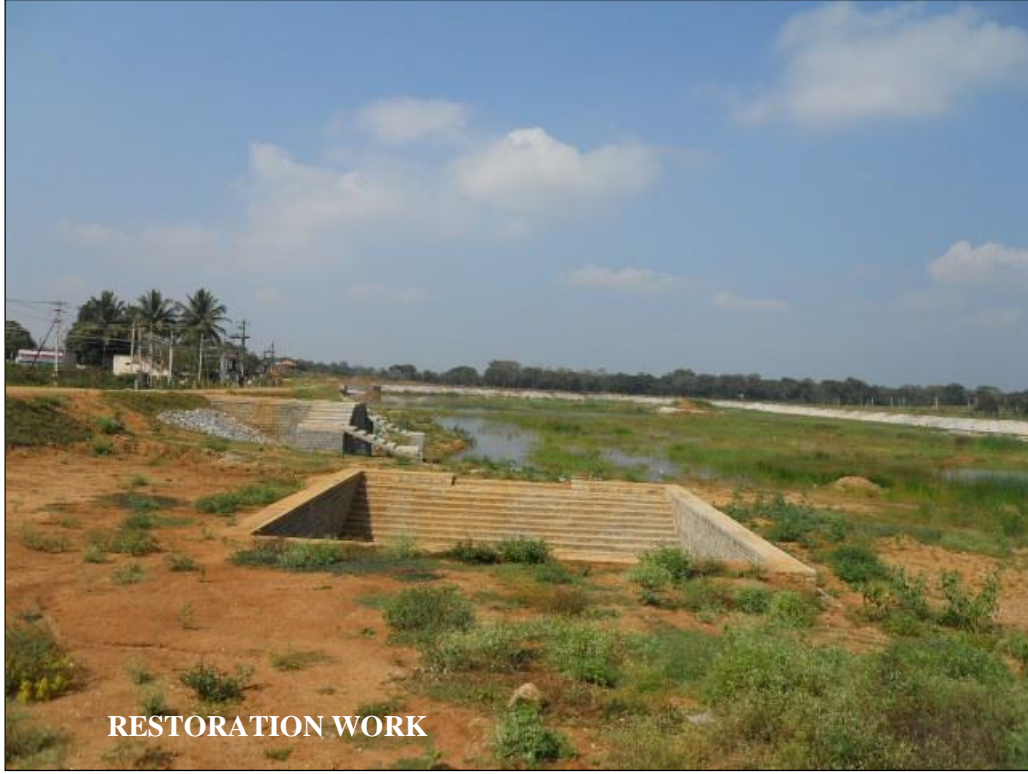
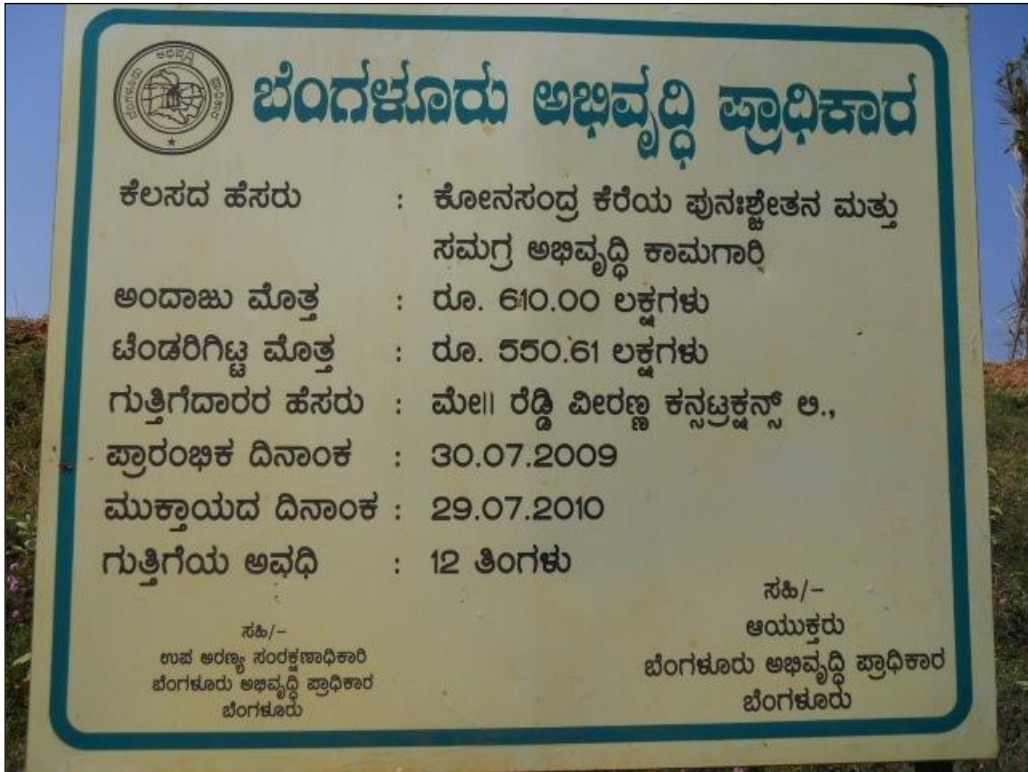
PLATE 17

- Sewage inflow
- Local human disturbances such as washing clothes, swimming, open defecation
- Weed cover
- Dumping of solid waste

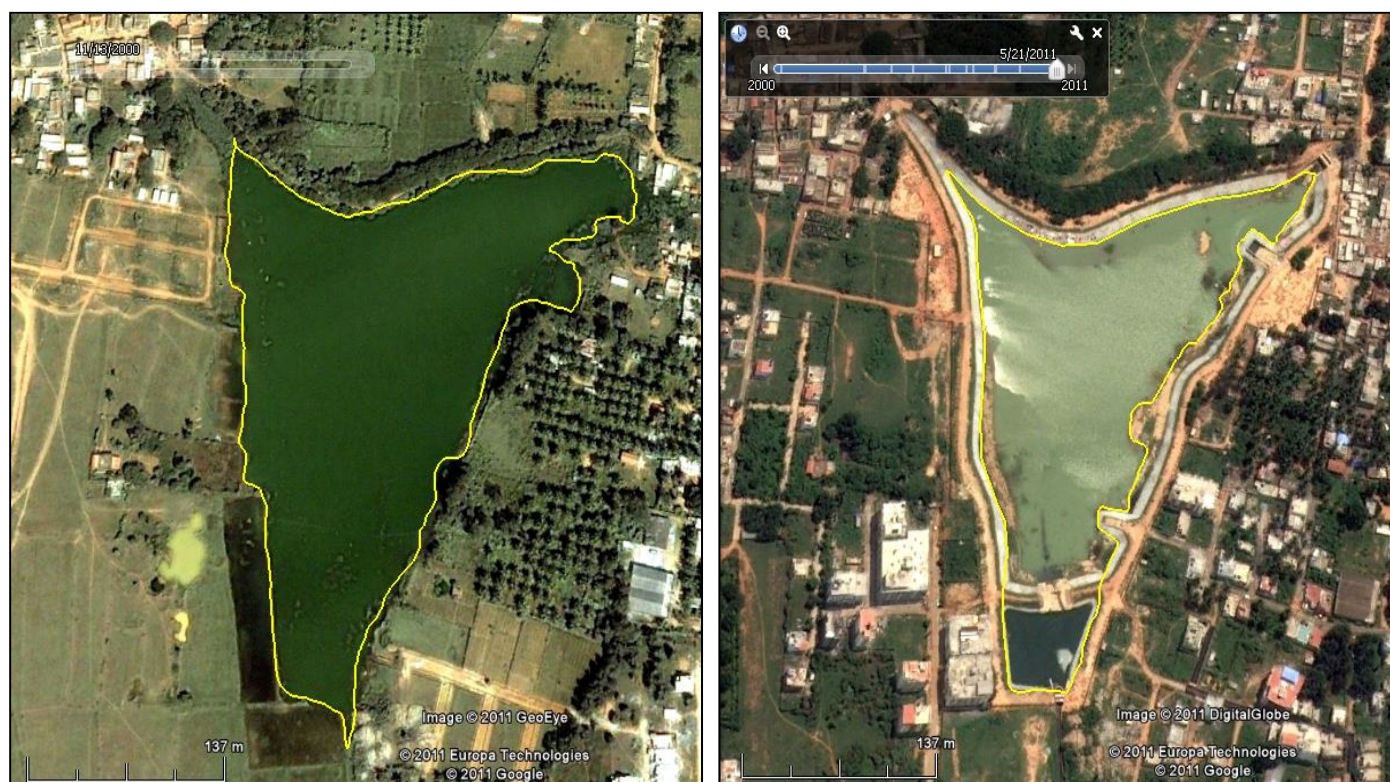
Figure 2 Google Earth image and area of Kothanur Lake during 2000 and 2011 respectively.

NAME OF THE LAKE	KOTHNUR LAKE
GEOGRAPHIC DETAILS	LAT/LONG: 12°52'24"N 77°34'48"E
AREA (2000/2011)	5.982/4.08 ha
ORGANIZATION	187- Puttenahalli
WARD / VILLAGE NAME	JP Nager
STATUS	High pollution
RESTORATION	July 2009 – July 2010 (Incomplete)
WATER CONDITION	Pre restoration-Polluted, Post restoration- Polluted.

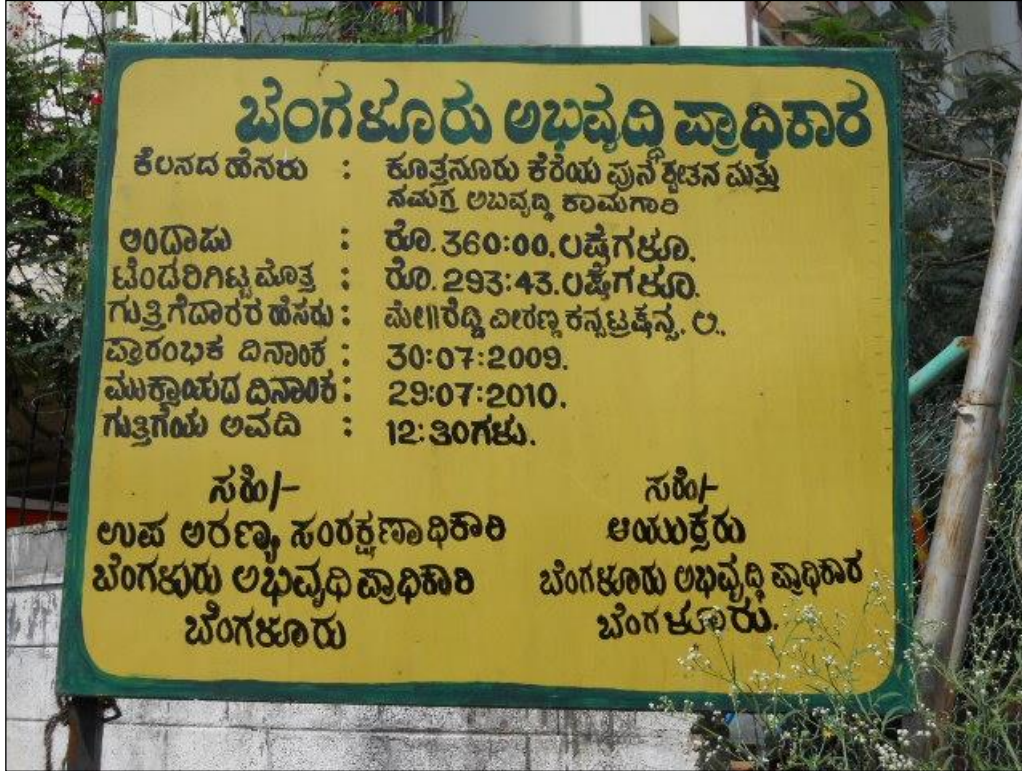
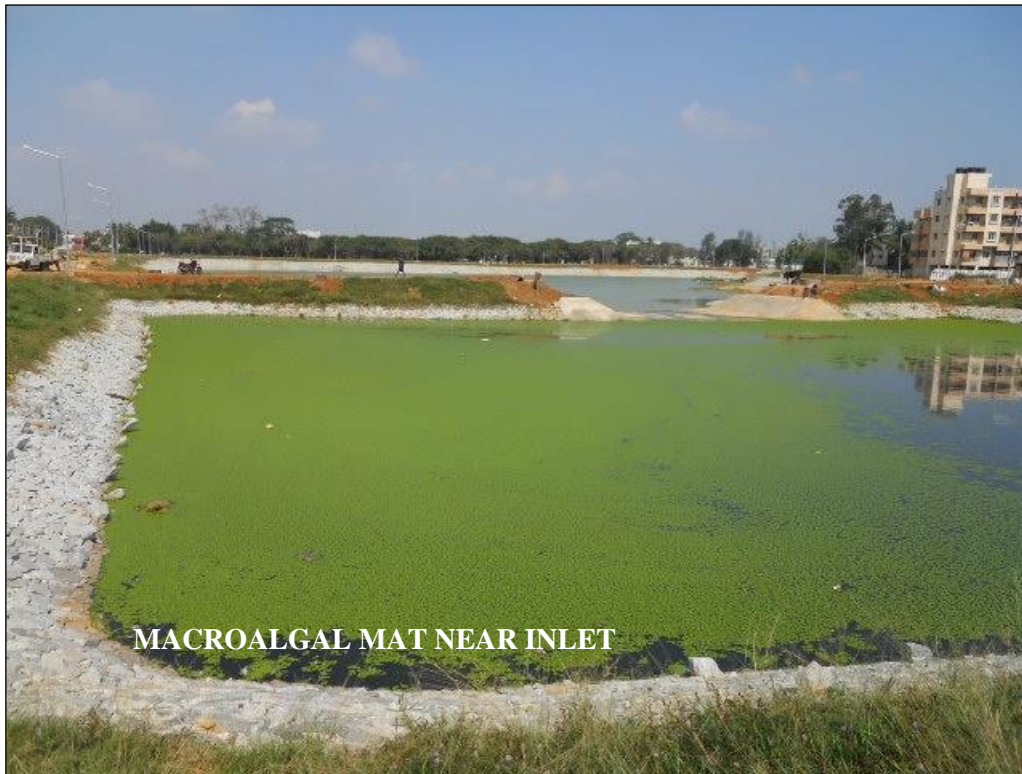
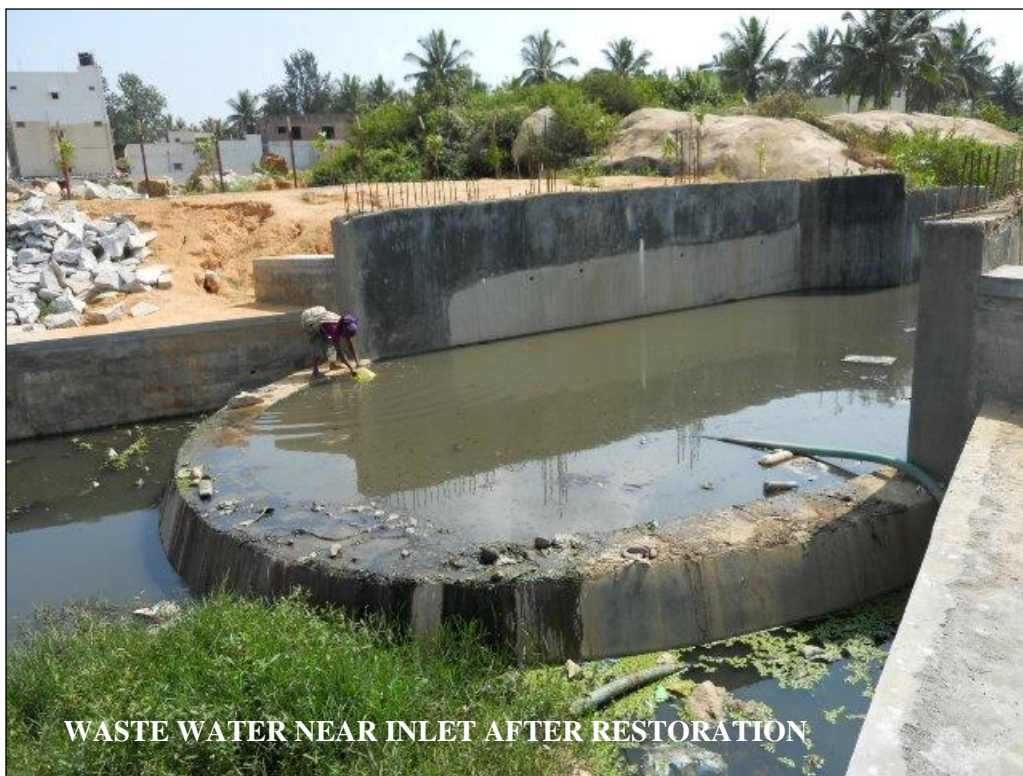
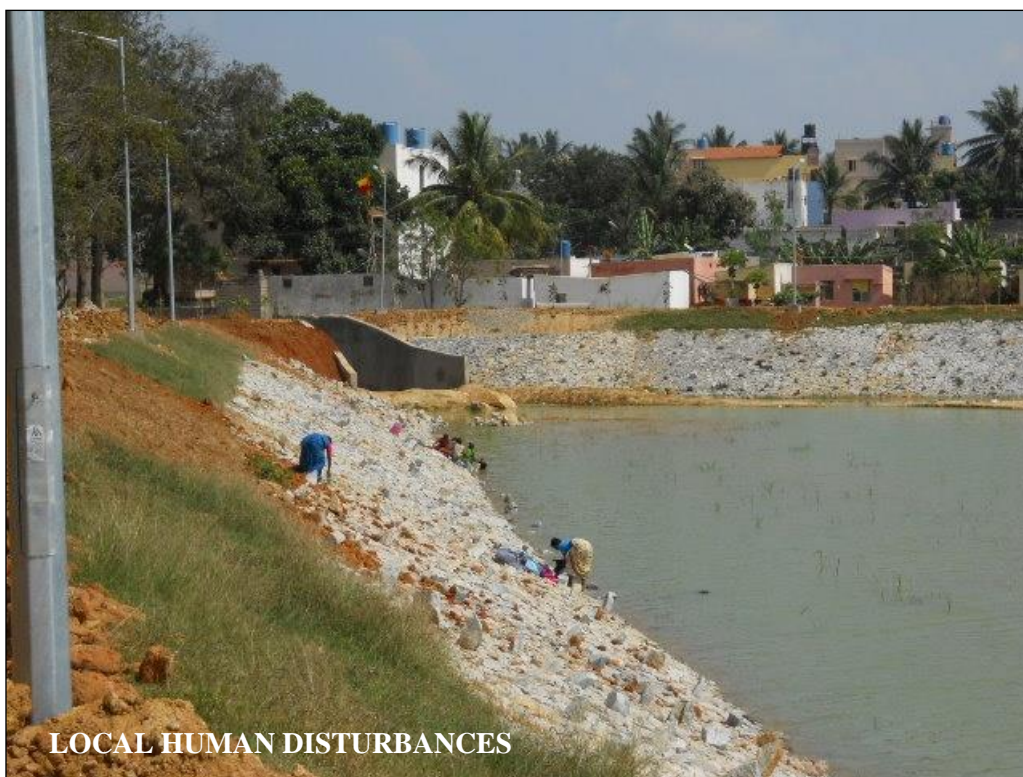
PLATE 18

- Sewage inflow,
- Construction of apartment in lake bed, dumping of waste in surrounding area
- Eutrophication, Algal bloom was observed
- Sewage inflow even after restoration

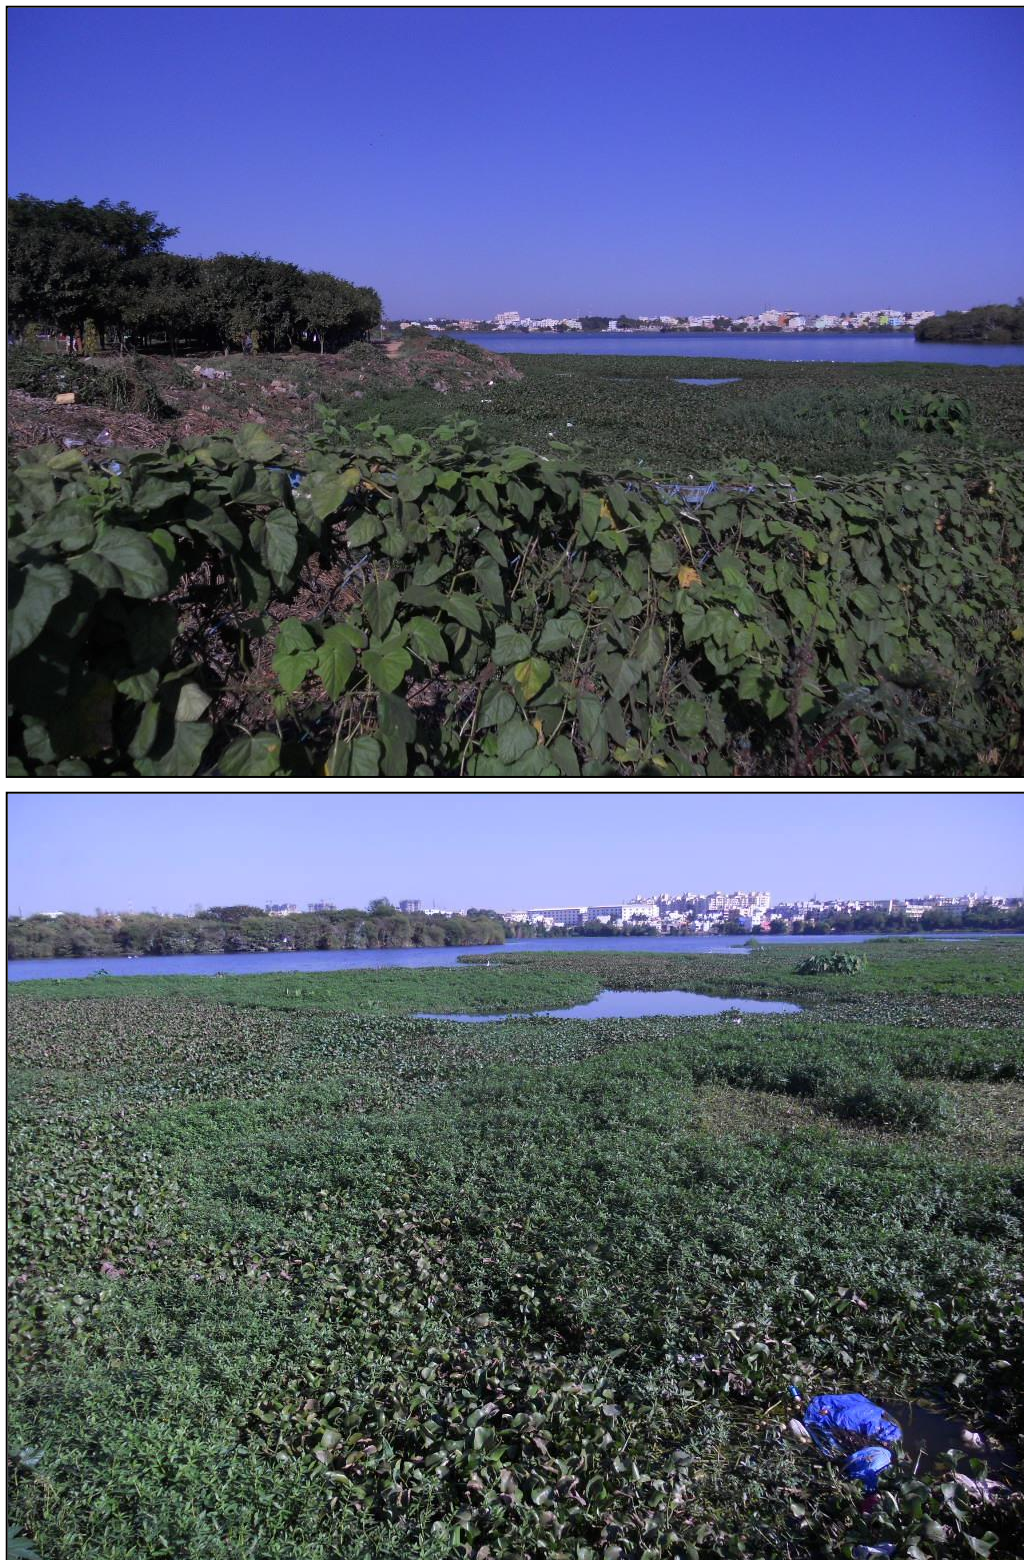
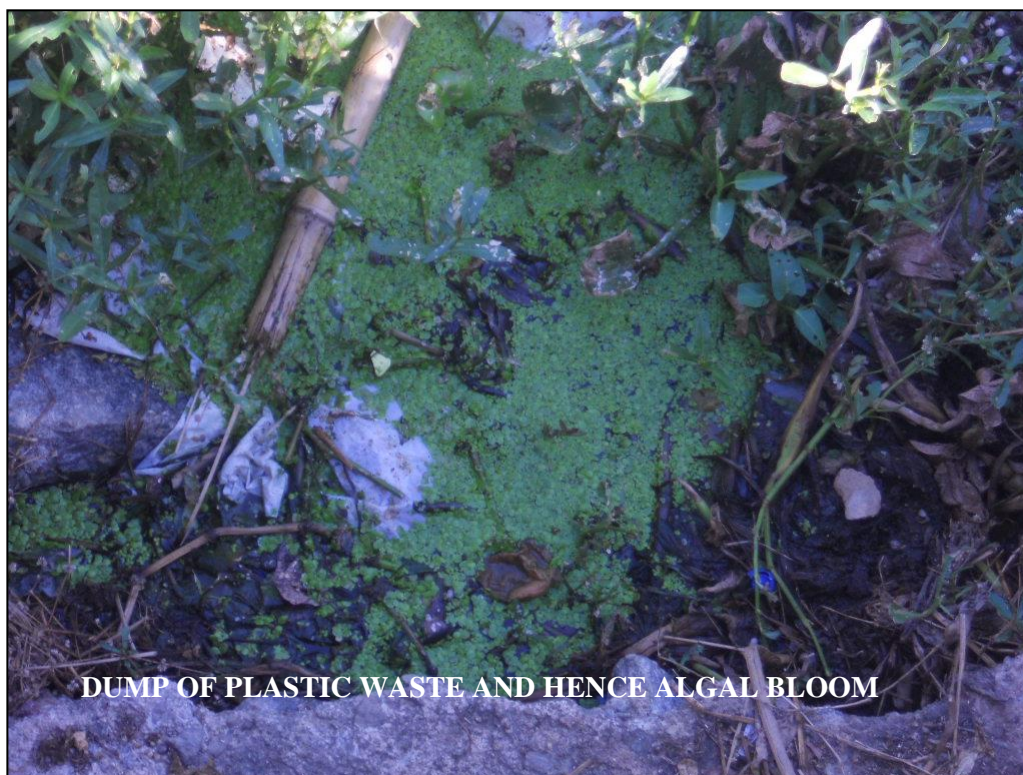
PLATE 19

- Sewage inflow
- Construction of apartment in lake bed
- Dumping of solid waste surrounding lake
- Local human disturbances such as washing clothes, swimming, open defecation

MASSIVE MACROPHYTE COVER AT ONE SIDE OF THE LAKE

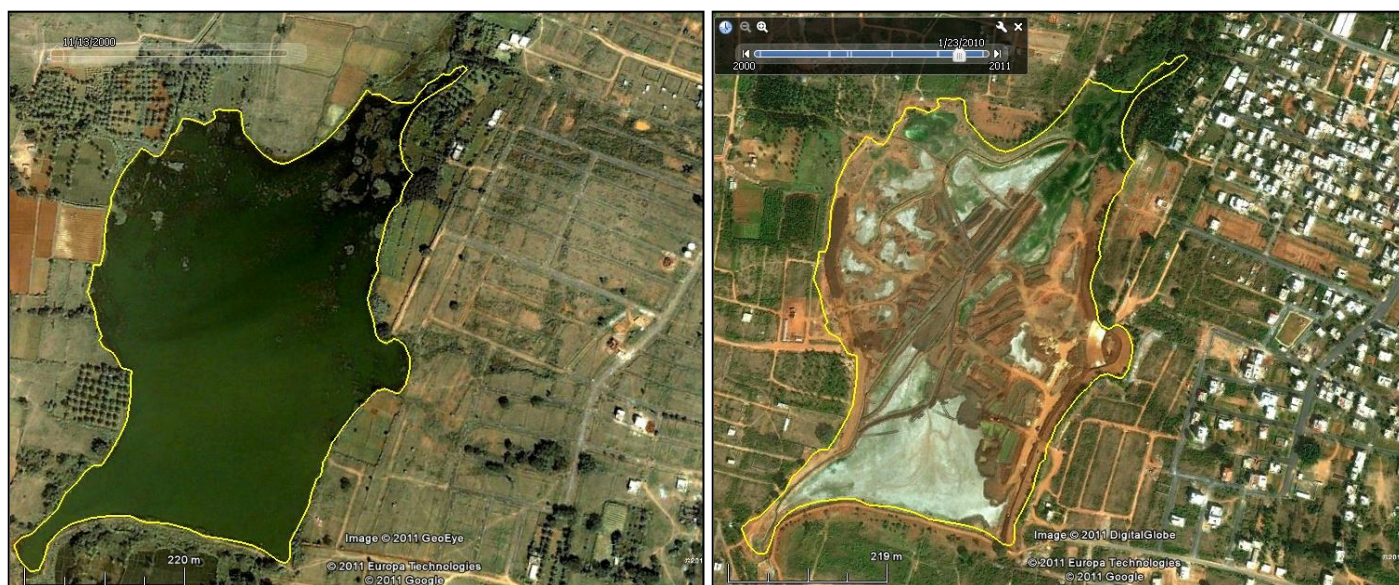
Figure 4 Google Earth image and area of Mallathahalli Lake during 2000 and 2010 respectively.

NAME OF THE LAKE	MALLATHAHALLI LAKE
GEOGRAPHIC DETAILS	LAT/LONG: 12°57'56"N 77°29'41"E
AREA (2000/2009)	22.89/21.87 ha
ORGANIZATION	BDA
WARD / VILLAGE NAME	Mallathahalli
STATUS	Moderate pollution
RESTORATION	July 2009 – July 2010 (Incomplete)
WATER CONDITION	Polluted.

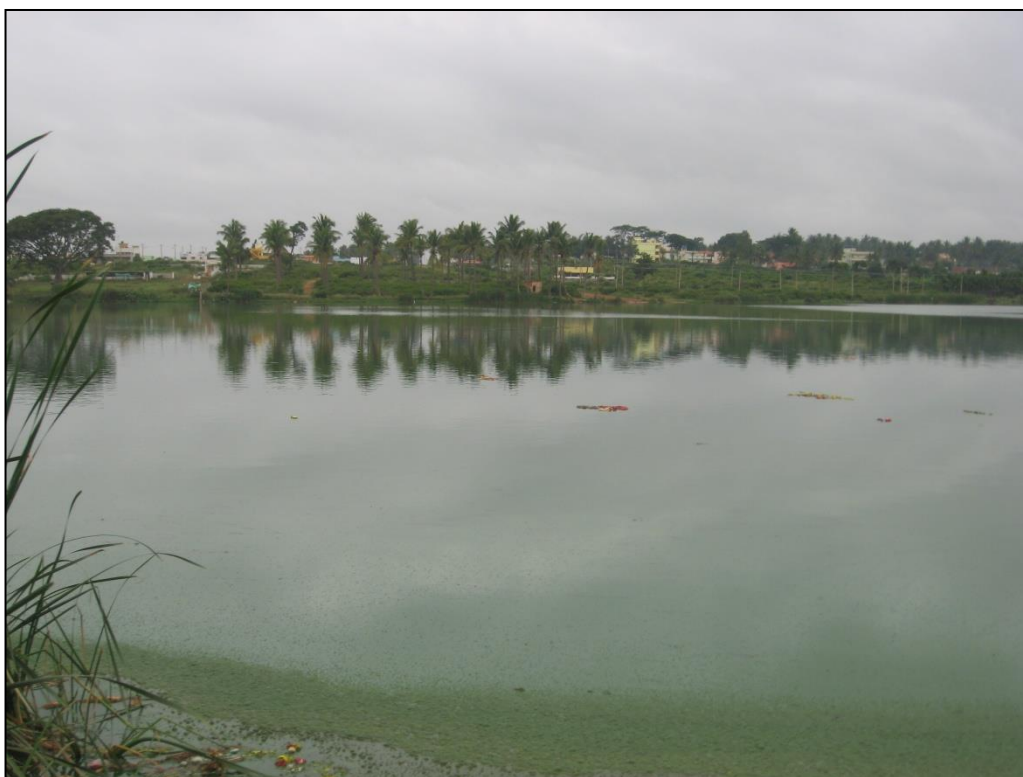
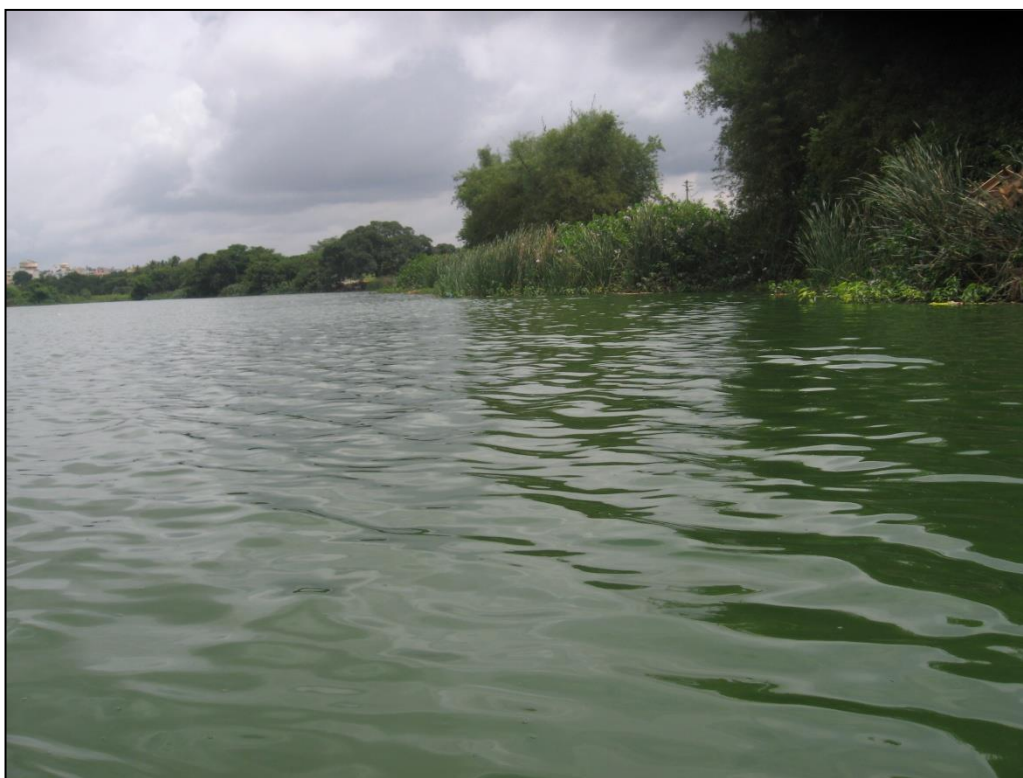
PLATE 20

EUTROPHIC GREEN WATER PRIOR TO RESTORATION

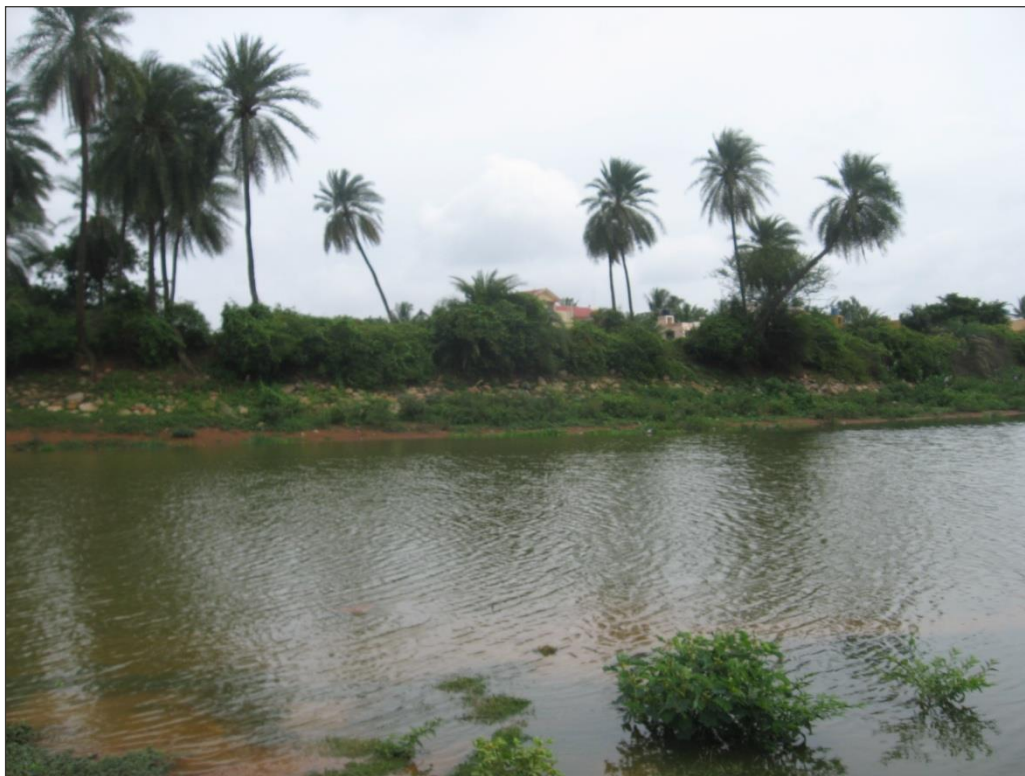
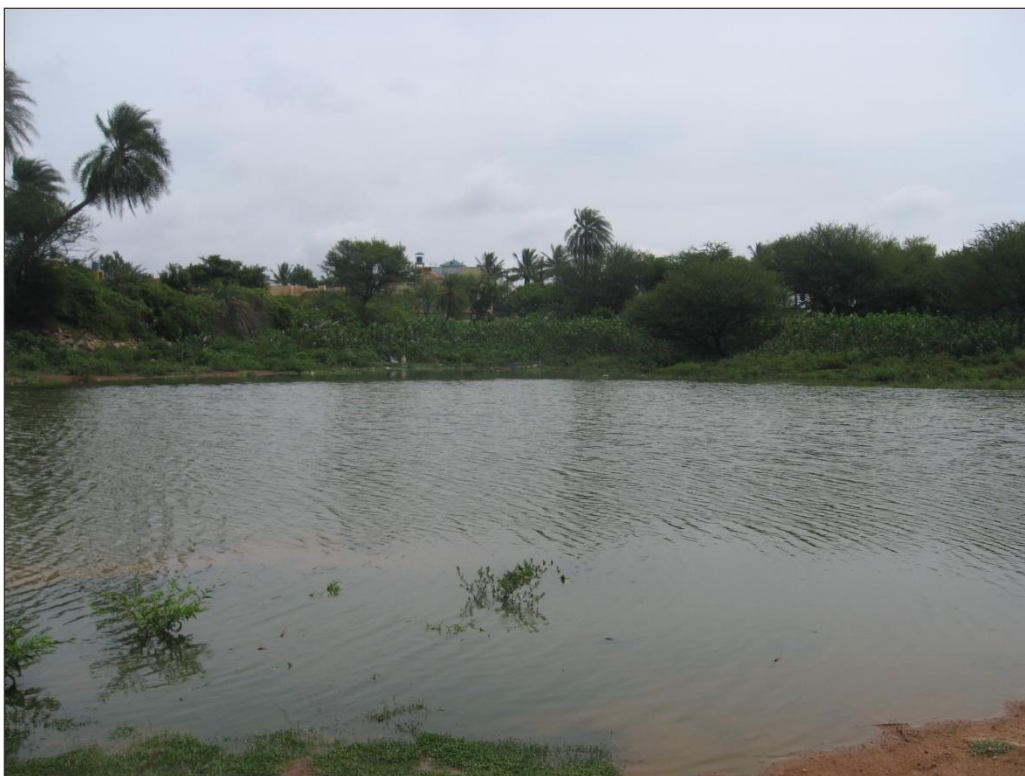
PLATE 21

- No defined lake boundary
- Human disturbances such as washing clothes, Open Defecation.

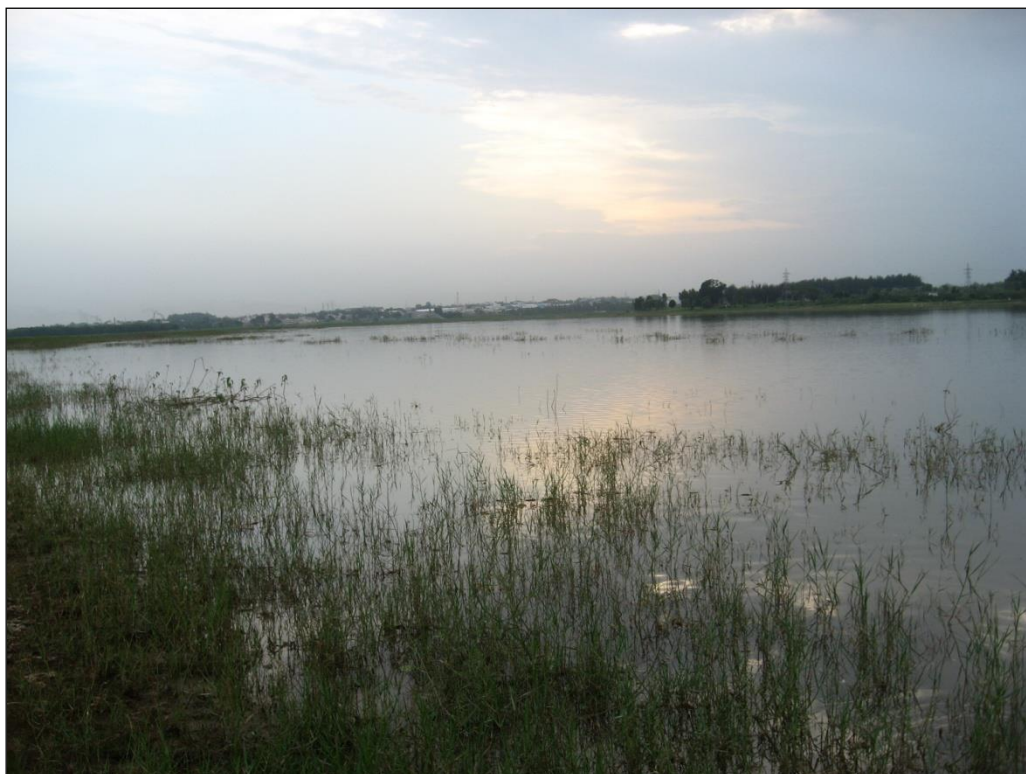
PLATE 22

- Washing clothes, Open Defecation
- Sewage from Electronic city (Initial stage).

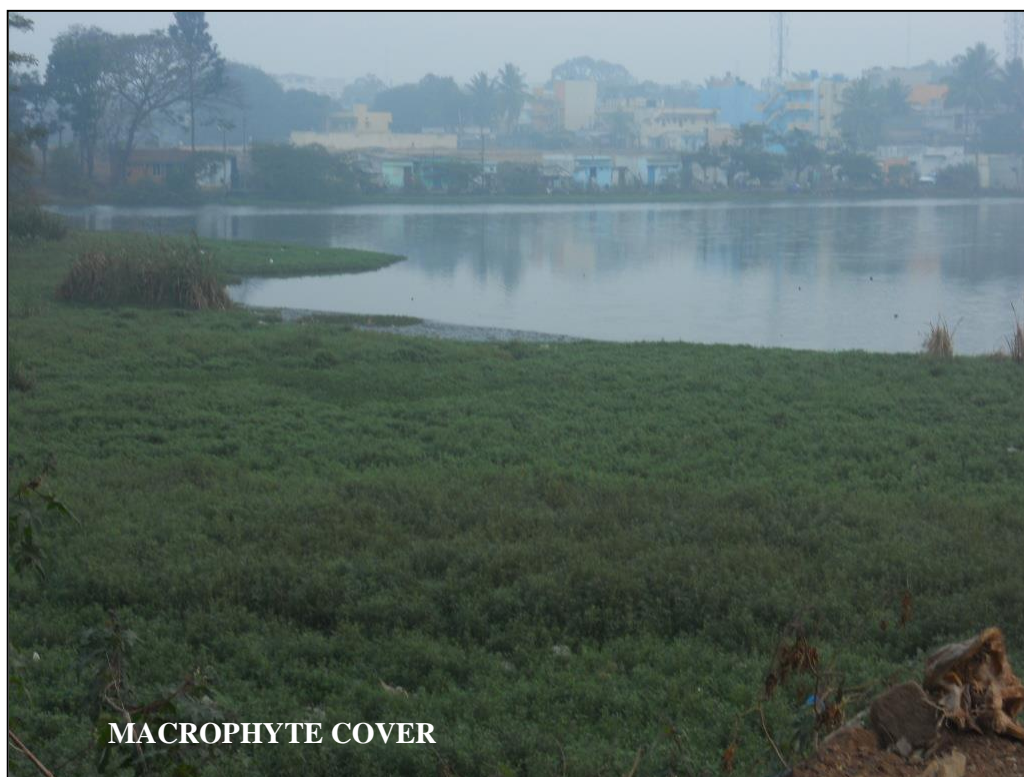
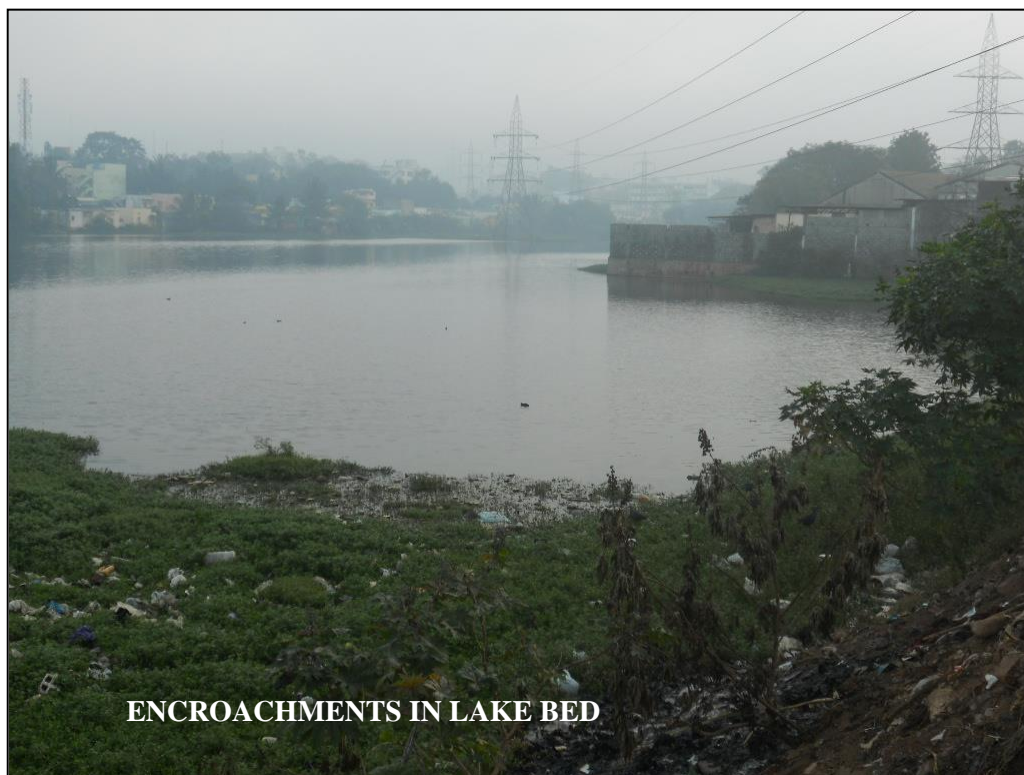
PLATE 23

- No defined lake boundary
- Washing clothes, Open Defecation,
- Construction of buildings next to lake bed
- Dumping of solid waste, Industrial waste.

ENCROACHMENTS IN LAKE BED

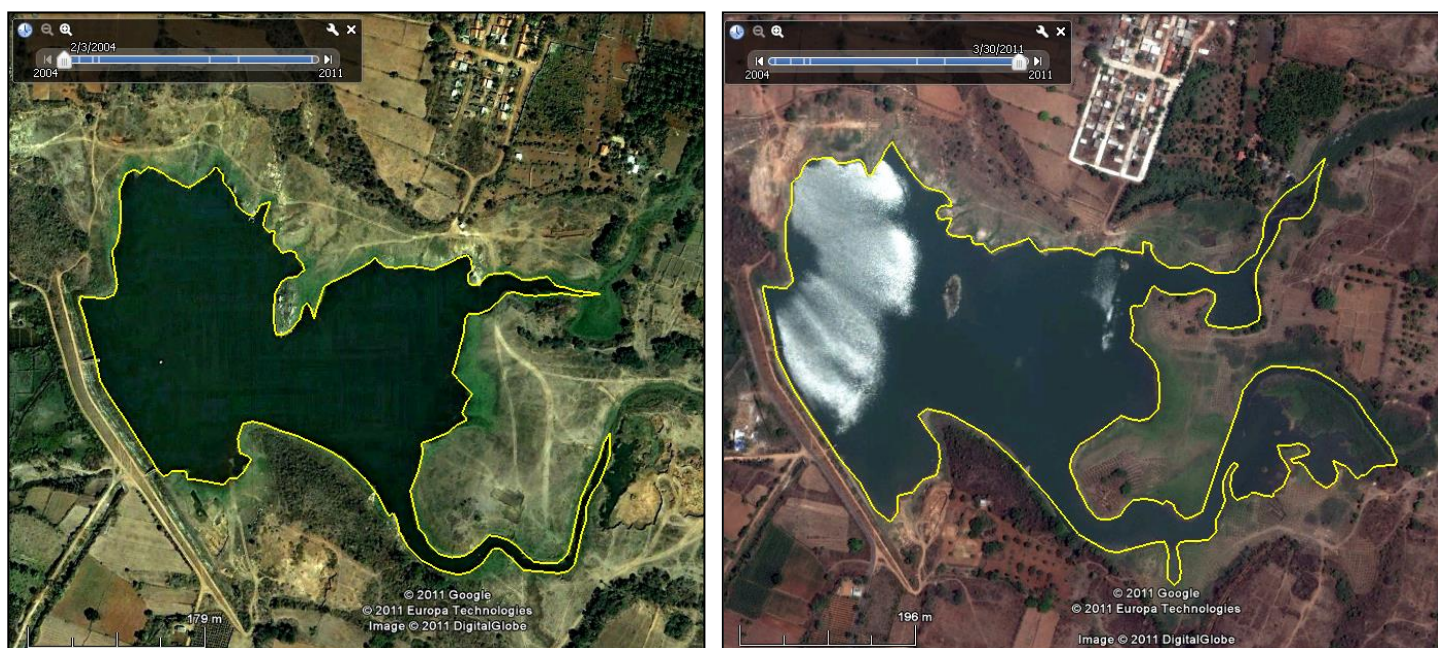
Figure 8 Google Earth image and area of Nelakondoddi Lake during 2004 and 2011 respectively.

NAME OF THE LAKE	NELAKONDODDI KERE
GEOGRAPHIC DETAILS	LAT/LONG: 12°48'22"N 77°31'47"E
AREA (2004/2011)	9.074/14.75 ha
ORGANIZATION	BBMP (Outskirts of Bangalore BBMP Boundary)
WARD / VILLAGE NAME	Nelakondoddi
STATUS	Clean/ No pollution
RESTORATION	NO
WATER CONDITION	Clean.

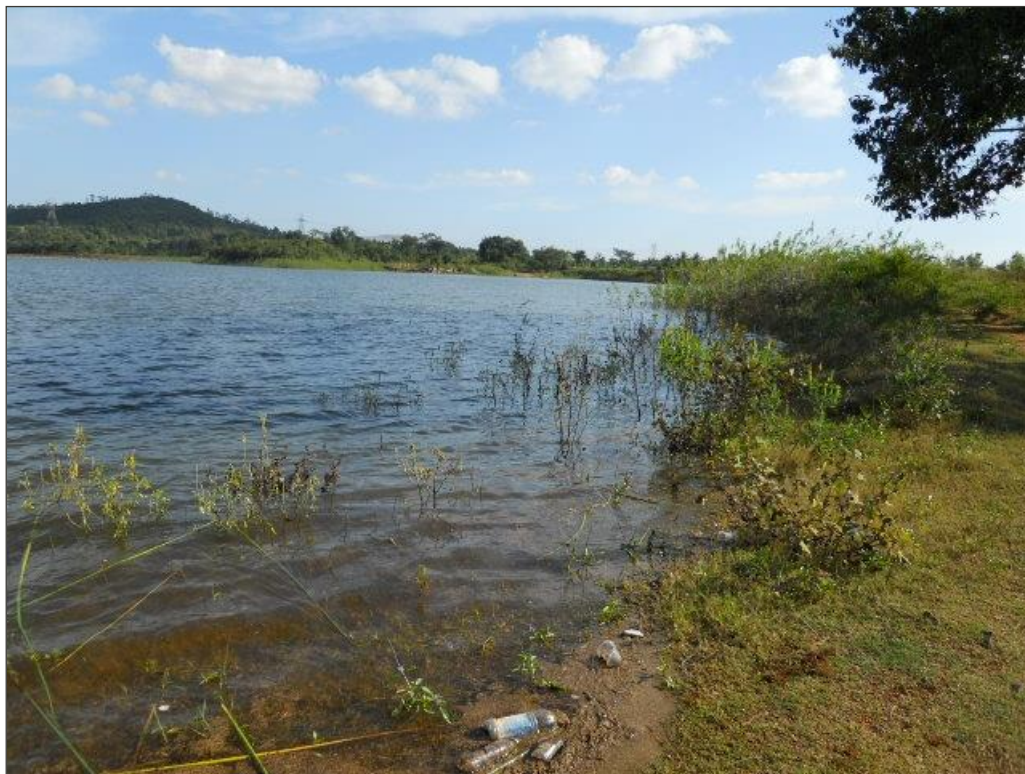
PLATE 24

Local human disturbances, grazing

CLEAN WATER CONDITION

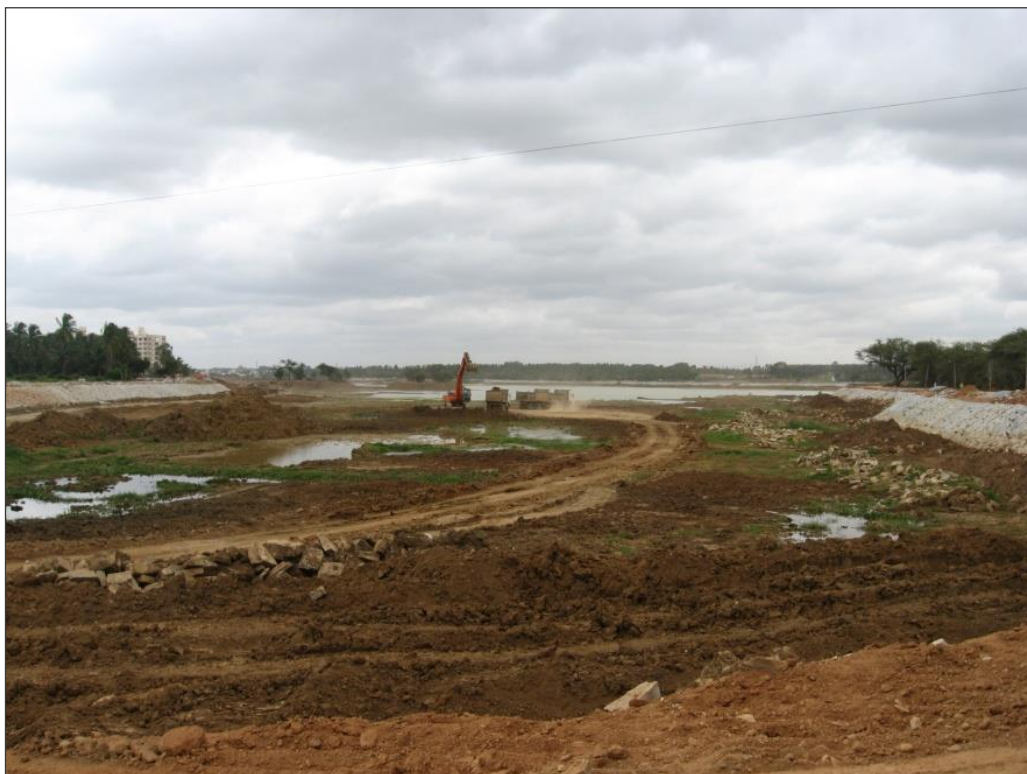
PLATE 25

RESTORATION DEADLINE!!!

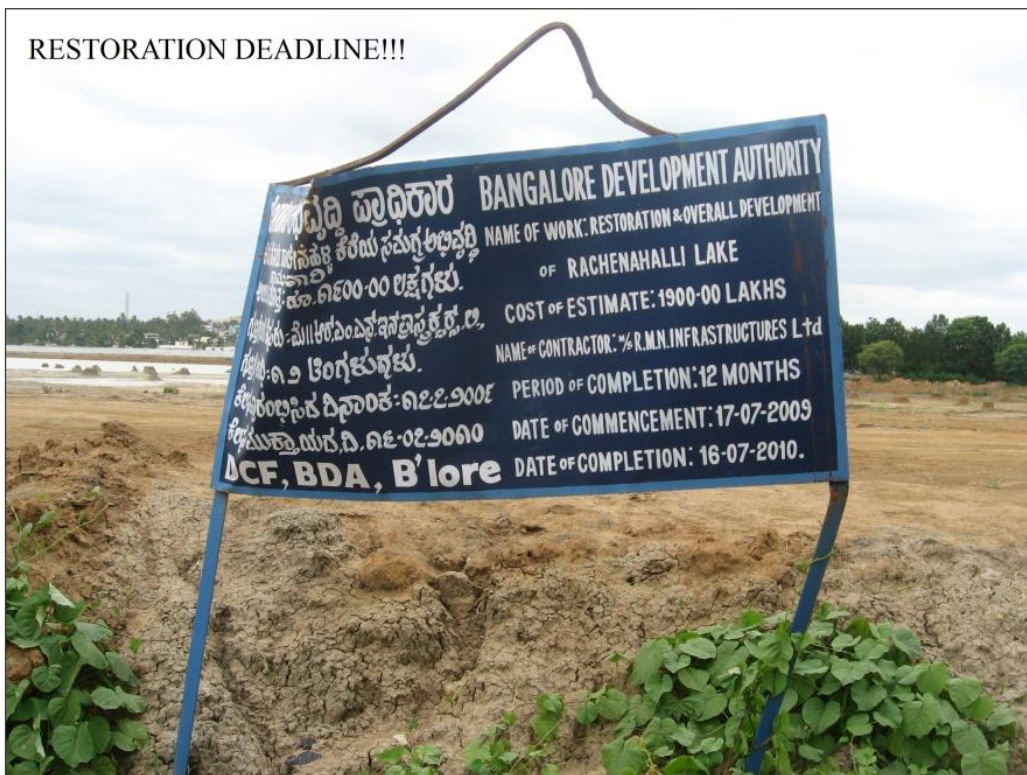
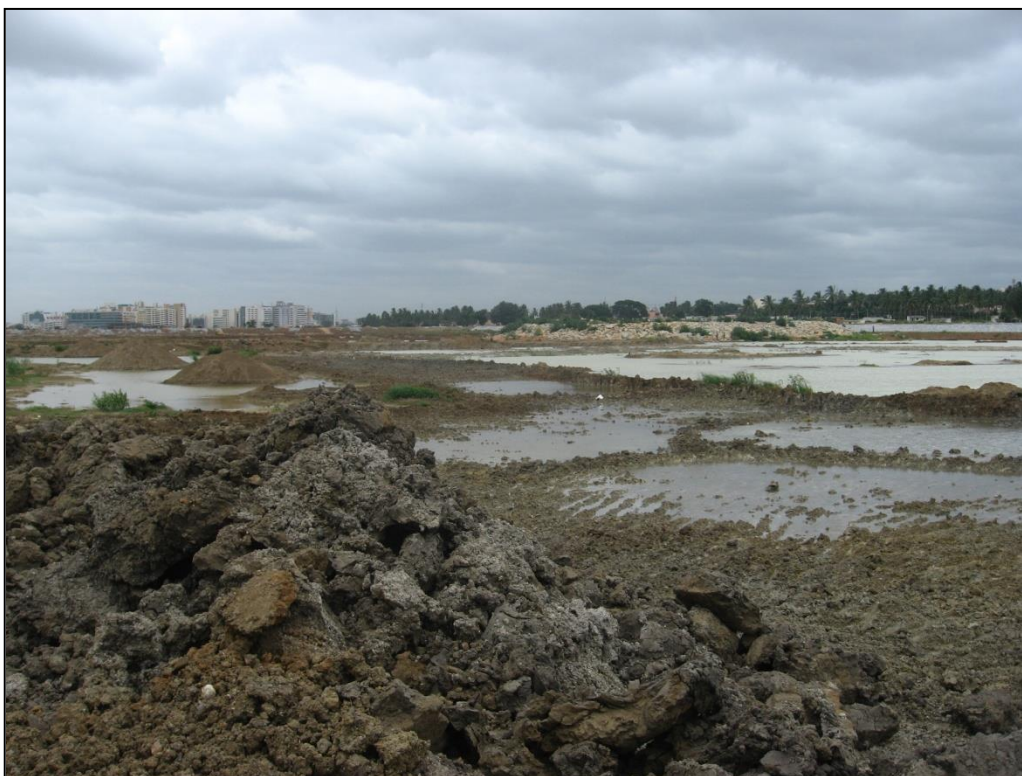
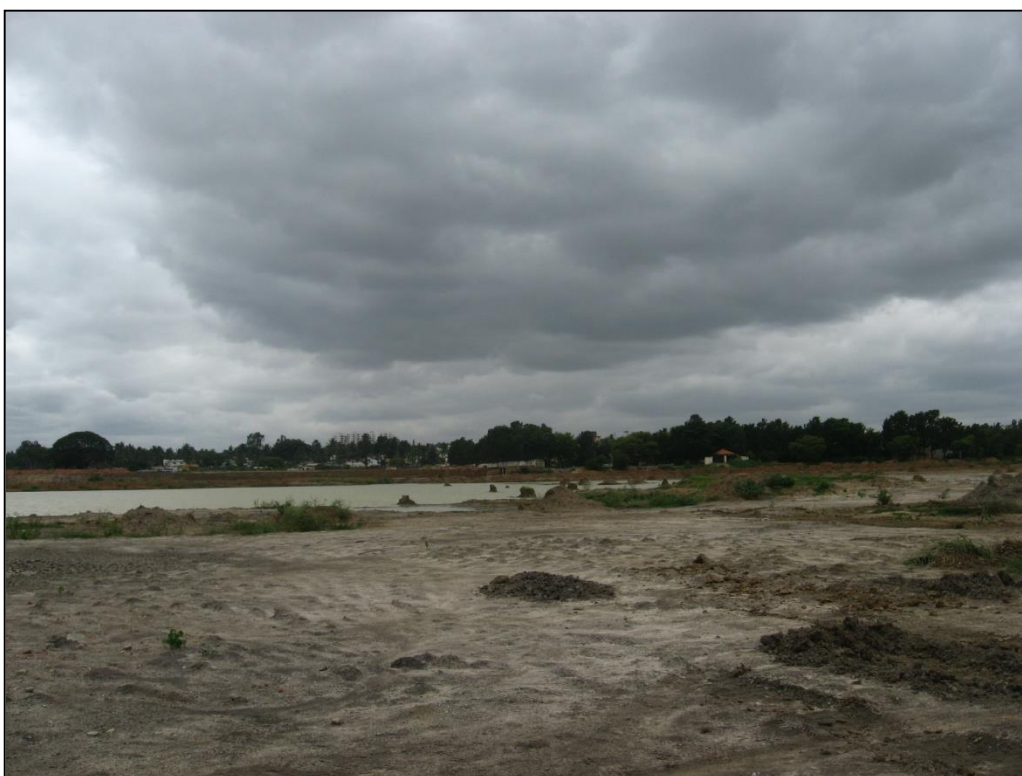
- Sewage and Agriculture inflow,
- Fishing and local human disturbances
- Improper maintenance.
- Weed cover

RESTORATION WORK – JUNE- JULY 2010
