ENVIRONMENTAL AUDITING OF BANGALORE WETLANDS

ENVIS Technical Report 72

January 2015

**Energy & Wetlands Research Group [CES TE15]
Centre for Ecological Sciences,
Indian Institute of Science,
Bangalore - 560012, INDIA**

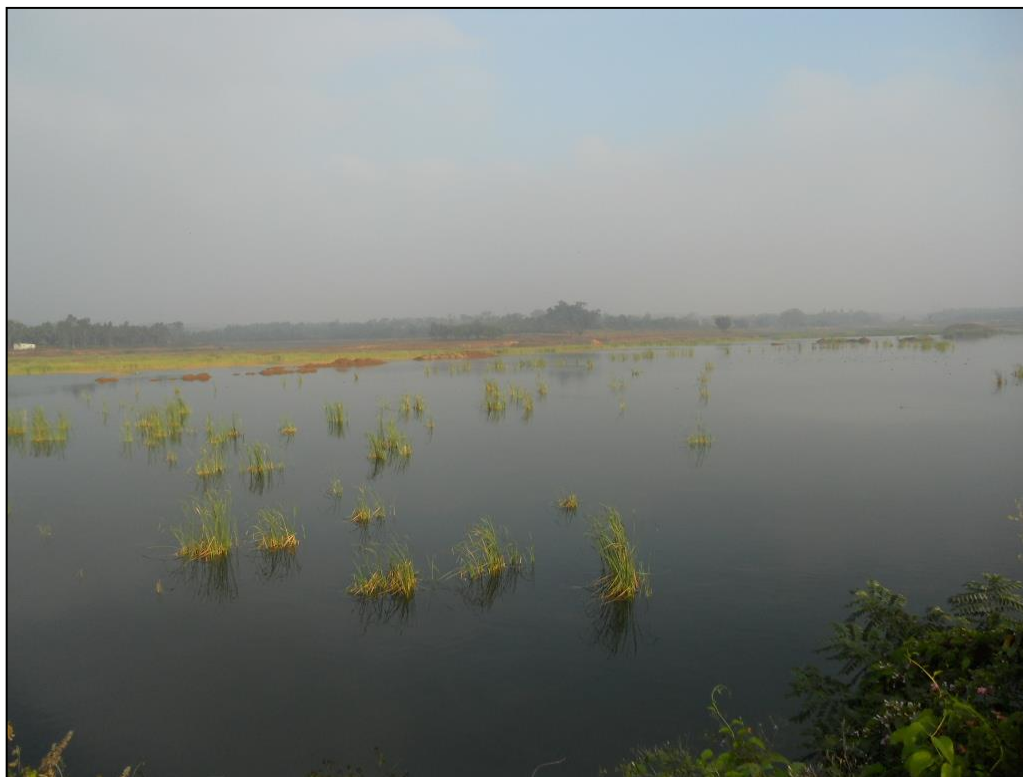
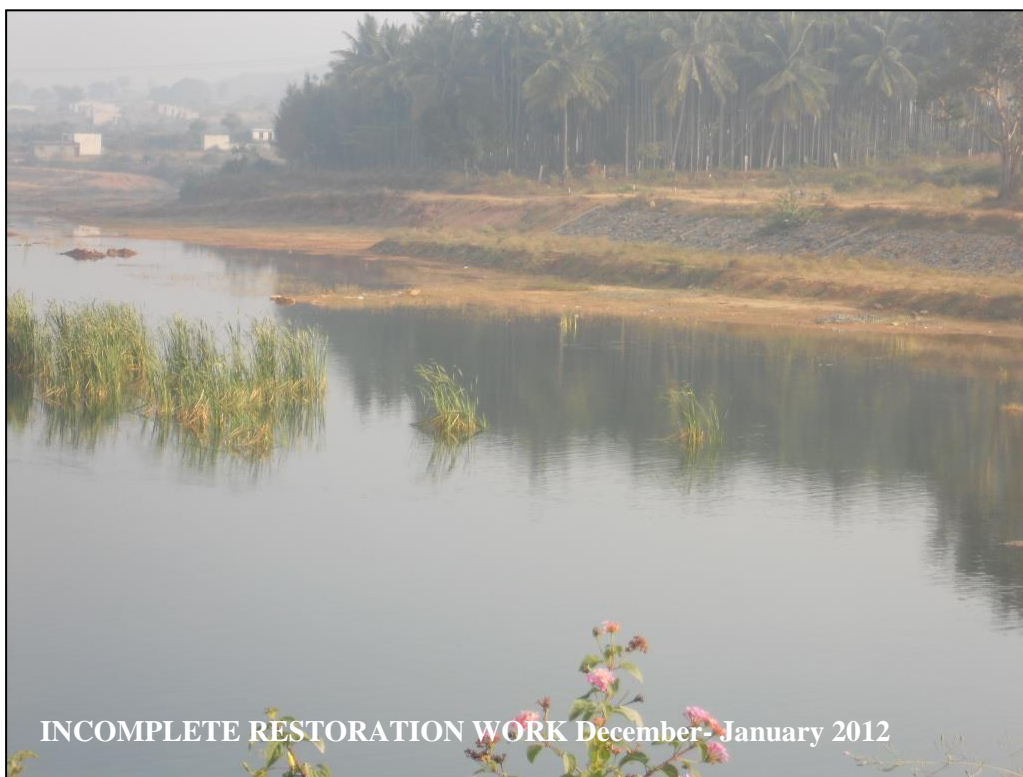
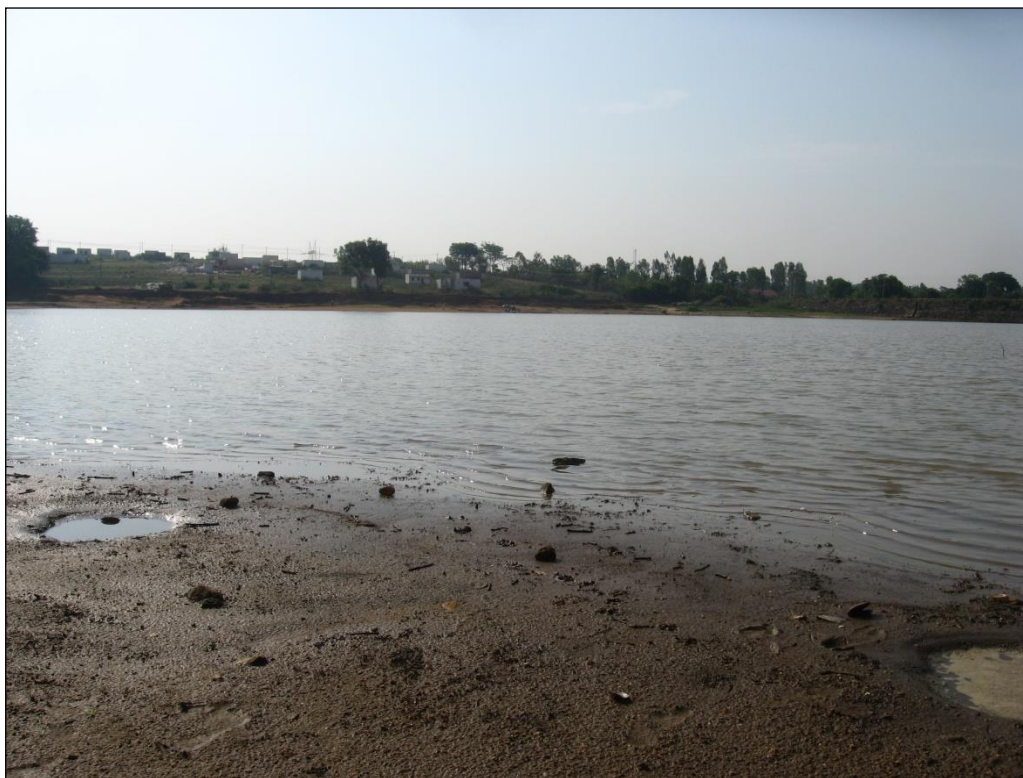
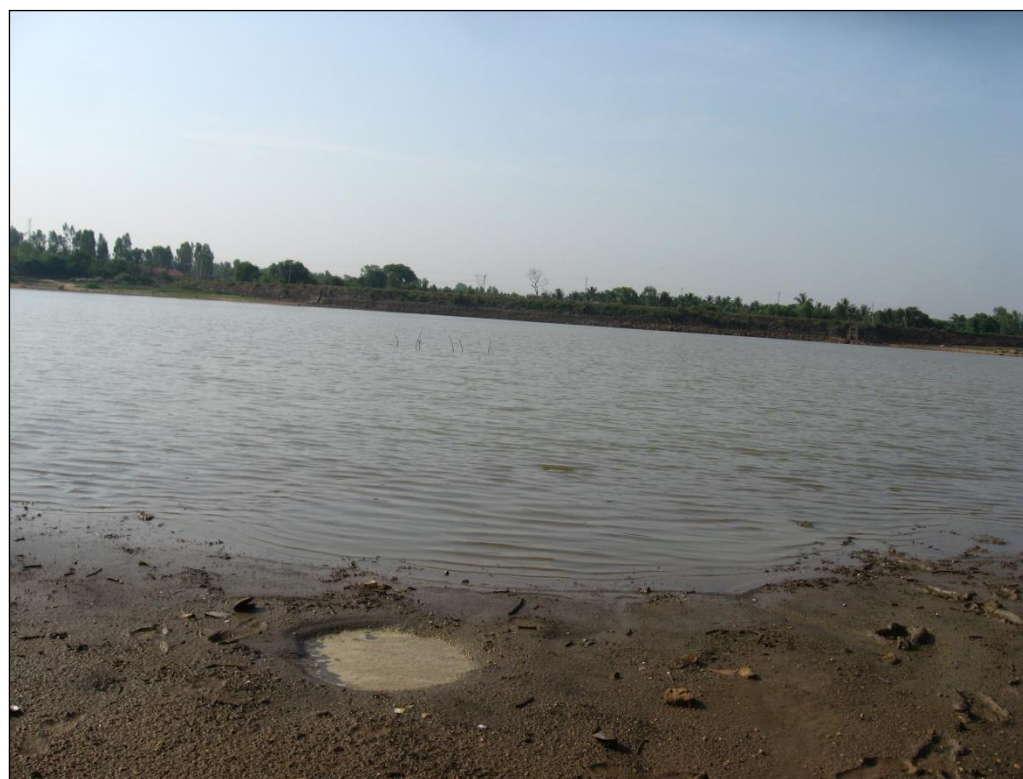
PLATE 27

Grazing, Fishing, Sand mining, Agricultural run-off, Local human disturbances.

INCOMPLETE RESTORATION WORK December-January 2012

RAMASANDRA LAKE PRIOR TO RESTORATION: February 2009

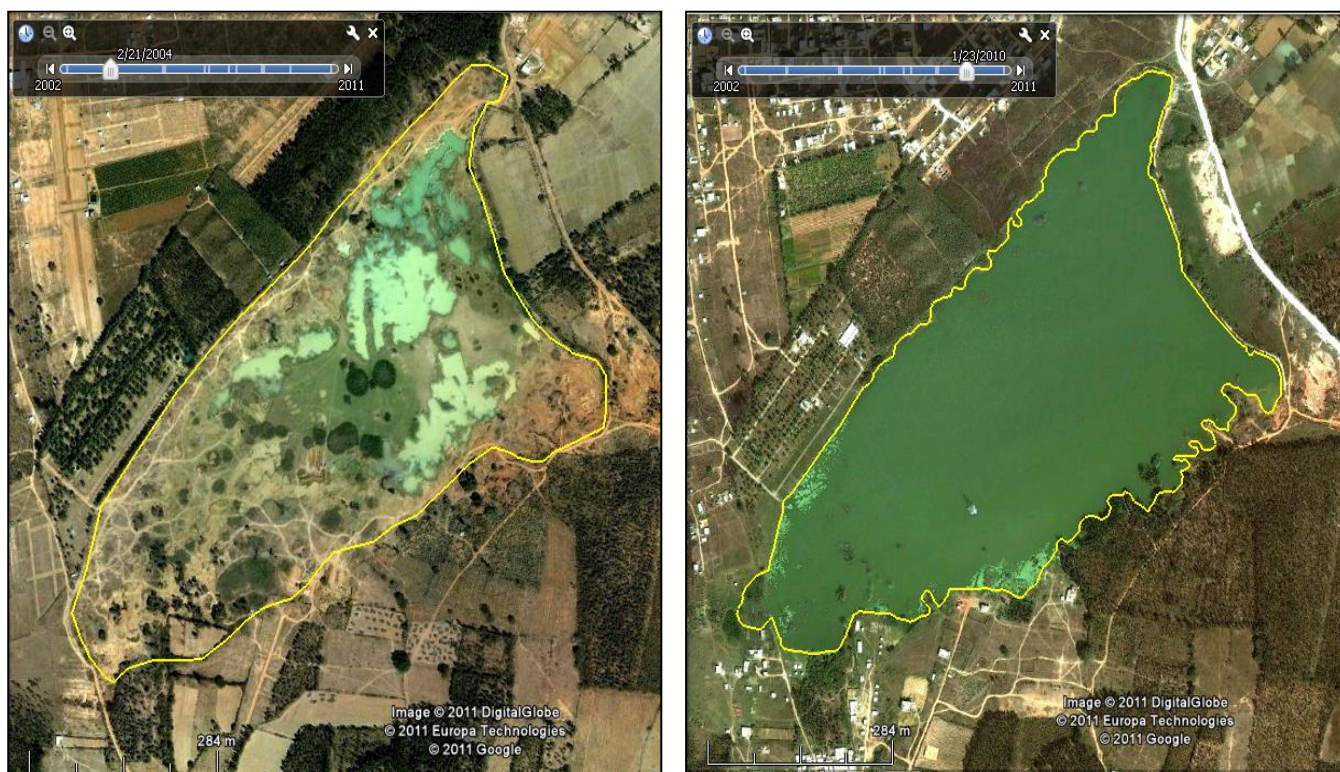
Figure 12 Google Earth image and area of Rayasandra Lake during 2004 and 2010 respectively.

NAME OF THE LAKE	RAYASANDRA LAKE
GEOGRAPHIC DETAILS	LAT/LONG: 12°52'11"N 77°40'35"E
AREA (2004/2010)	-- / 28.59ha
ORGANIZATION	BBMP
WARD / VILLAGE NAME	Jigani
STATUS	Clean – Moderately polluted
RESTORATION	NO
WATER CONDITION	Clean – Moderate.

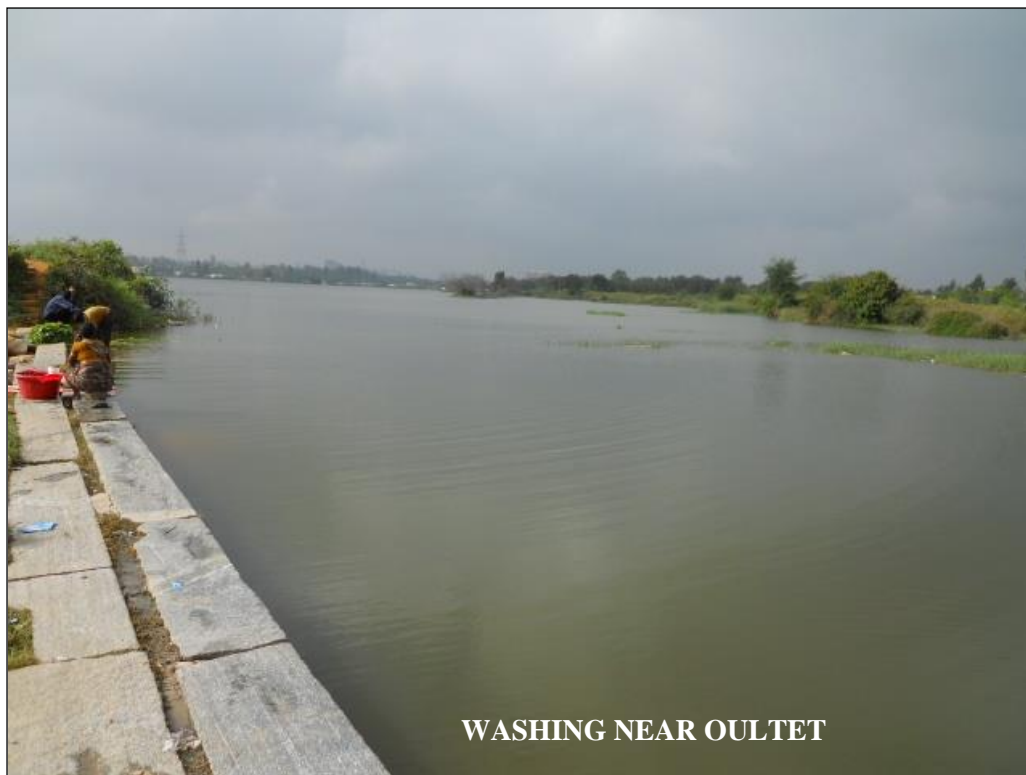
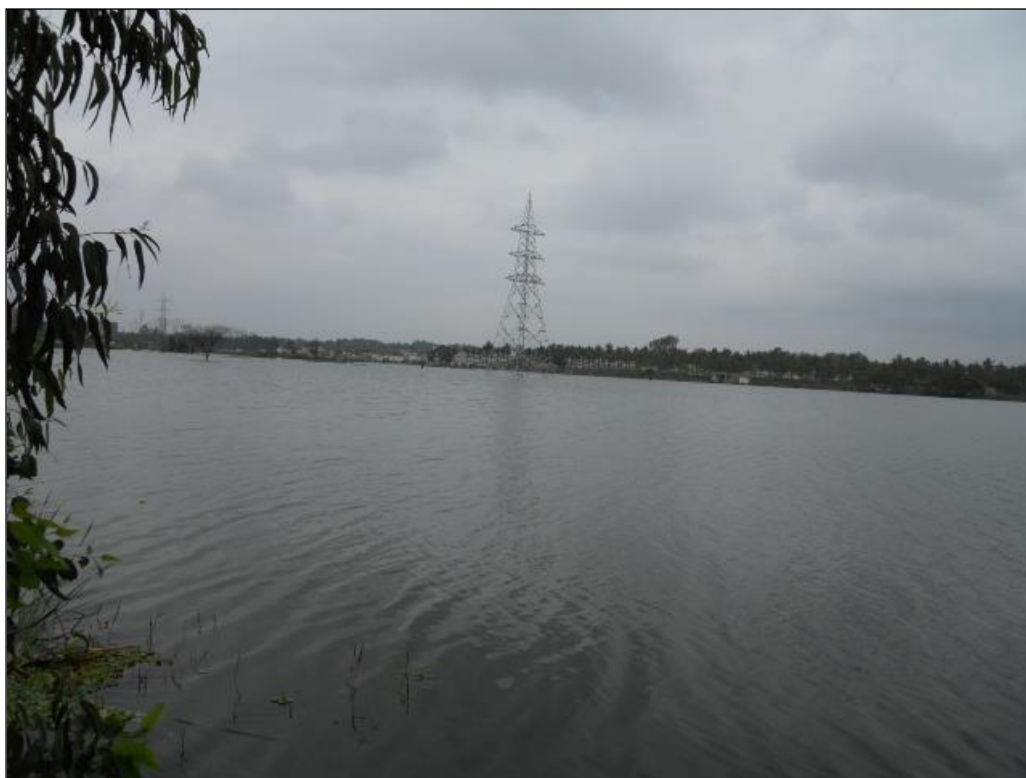
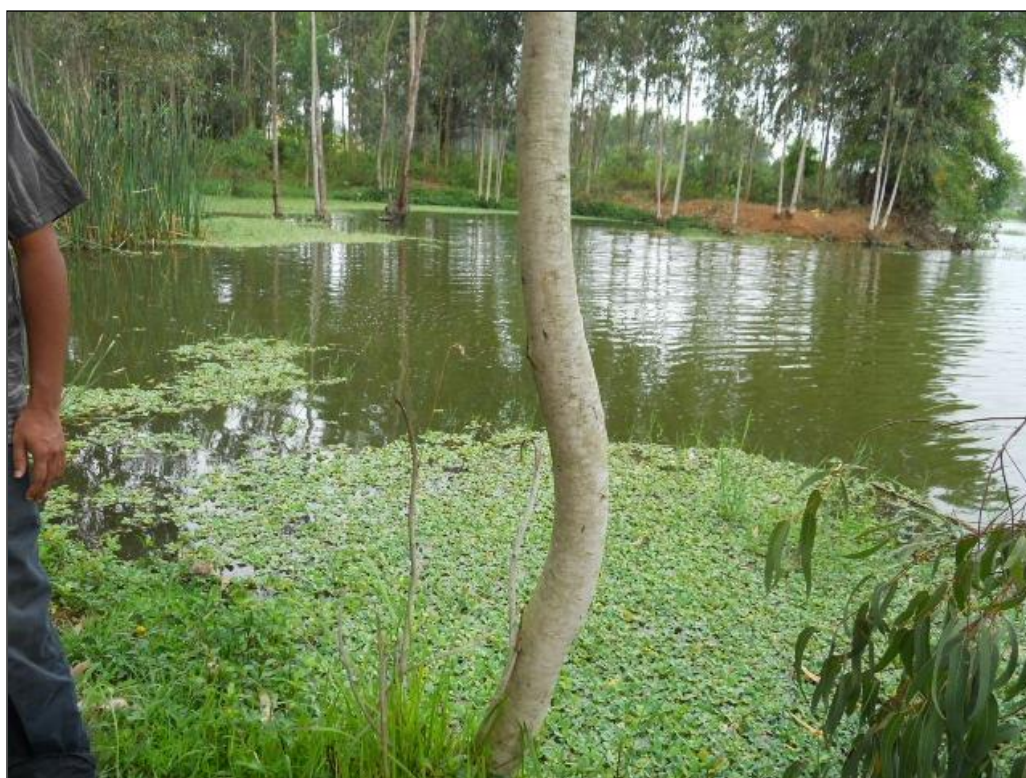
PLATE 28

- Local disturbances,
- Untreated sewage inflow

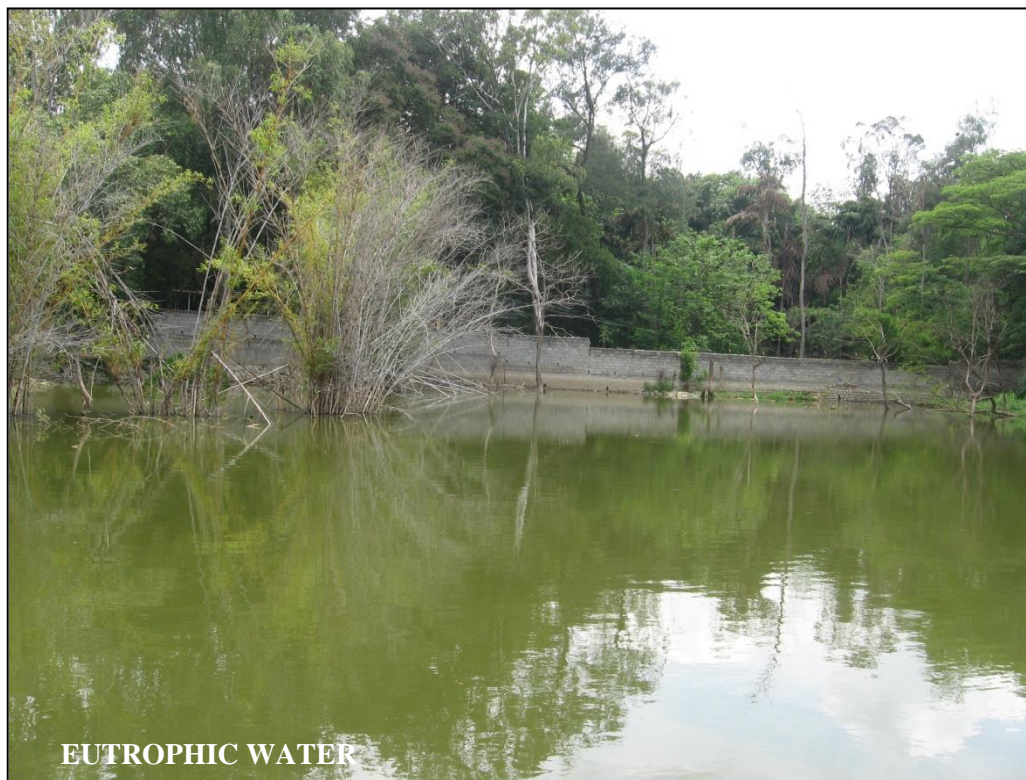
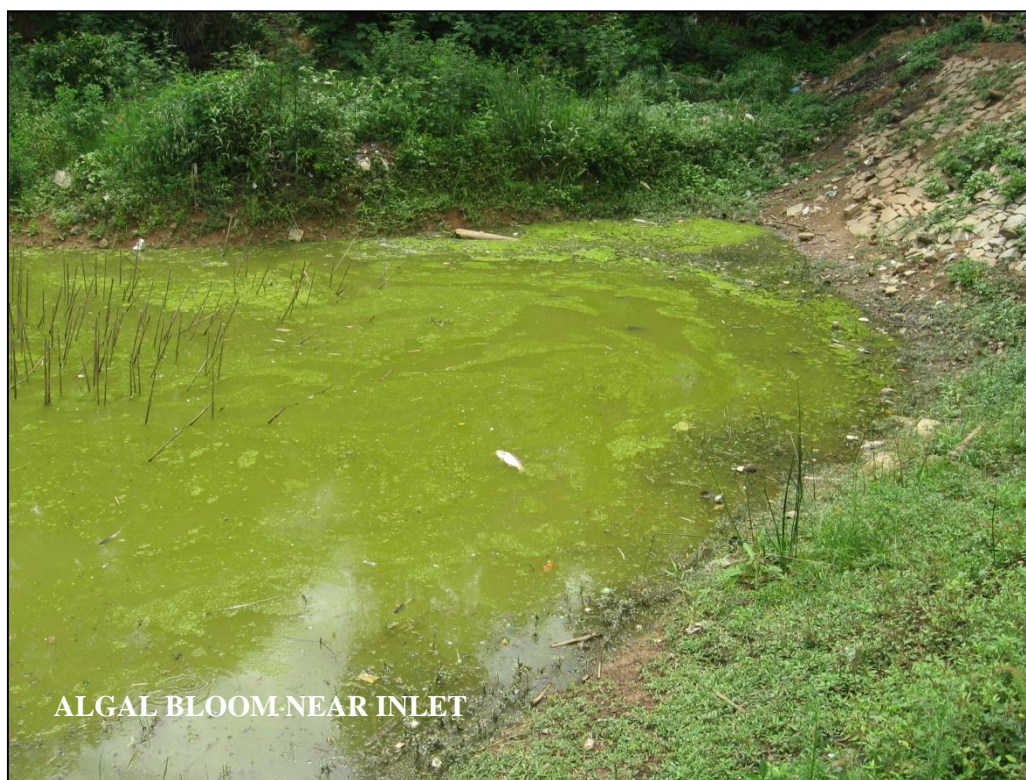
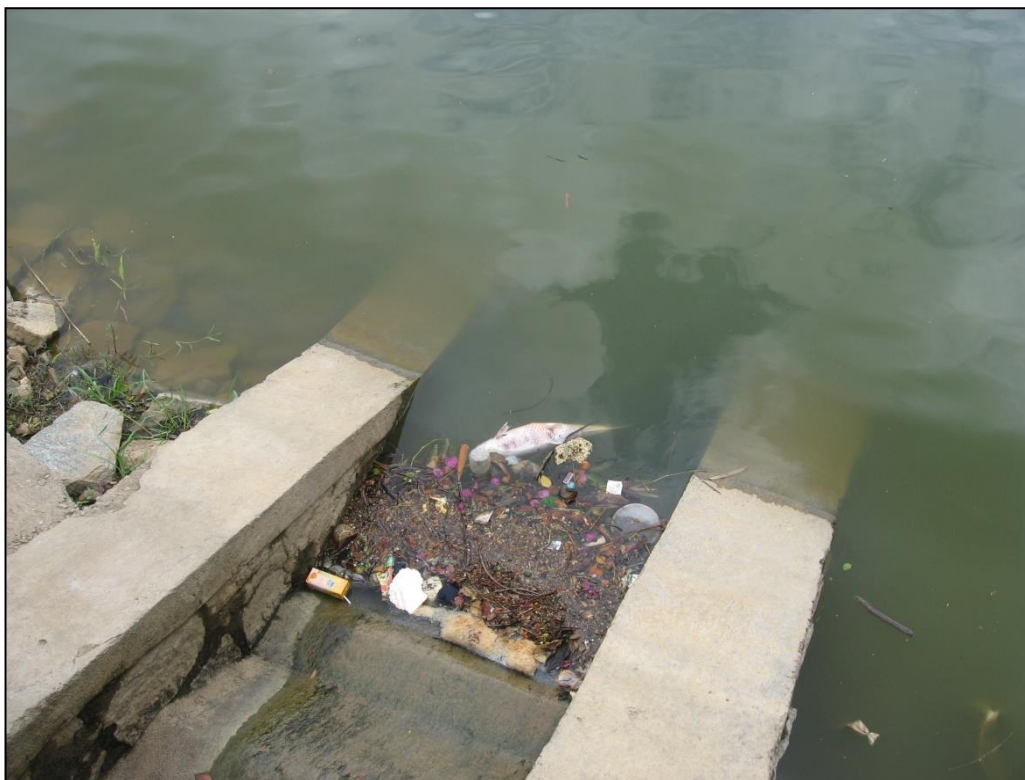
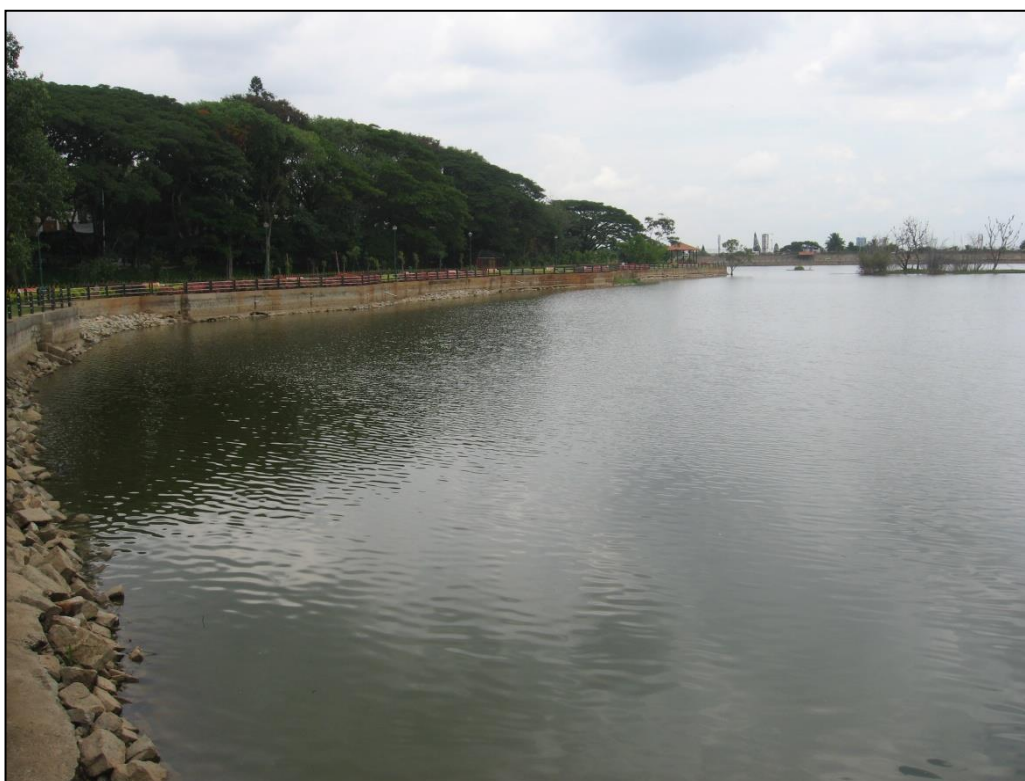
PLATE 29

CURRENT THREATS (Refer Figure 29 and Plate 29)

- Local human disturbances,
- Untreated sewage inflow

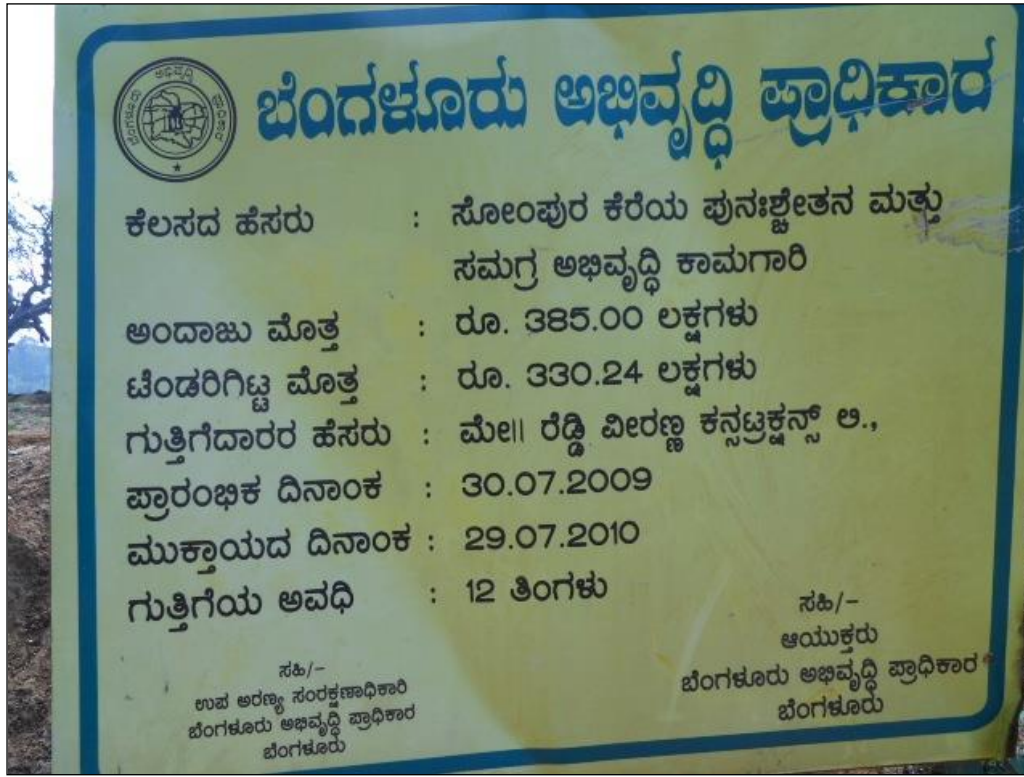
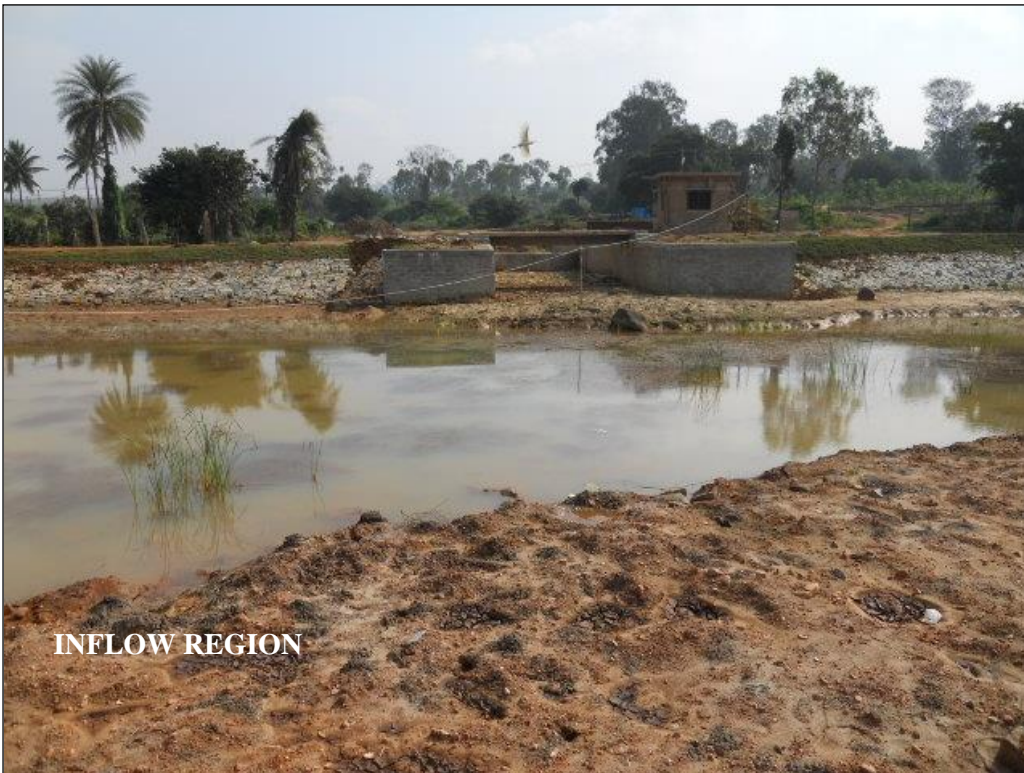
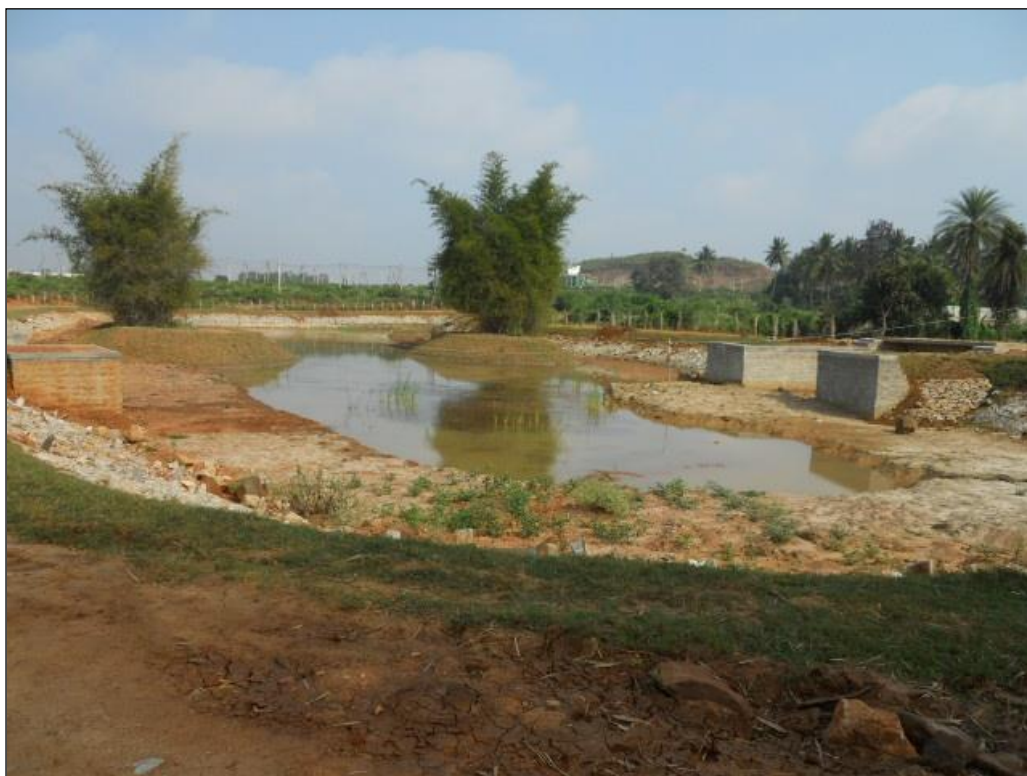
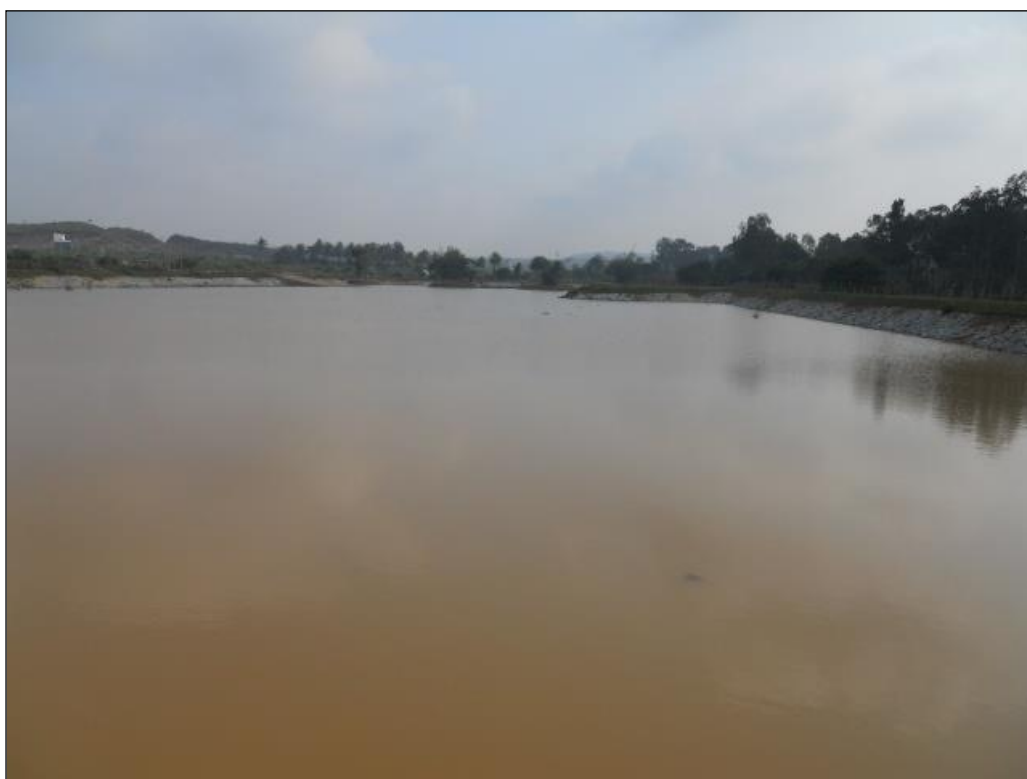
PLATE 30

Water quality of Somapura Lake has been listed in Table 30 which reflected clean to moderate water quality at all the sampling sites. Among all the variables recorded, electric conductivity was found to be high ranging from 1020.67- 1024 $\mu\text{S}/\text{cm}$ which is slightly lesser than the BIS limits from surface standards. Apart from sewage inflow, the asphalted road in addition contributed to lake contamination with chloride concentration. Organic pollution was slightly higher at inlet with 12.88 ppm of BOD and 36 ppm of COD concentrations. The only pollution source found was sewage at inflow which if treated will help in balancing the ecosystem.

CURRENT THREATS (Refer Figure 30 and Plate 30)

- Local disturbances
- Untreated sewage inflow

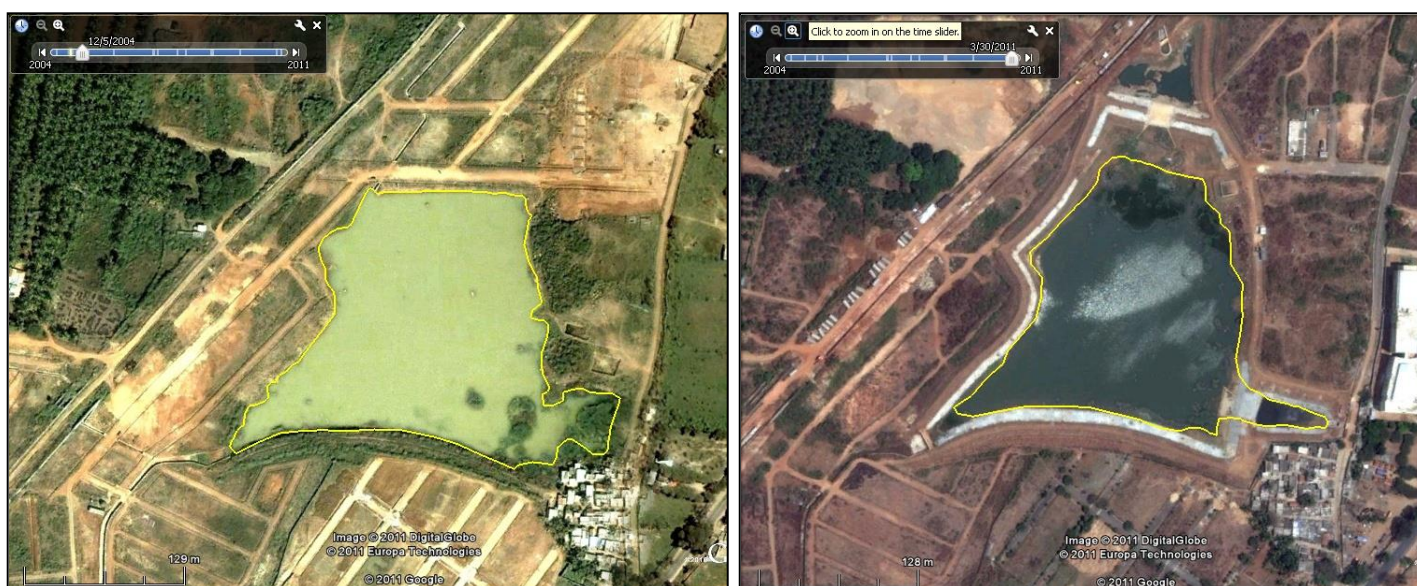
Figure 2 Google Earth image and area of Talghattapura Lake during 2004 and 2011 respectively.

NAME OF THE LAKE	THALGHATTAPURA LAKE
GEOGRAPHIC DETAILS	LAT/LONG: 12°51'55"N 77°31'59"E
AREA (2004/2011)	4.131/ 3.454 ha
ORGANIZATION	BDA
WARD/ VILLAGE NAME	Thalghattapura
STATUS	Moderate pollution
RESTORATION	August 2009- August 2010 (Incomplete)
WATER CONDITION	Moderate (2010) – Poor (2009 before restoration)

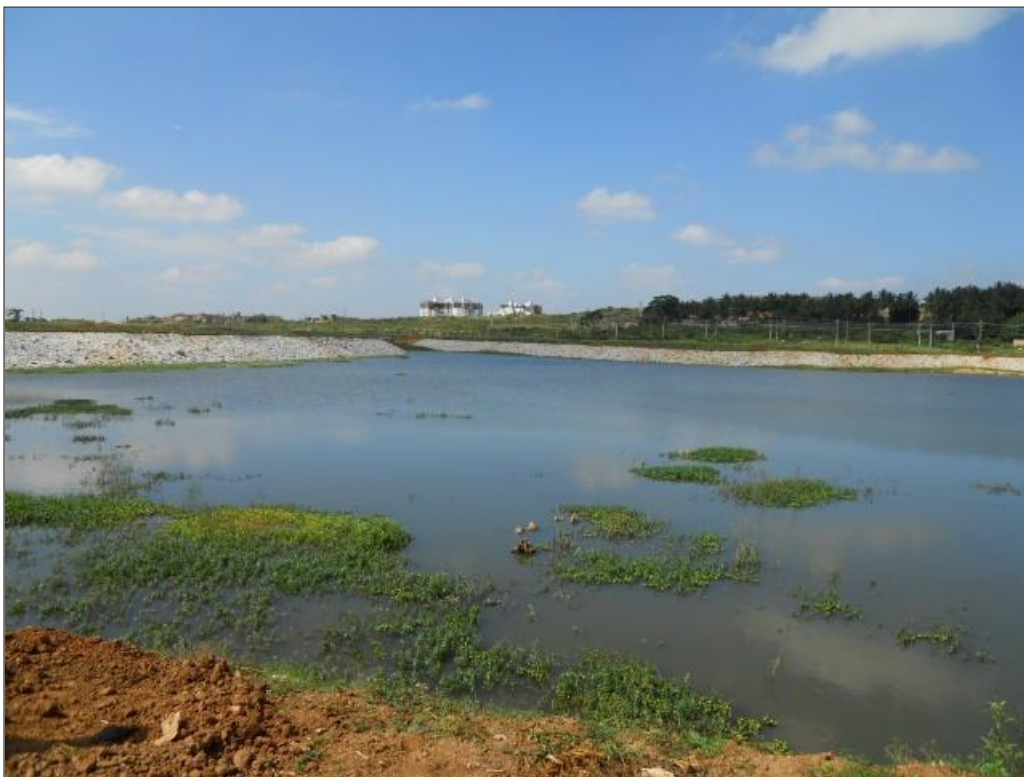
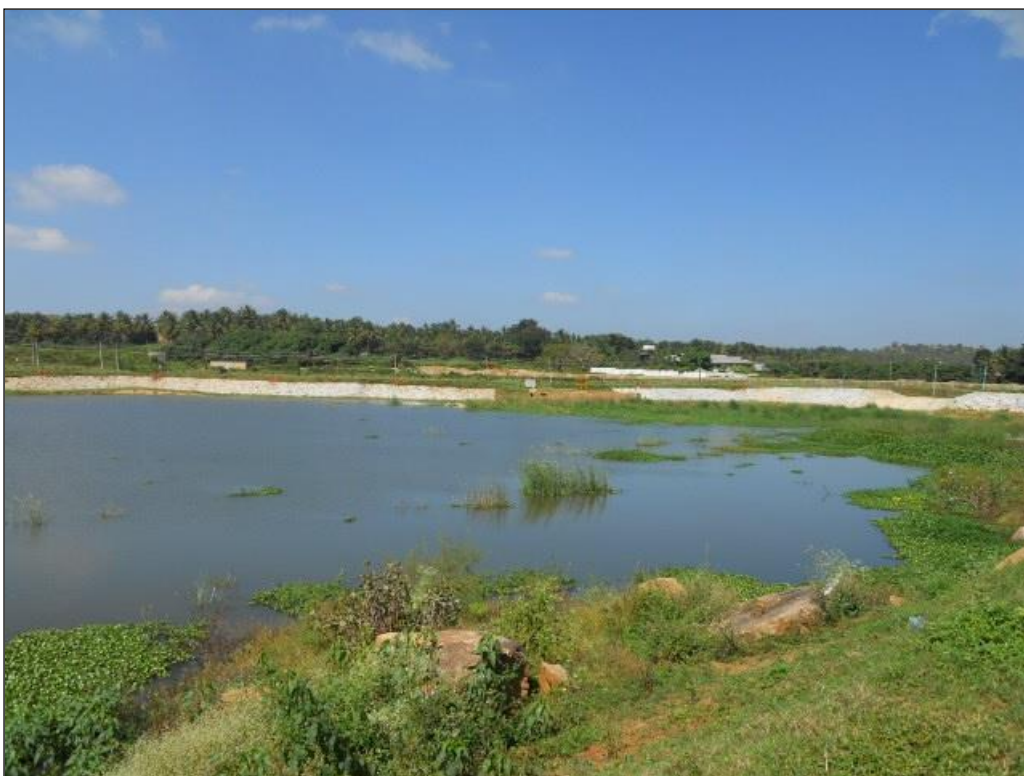
PLATE 32

INCOMPLETE / IMPROPER RESTORATION

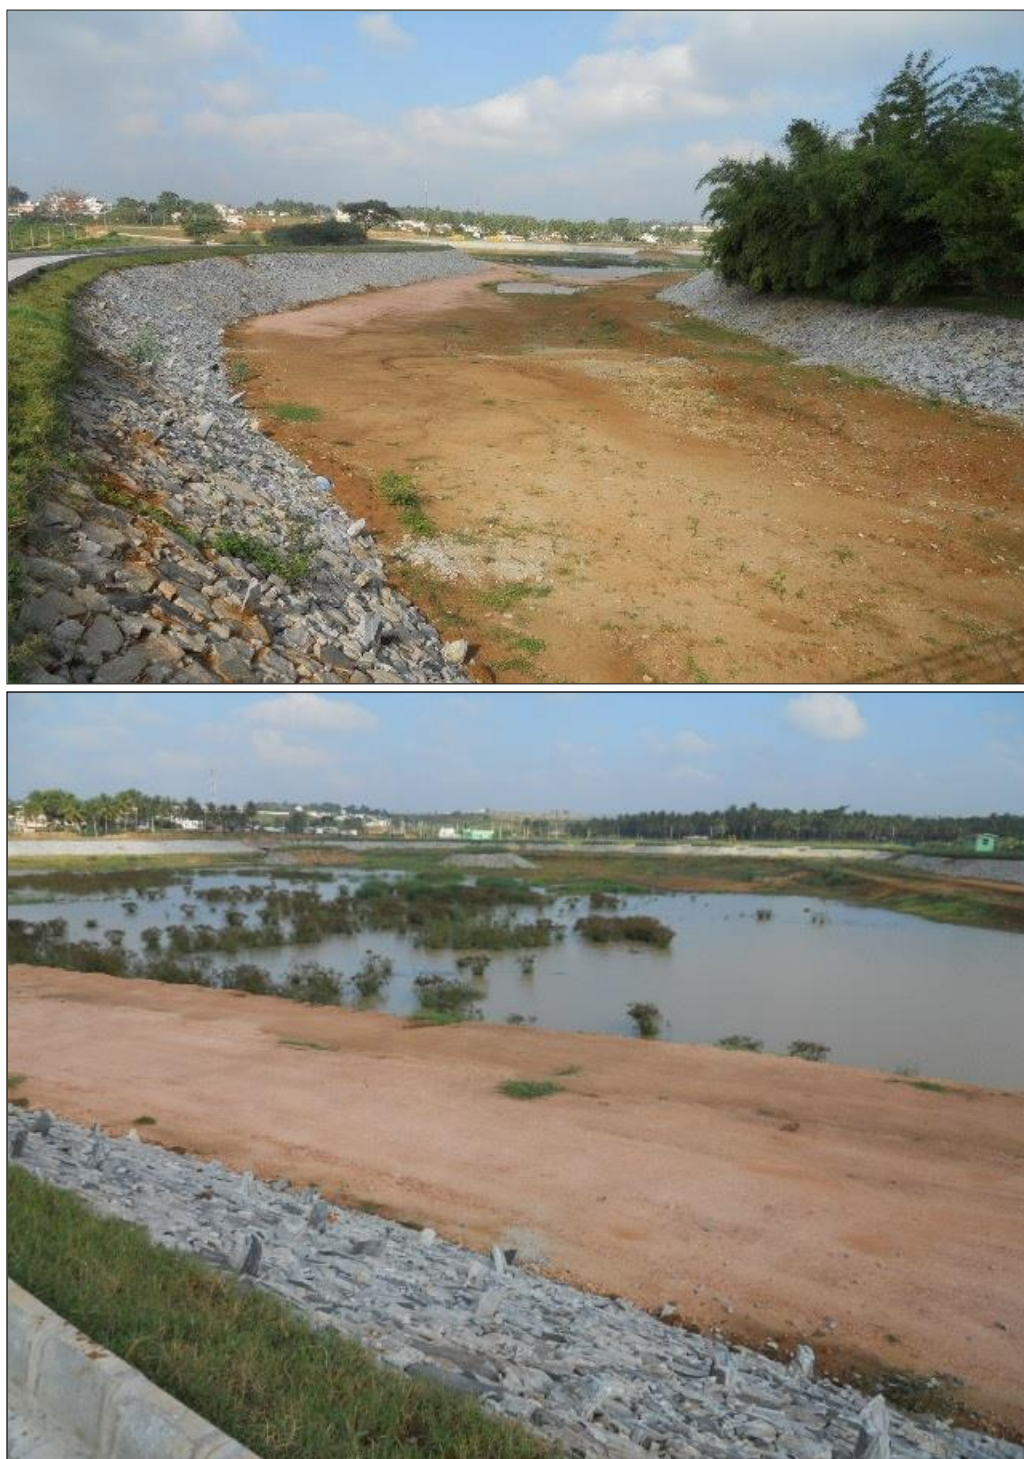
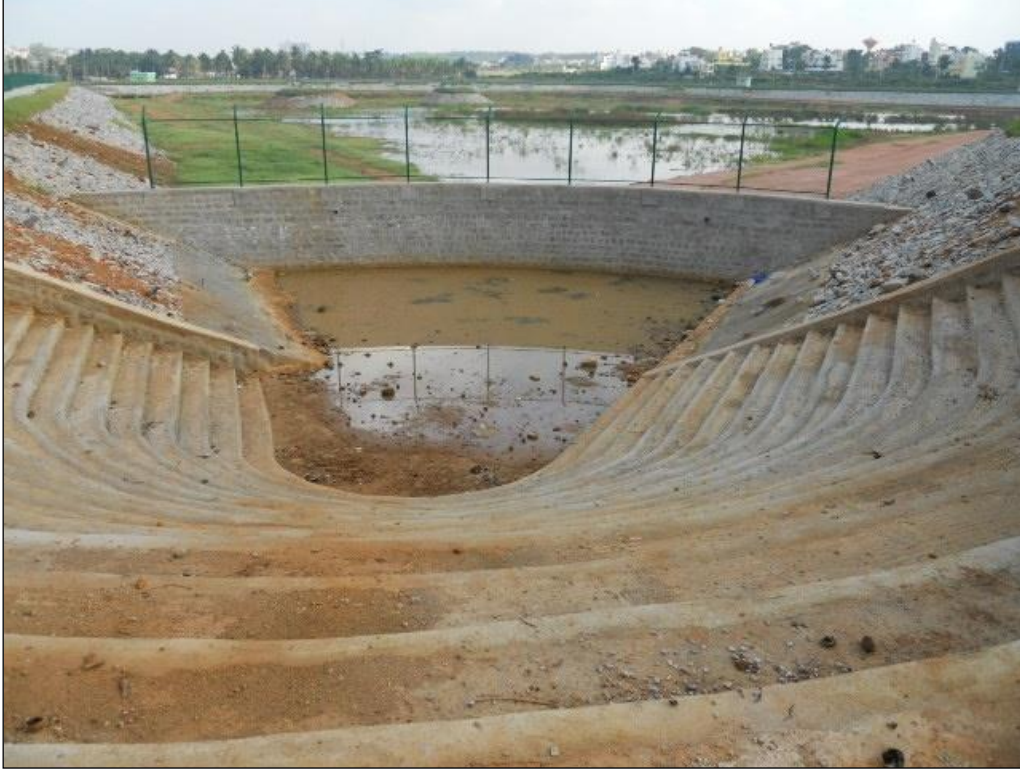
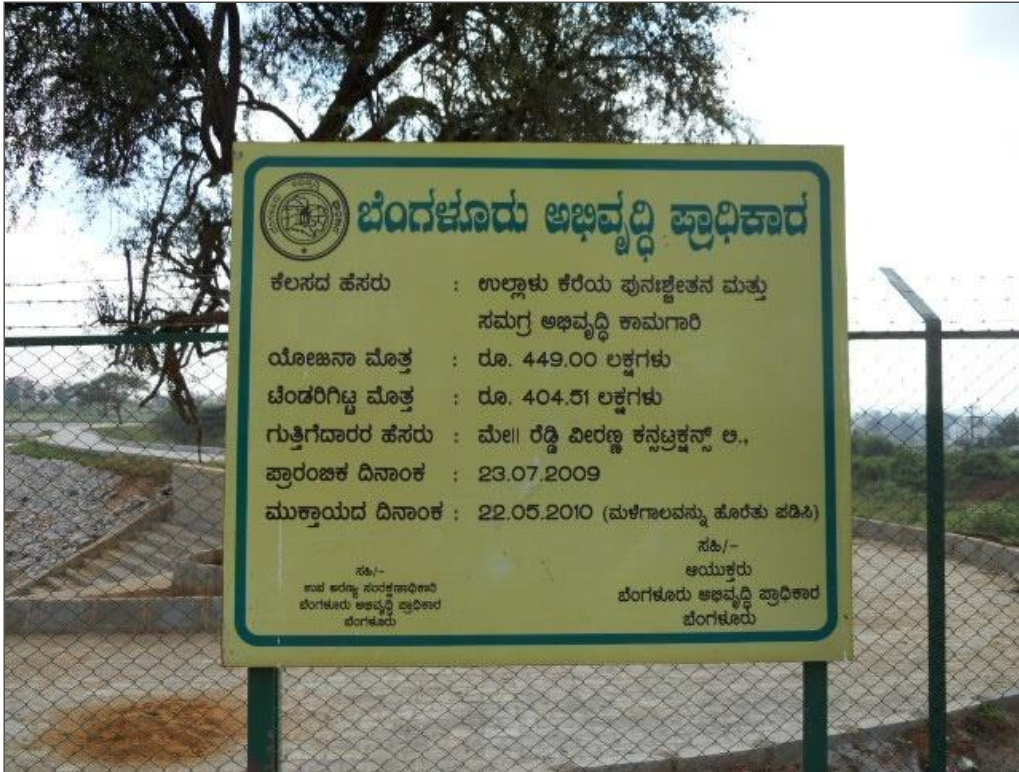
PLATE 33 RESTORATION OF LAKE

CURRENT THREATS (Refer Figure 33 and Plate 33)

- Sewage inflow (before and after restoration)
- Fragmentation of lake
- local human disturbances
- No shoreline and aquatic habitat availability

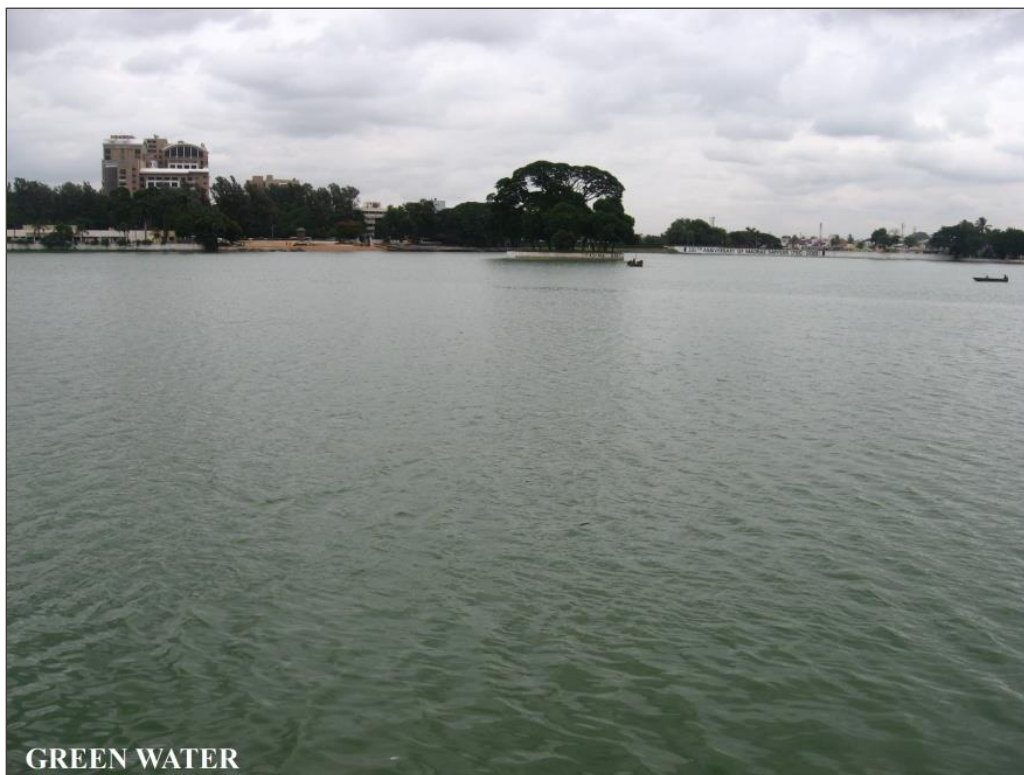
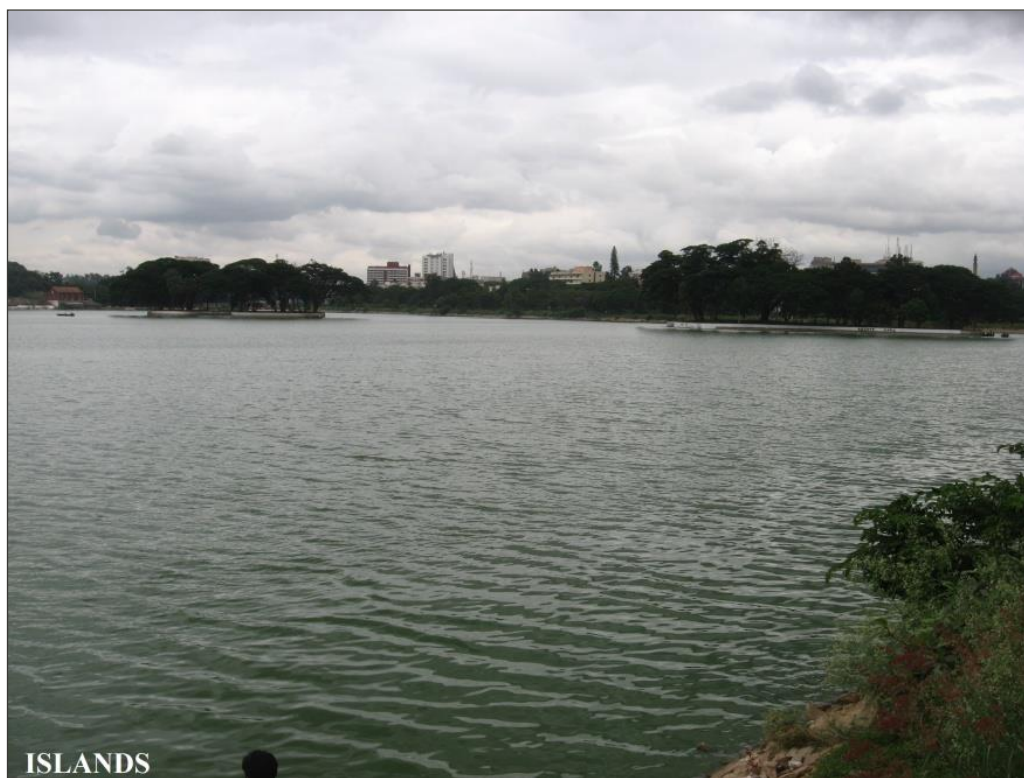
PLATE 34 EUTROPHICATION IN ULSOOR LAKE
