ENVIRONMENTAL AUDITING OF BANGALORE WETLANDS

ENVIS Technical Report 72

January 2015

**Energy & Wetlands Research Group [CES TE15]
Centre for Ecological Sciences,
Indian Institute of Science,
Bangalore - 560012, INDIA**

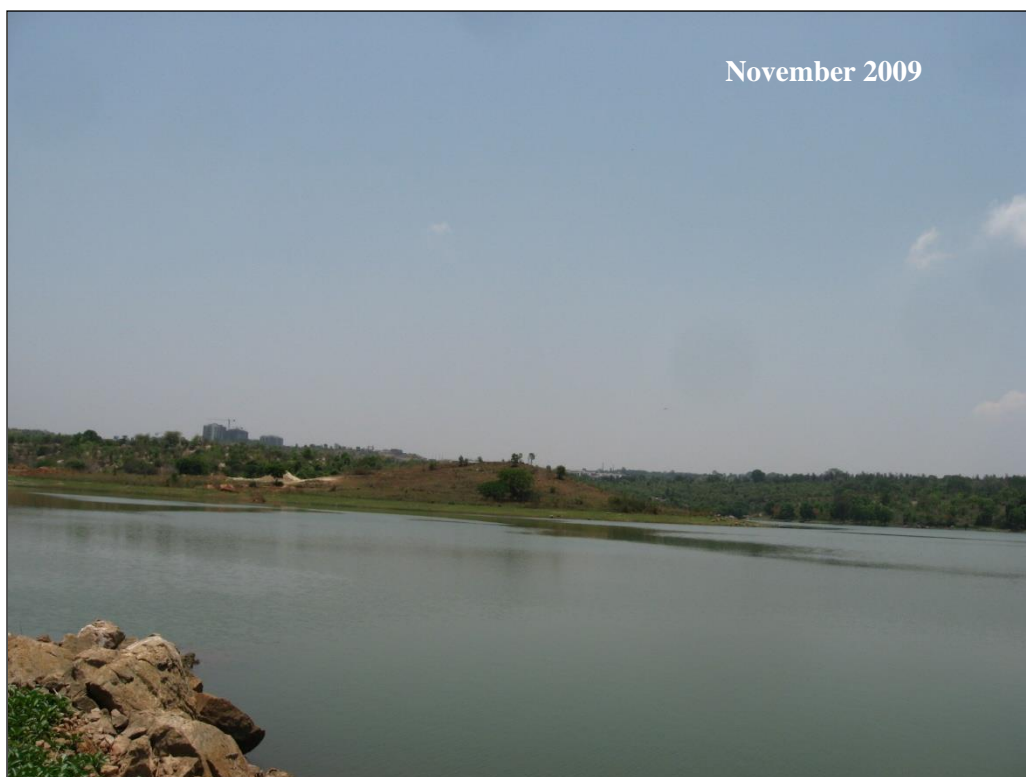
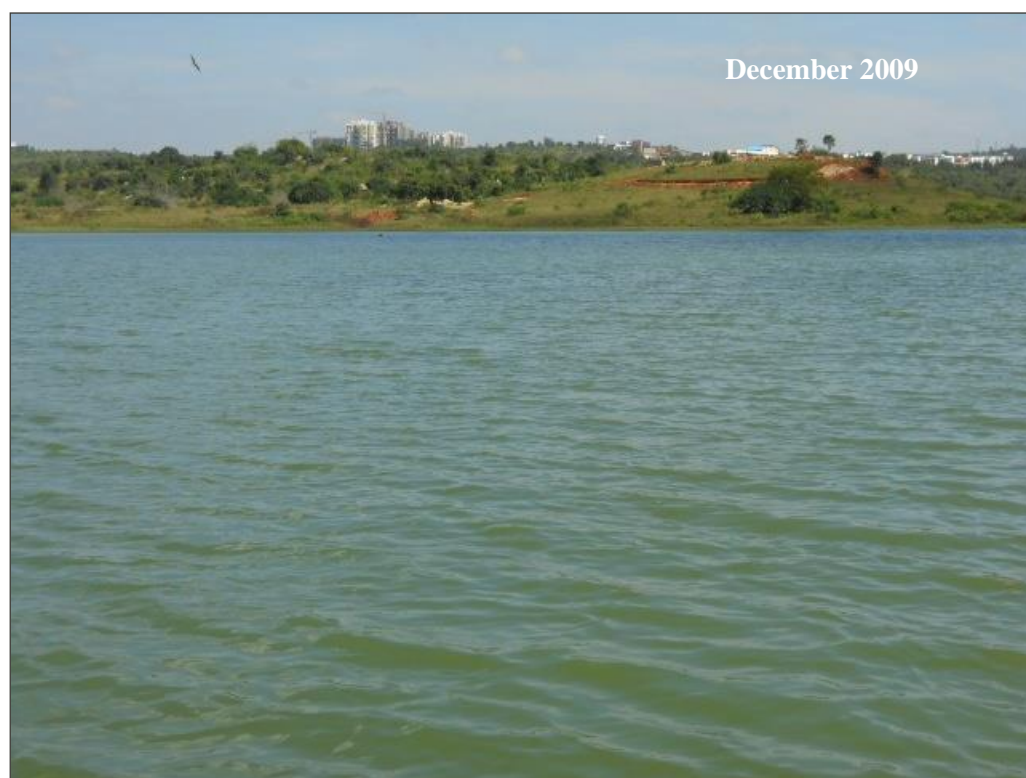
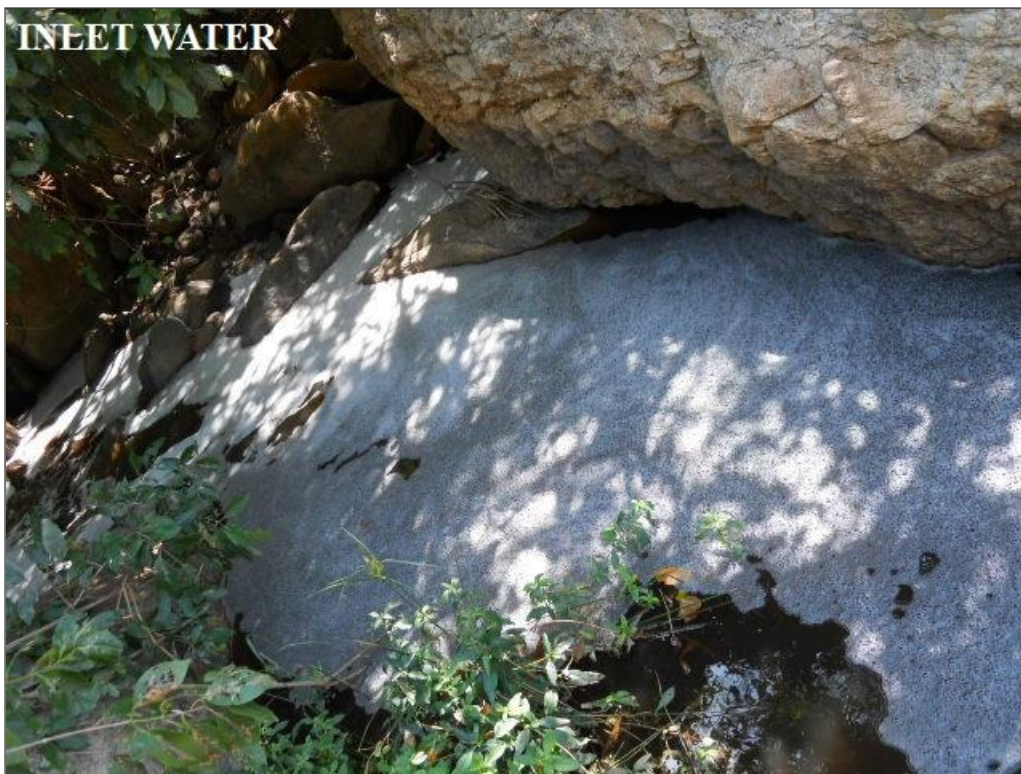
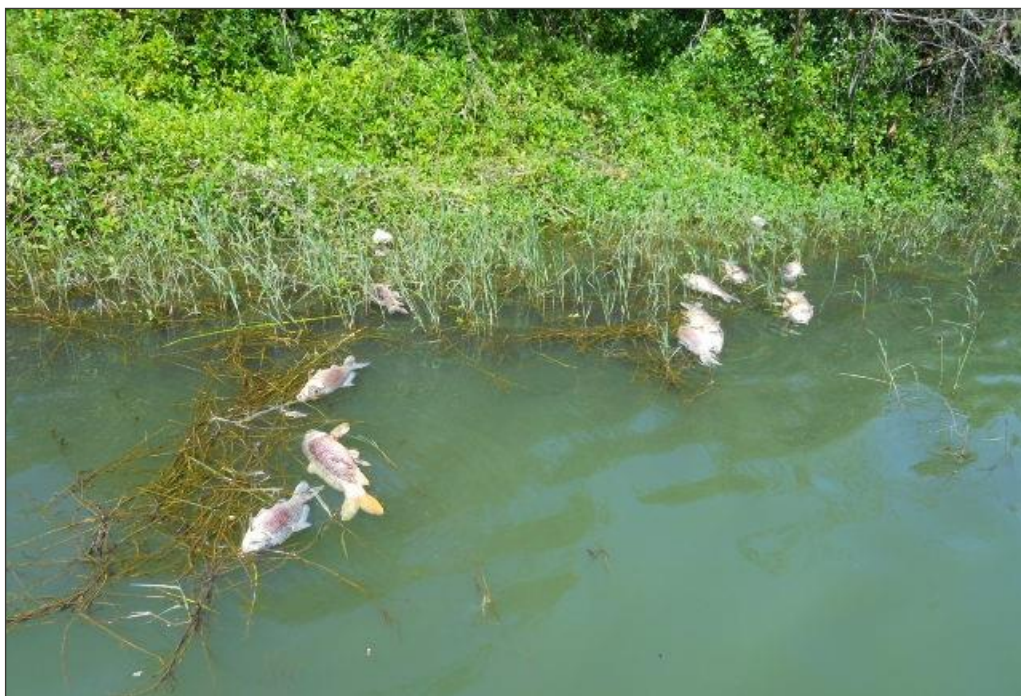
PLATE 35

CURRENT THREATS (Refer Figure 35 and Plate 35)

- Inflow of sewage and Industrial waste,
- Massive fish death in November 2010 due to increased organic matter and decreased oxygen level.
- Local human disturbances
- Recreational activities

DEAD FISH IN THE LAKE

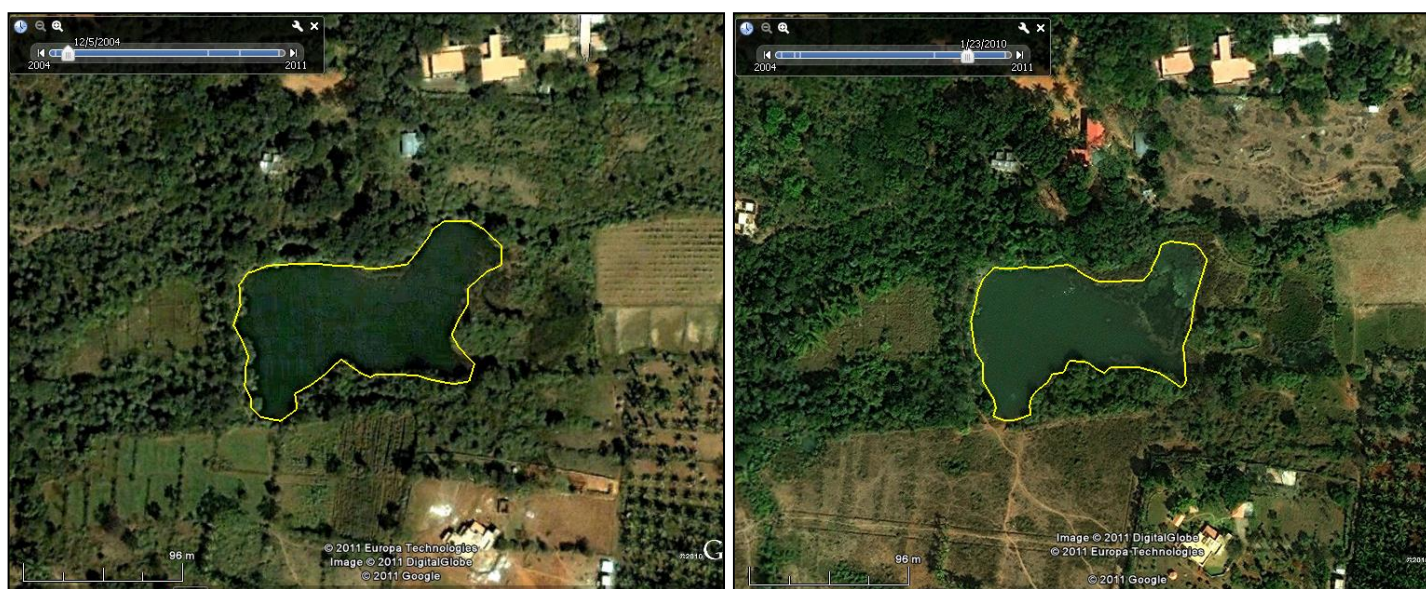
Figure 6 Google Earth image and area of Valley school during 2004 and 2010 respectively.

NAME OF THE LAKE	VALLEY SCHOOL LAKE
GEOGRAPHIC DETAILS	LAT/LONG: 12°51'6"N 77°30'18"E
AREA (2004/2010)	1.088/0.892 ha
ORGANIZATION	Valley school, Forest department
WARD / VILLAGE NAME	Valley school
STATUS	Clean water
RESTORATION	NO
WATER CONDITION	Good

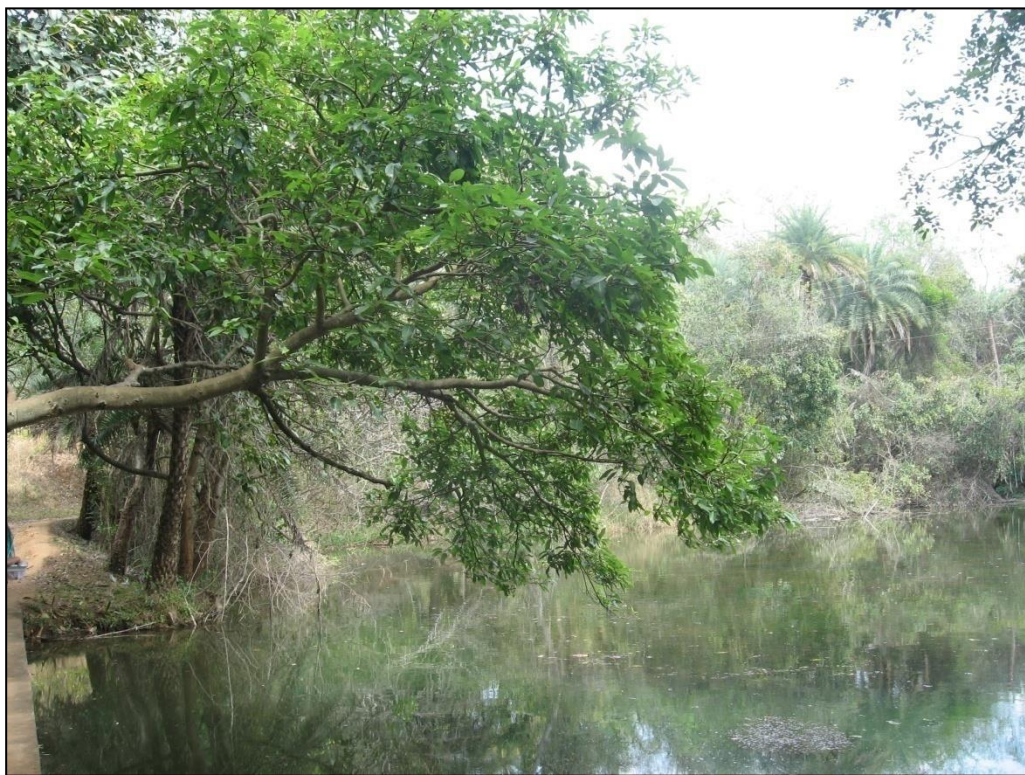
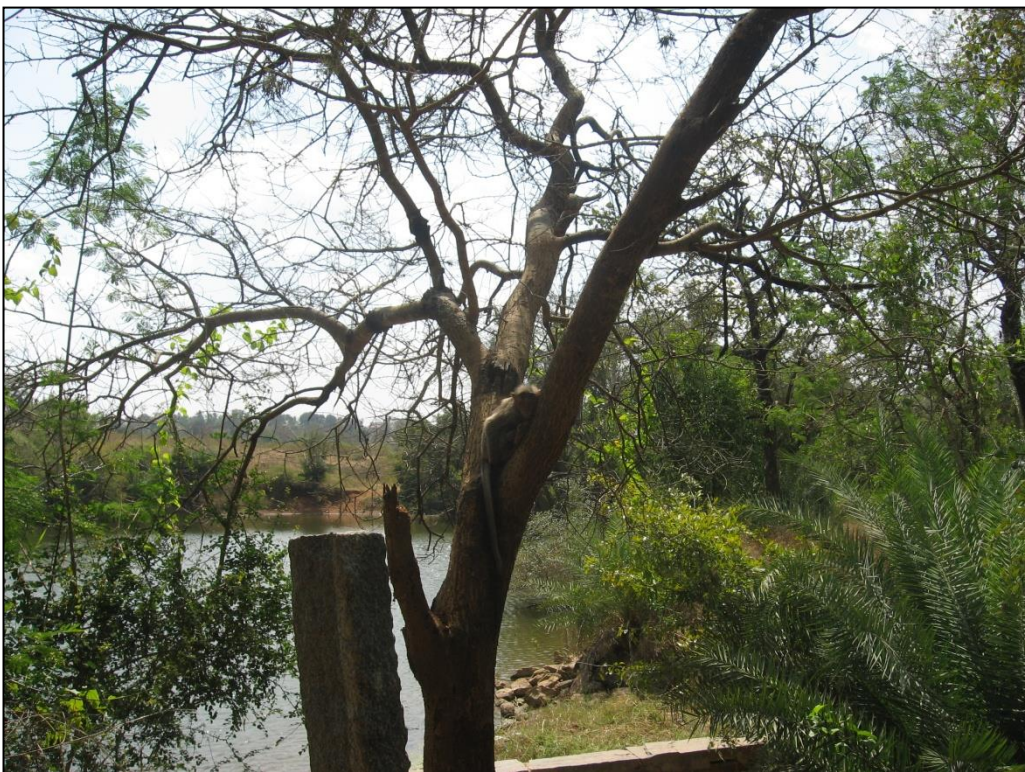
PLATE 36

CURRENT THREATS (Refer Figure 36 and Plate 36)

- Inflow of sewage waste
- local human disturbances (washing, swimming)

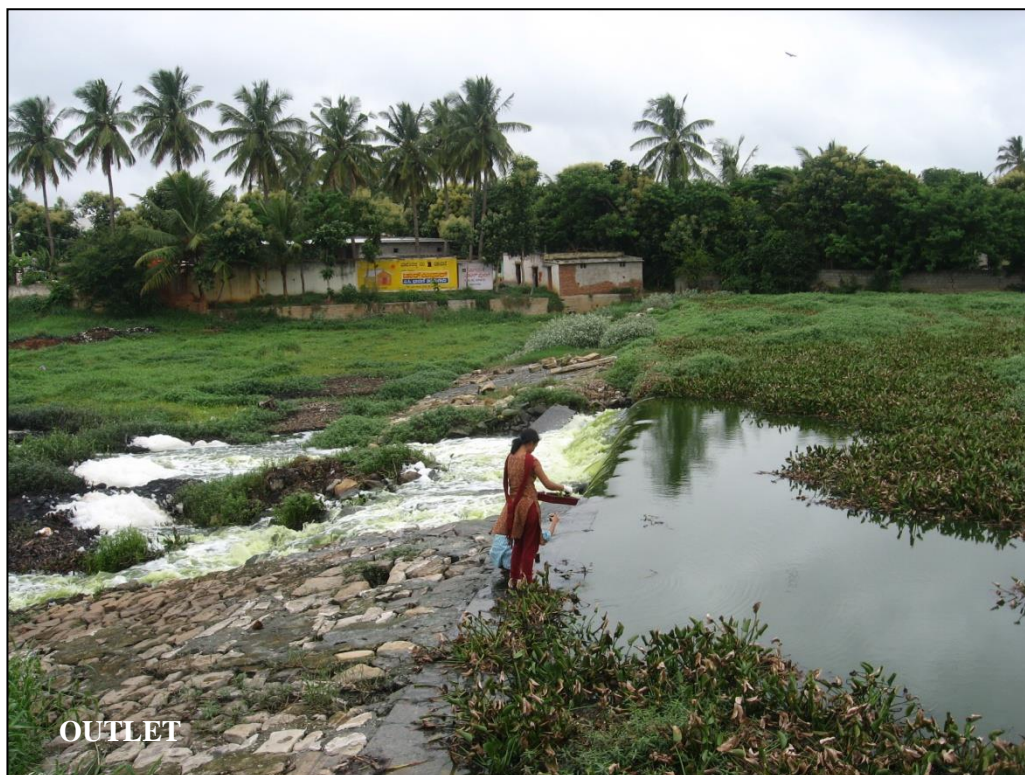
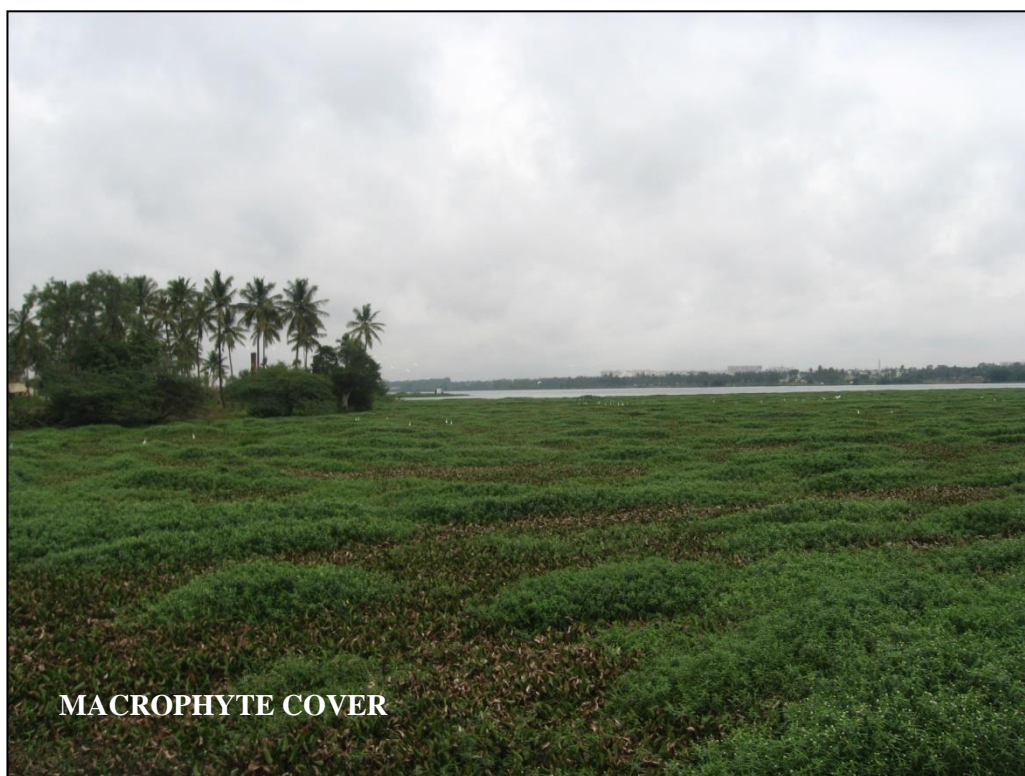
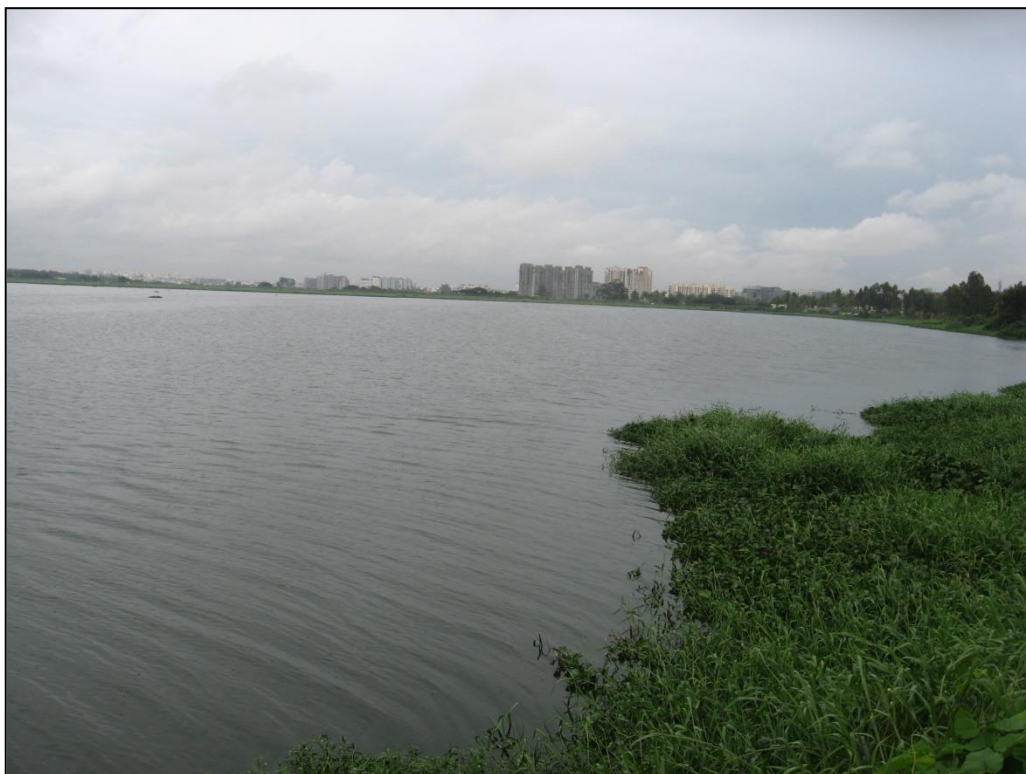
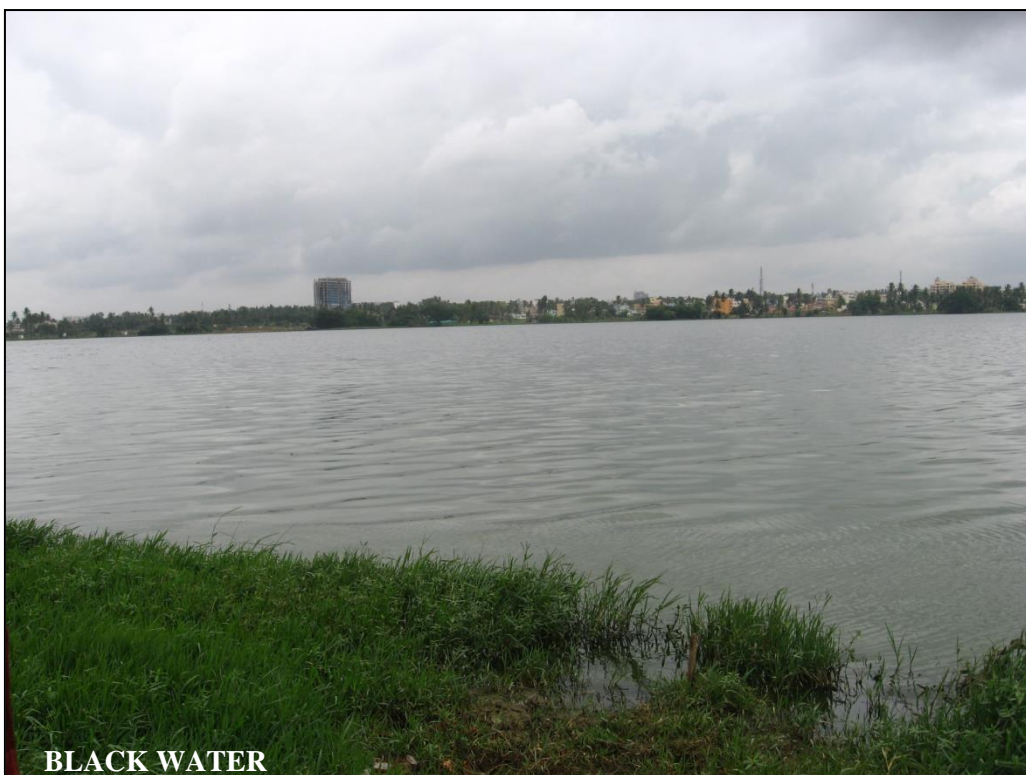
PLATE 37

CURRENT THREATS (Refer Figure 37 and Plate 37)

- Inflow of sewage and industrial waste
- Local pollution such as washing clothes, defecation, swimming etc.
- Agricultural field and plantation run-off,
- Macrophyte cover

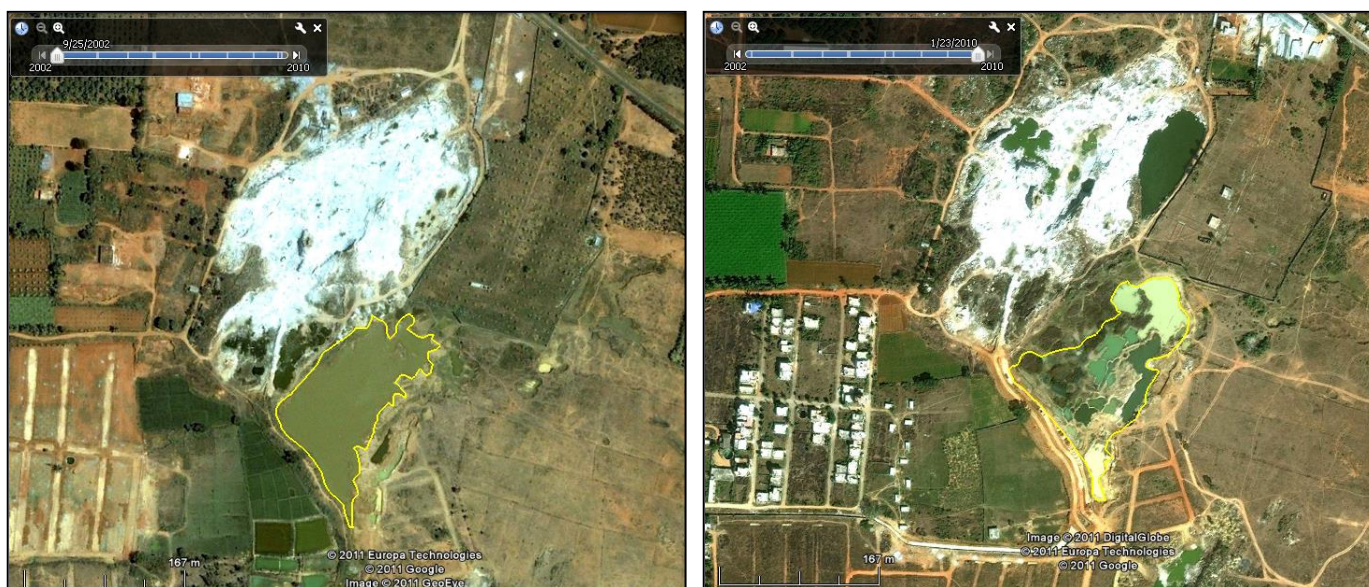
Figure 8 Google Earth image and area of Venkateshapura Lake during 2002 and 2009 respectively.

NAME OF THE LAKE	VENKATESHAPURA LAKE
GEOGRAPHIC DETAILS	LAT/LONG: 13°5'36"N 77°37'49"E
AREA (2002/2009)	1.504/1.756 ha
ORGANIZATION	BDA
WARD / VILLAGE NAME	Jakkur
STATUS	Clean / No / Less pollution
RESTORATION	July 2009- August 2010 (Incomplete)
WATER CONDITION	Good.

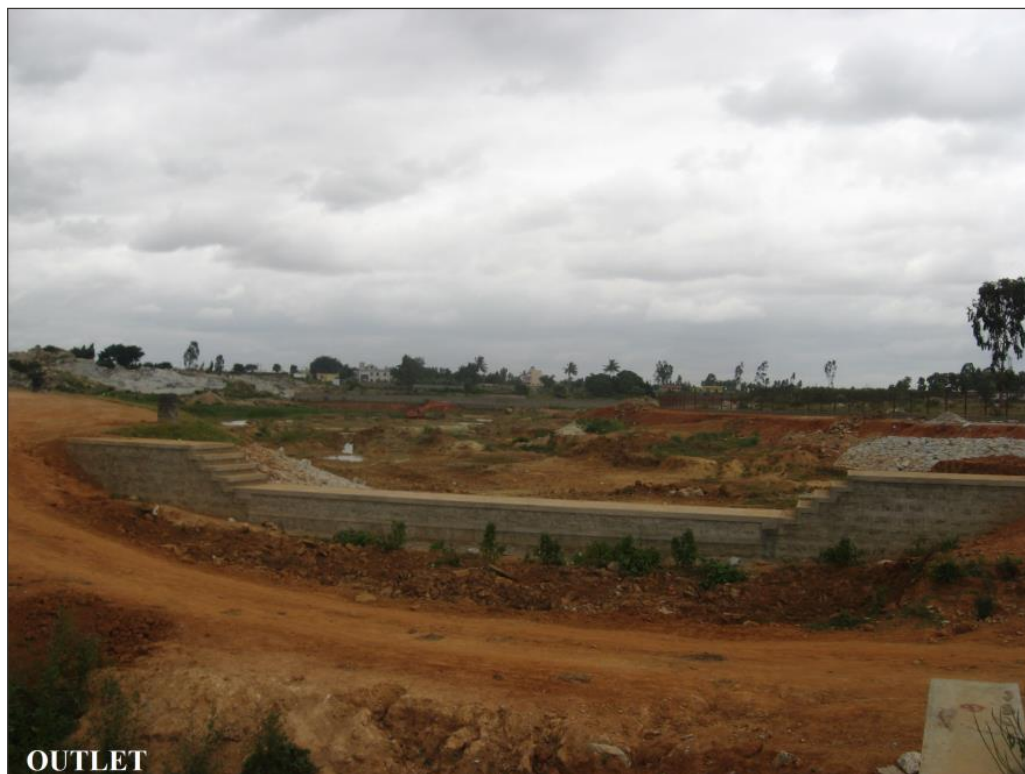
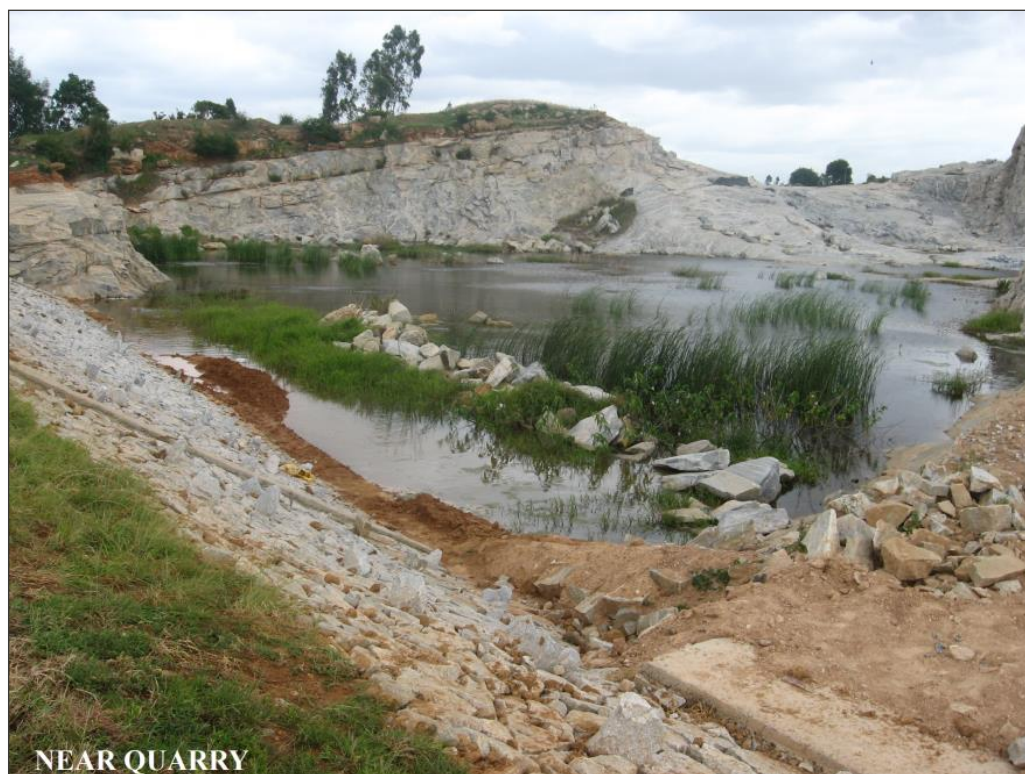
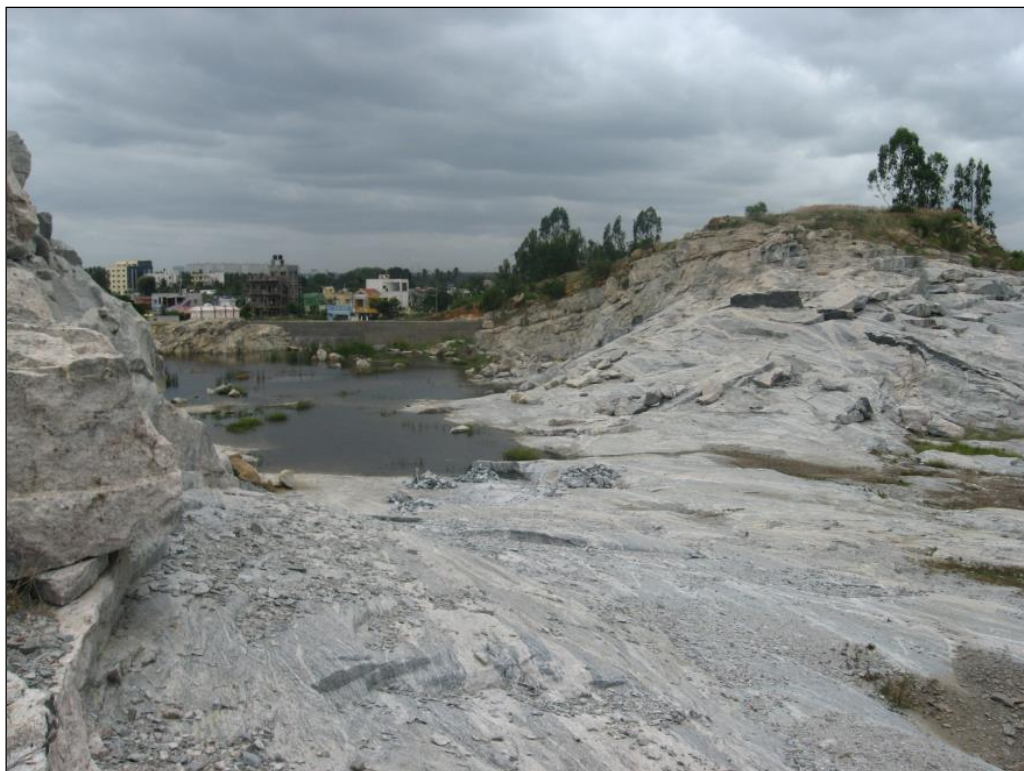
PLATE 38

CURRENT THREATS (Refer Figure 38 and Plate 38)

- Inflow of sewage,
- Regional pollution such as washing clothes, defecation, swimming etc.
- Agricultural field and plantation run-off
- Quarry

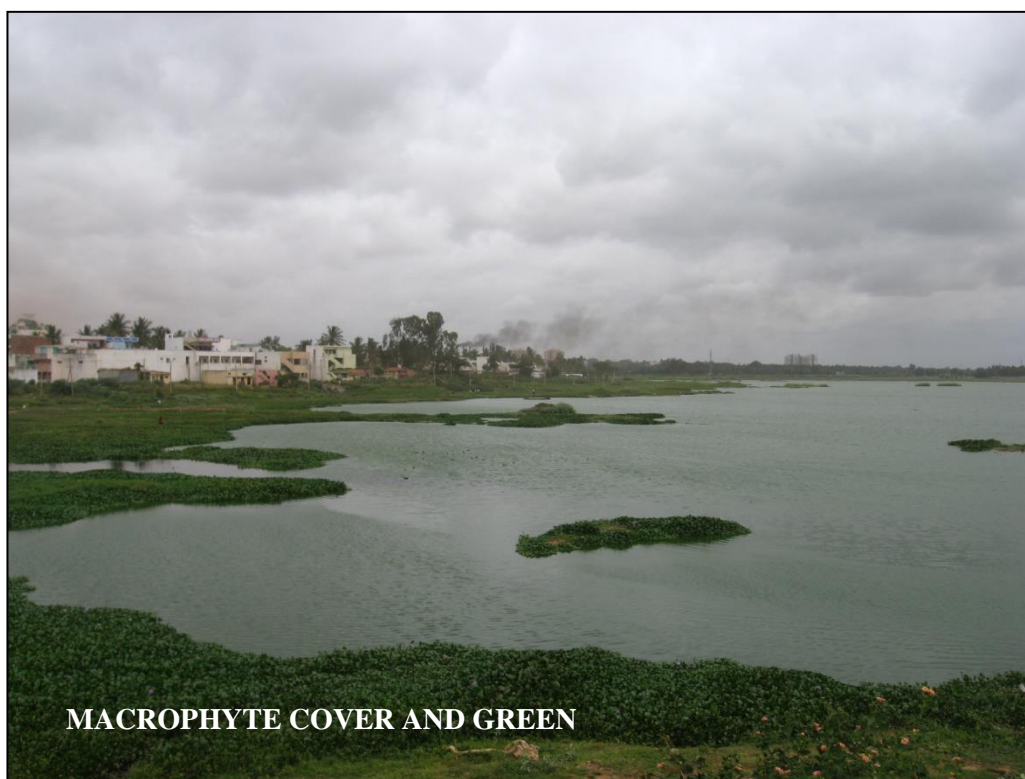
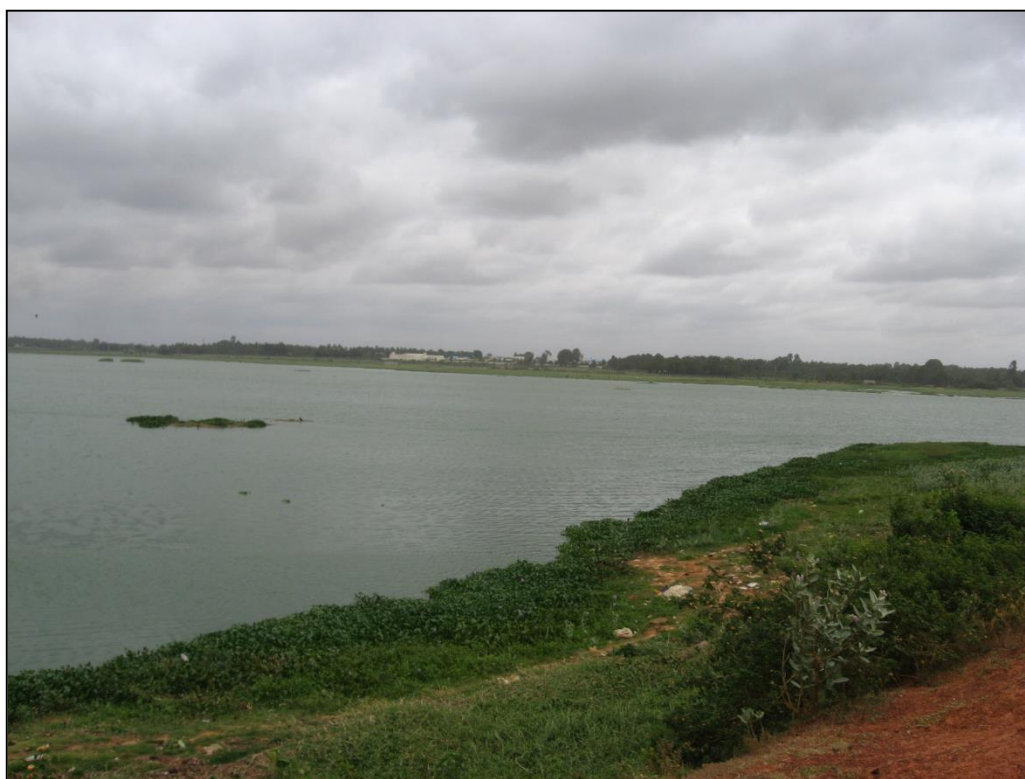
PLATE 39

CURRENT THREATS (Refer Figure 39 and Plate 39)

- Inflow of sewage and Industrial waste from surrounding area
- Regional pollution such as fishing, defecation, swimming etc.
- Field and plantation run-off,
- Massive macrophyte cover.
- No/ less oxygen availability and hence Loss of Biodiversity (Only African catfish is available)

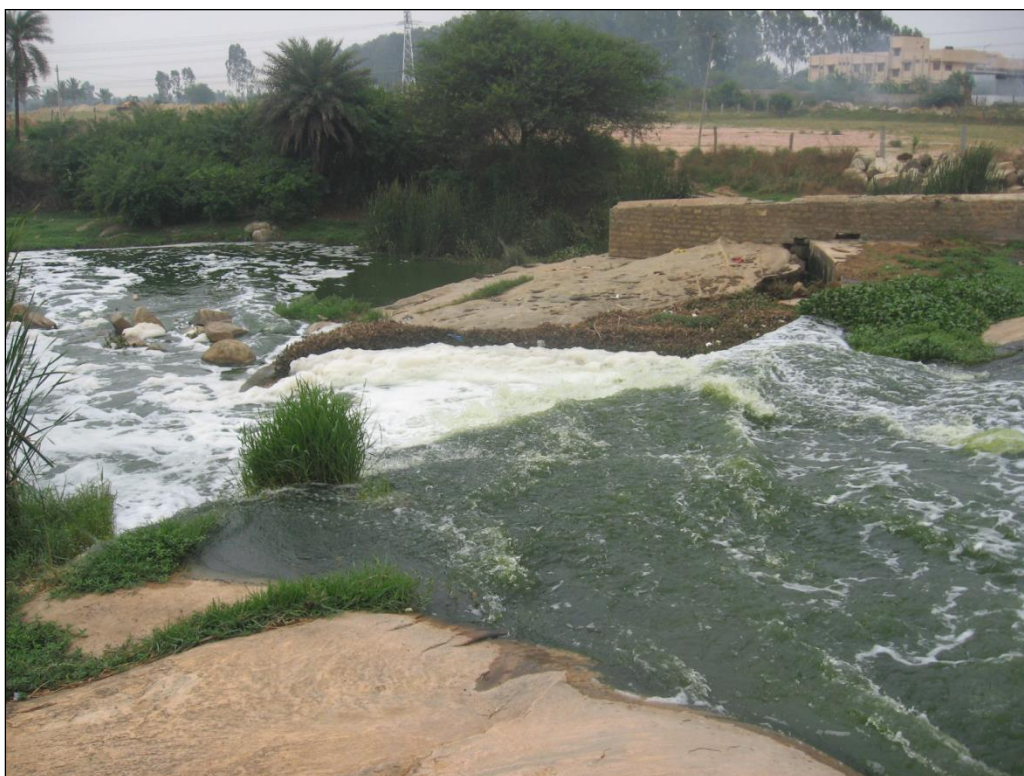
PLATE 40

CURRENT THREATS (Refer Figure 40 and Plate 40)

- Inflow of sewage and Industrial waste from surrounding area,
- Regional pollution such as fishing, defecation, swimming etc.
- Field and plantation run-off,
- More macrophyte cover,
- Loss of Biodiversity (Only African catfish is available)

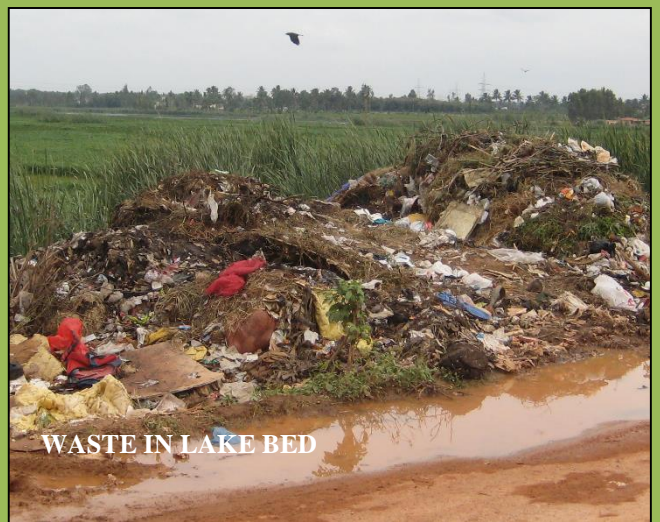
WASTE IN LAKE BED

Evergreen - Froth

Construction debris, Solid waste

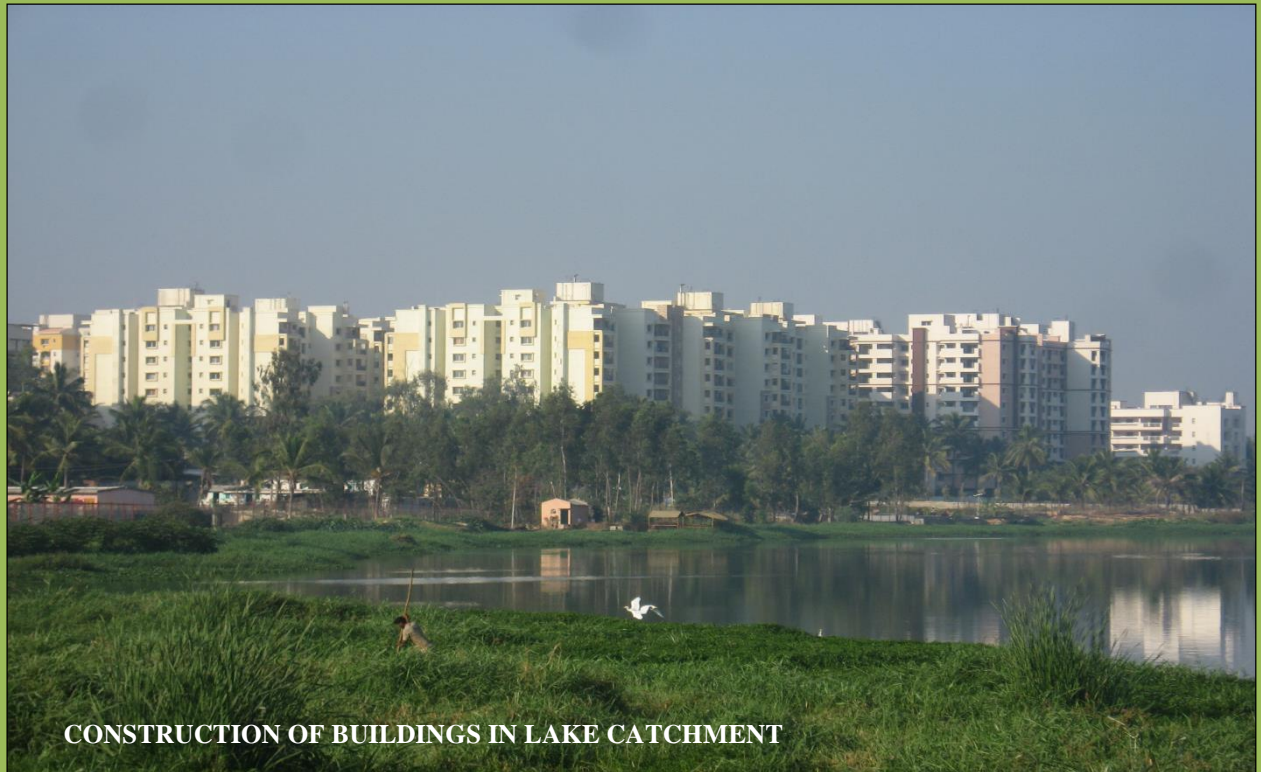
CONSTRUCTION OF BUILDINGS IN LAKE CATCHMENT

Bellandur Lake- Encroachments – Lake bed, storm water drains,..
