# *Landslides at Karwar, October 2009: Causes and Remedial Measures*

**ENVIS TECHNICAL REPORT: 33**  
**November 2009**

# **Landslides at Karwar, October 2009: Causes and Remedial Measures**

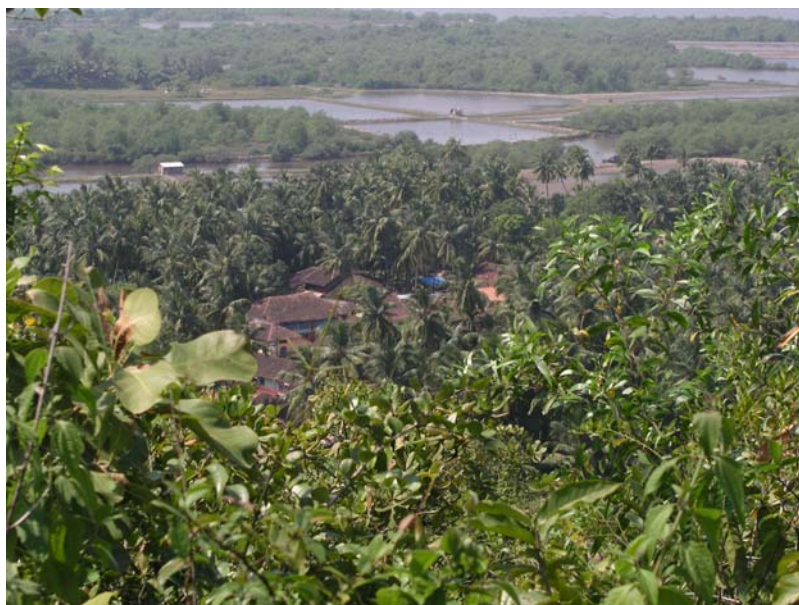
Fig. 2.17: The densely settled Kadwad village at the foot of the hill, bordered by mangrove swamps and prawn farms

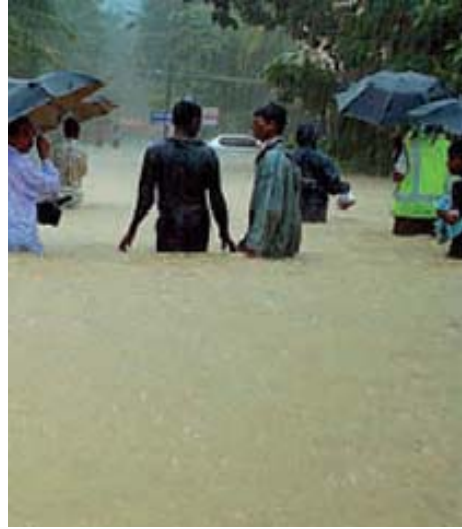
blocked water. The flooding of Karwar city during those October first week days was attributed by locals to poorly engineered drainage system and choking of drainage canals due to inaction of the Municipality. A minor landslide in Canacona in South Goa, that took place at 5.30 am on 2 October, 2009 halted the trains on the Konkan Railway. Railway tracks, south of Karwar were already flooded (<http://www.indianews.com/business/2009/1002/224517.htm>). Dakshina Kannada had also reported floods and landslides on October, 2. Landslides happened in Venur and Laila of Belthangidi taluk (<http://www.daijiworld.comnews>)

Fig. 2.18. Karwar flooded during October first week, 2009

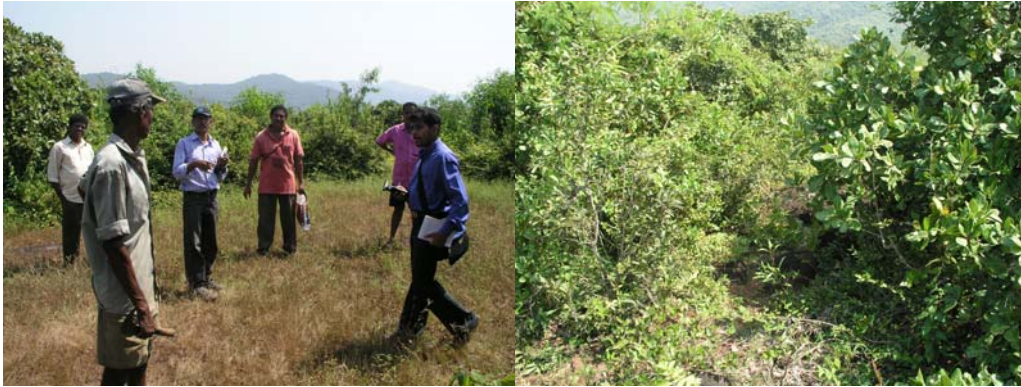
***Insufficiency of vegetation:*** Good tree cover would have been an effective insurance against erosion and landslides, especially on small hills. Whereas a good forest in Uttara Kannada normally has 350 plus trees, density of mere 76 trees/ha is too poor a protective cover. Whereas a multi-canopied vegetation is desirable as in most natural vegetation elsewhere there are only low, stunted and isolated cashew trees. Most trees bear marks of cutting and lopping. Coppices of *Terminalia paniculata*, *Tectona grandis*, *Odina woder* etc are also found sparingly. That the slope instability, to a major extent, could have been

caused by poor tree cover can be assumed from the fact in the split part of the hill hardly had any deep going dicot tree roots. Most plants are of shallow rooted shrubs and climbers and palms like *Caryota urens*. The lower slope bordering human habitation has very poor natural tree growth. Combined and cumulative impact of soil removal, toe cutting and torrential rains was in the form of the major landslide that destroyed homes and killed 19 people.

Fig: 3.1. Surveying vegetation of Zariwada hill in Kadwad

Fig: 3.2. View of the scrubby vegetation of the Zariwada hill

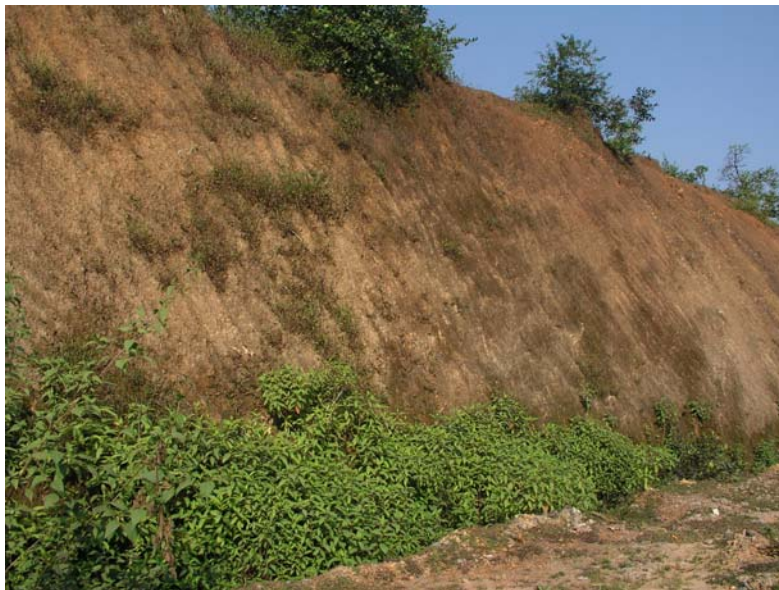
The landslide chances of lateritic hills of southern coast (Kumta to Bhatkal) are slim because of the hardness of the exposed surface. A road cutting in Kumta taluk shows such hardened surface with least chances of landslide (figures 4.4-4.5) unlike the granite-soil complex of Karwar hills along the NH-17 where several slides have happened. Note that the picture of road cutting is in contrast to the collapsed hillside of same NH-17 in the Arga hill of Karwar (Figure 4.6).

Fig: 4.4. A stable road cutting on NH-17 in Kumta showing hardened lateritic surface

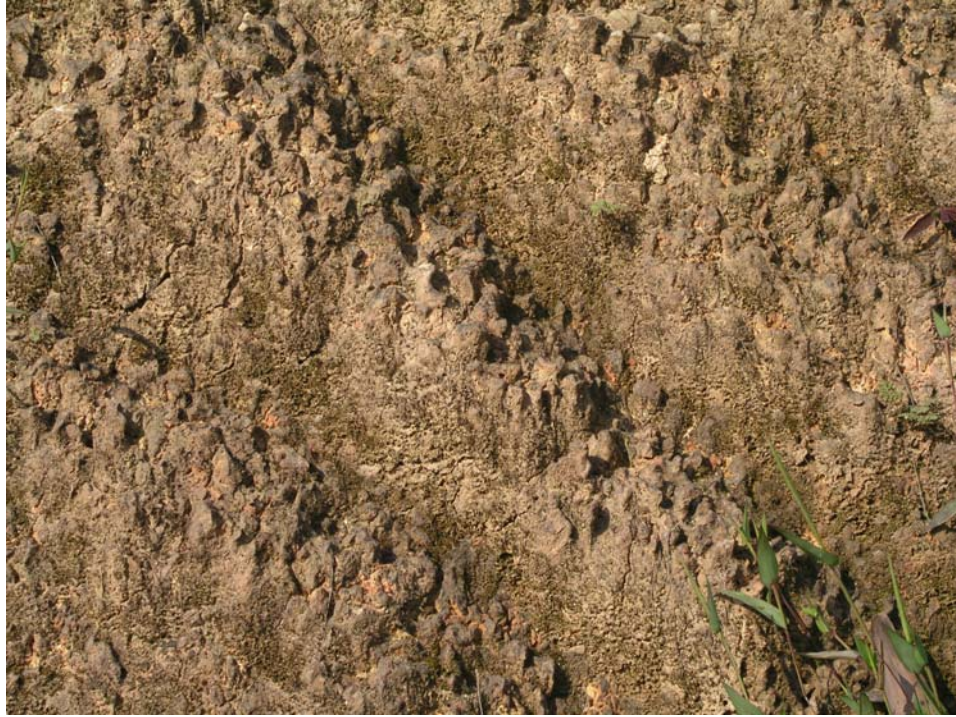
Fig: 4.5. Hardened lateritic surface of road cutting in Kumta – close view

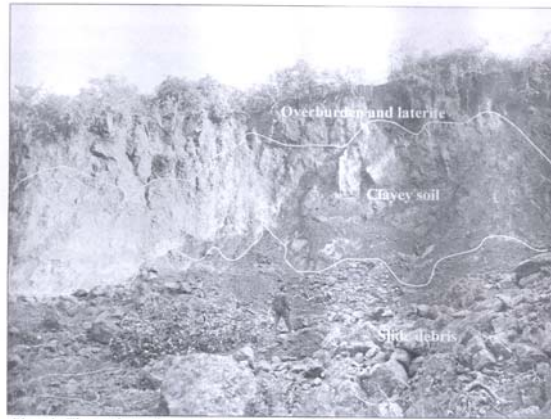
*Photo1: The geological set up at the site.*

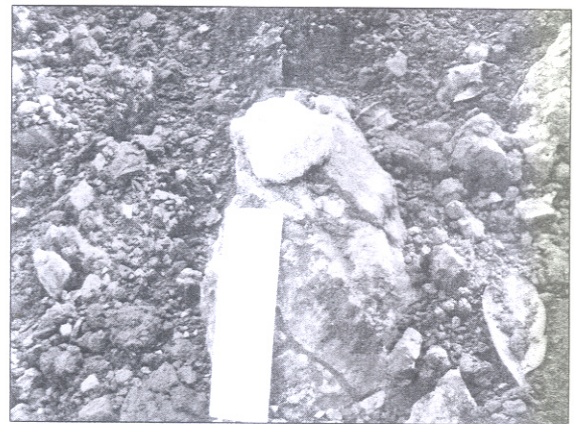
*Photo3: The weathered granite (saprolite) in the slide debris in the mid slope (right flank).*

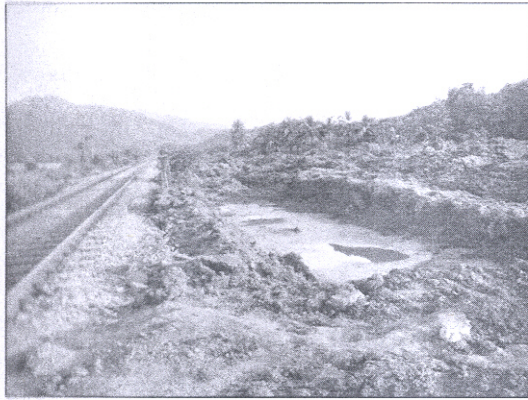
*Photo10: View of the toe of the slide blocked by the embankment of Konkan railway*

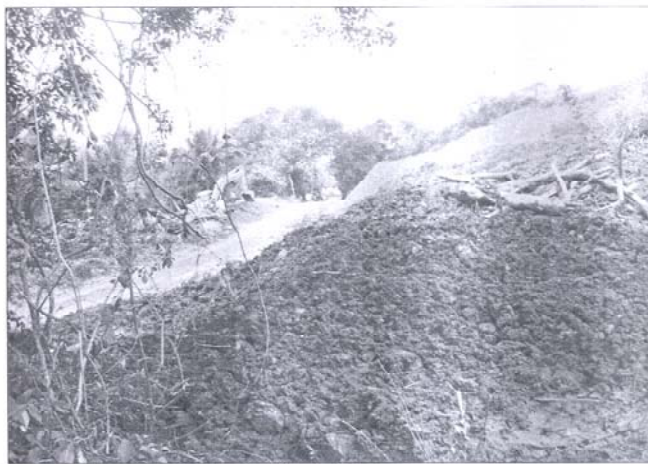
Photo 14: The soil and debris has blocked the road

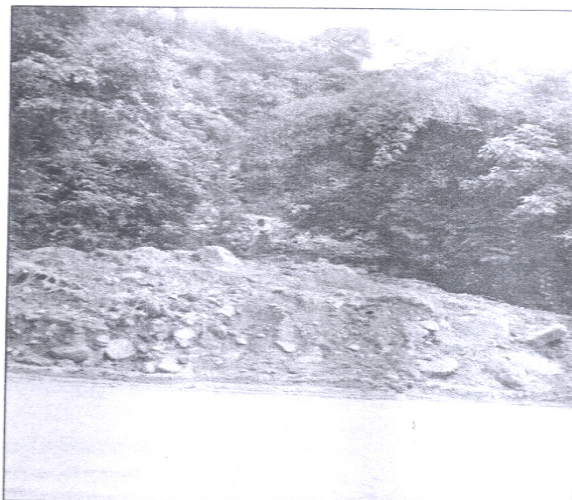
*Photo17: The middle of the three coalesced slides and is the longest slide*

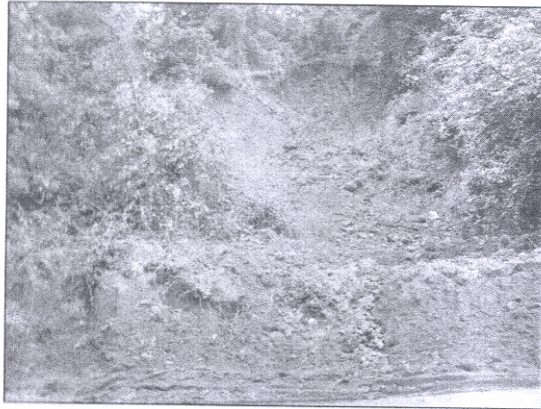
*Photo18: The source of the maximum debris on to the road*
